Case Report

# Combination of Diagnostic Tools for the Proper Identification of Moisture Pathologies in Modern Residential Buildings

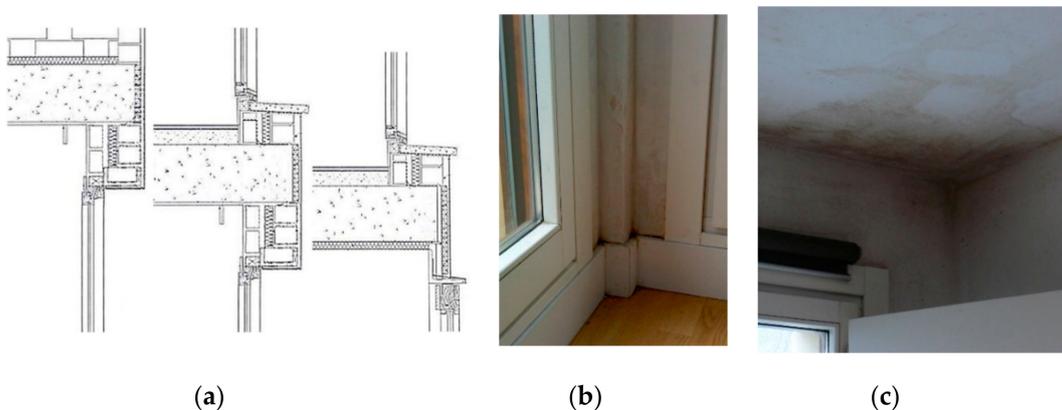
Figure 2. (a) Constructive section in detail; (b) dwelling 1A pathologies; (c) dwelling 1E pathologies.

Numerous areas with water condensation, mold, and deformed wooden elements, such as skirting boards or window frames, were detected in six out of the 14 investigated dwellings. All the problems were located in the North façades of the first and the second floors, in dwellings with letters A, D, and E, see Figure 1a. The façades of other dwellings did not have visible pathologies or moisture-related

problems. Large growths of mold and microorganisms were especially apparent in the corners of pillars, ceilings, and window perimeters. Dwellings located in the attic did not have any humidity problems and were thus excluded from the study.

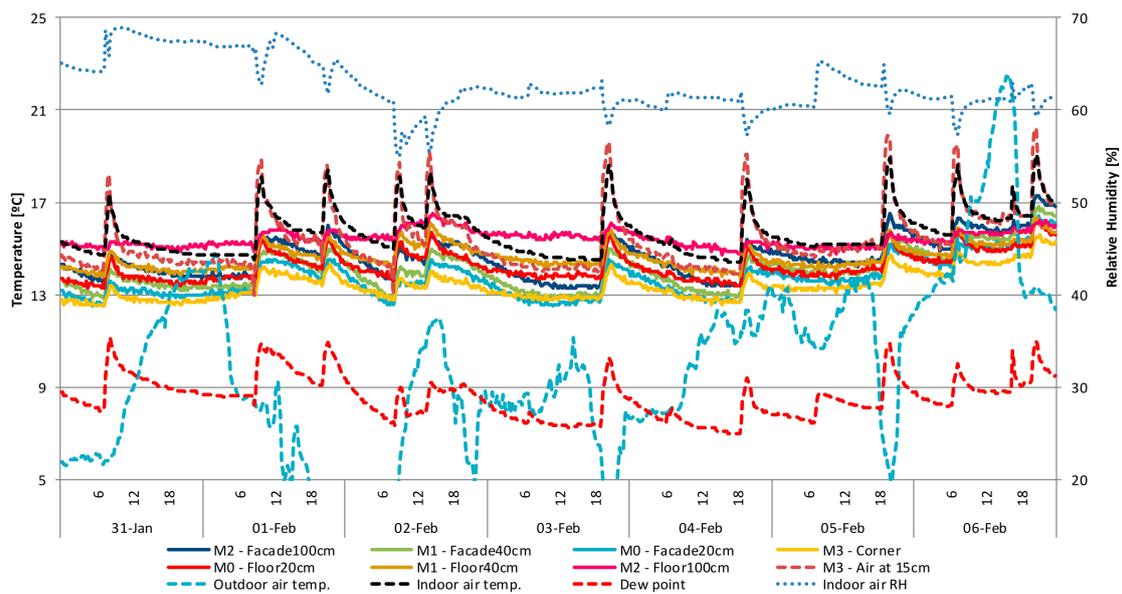
Continuous monitoring of the surface temperatures in two thermal bridges and in the adjacent opaque elements allowed assessing the likelihood of surface condensation in 40 days. Figure 6 shows a comparison between the dew point of one dwelling (calculated using the instant air temperature and RH) and the indoor surface temperatures of the sensors placed along the thermal bridge. It was observed that there is a margin of 3–4 °C between the measured air dew point and the envelope surface temperature. Therefore, according to these measurements, there was no risk of surface condensation during the 40 studied cold winter days.

**Figure 6.** Monitored values of the possible thermal bridge in the façade-slab connection. Dwelling 2D data from 31 January until 6 February.

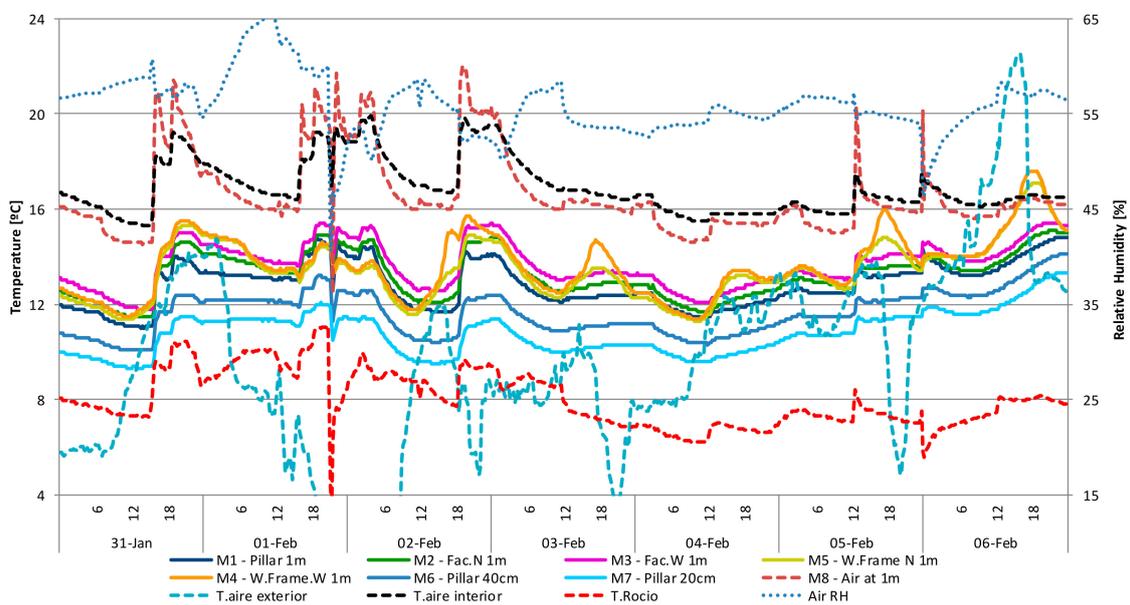
Figure 7 shows the analogous study conducted in the corner pillar thermal bridge. In this case, the margin between dew point and measured surface temperatures is smaller. The minimum gap between them was slightly below 1 °C, and during the three coldest days the difference remained small: between 1–2 °C. For this reason, there is a real condensation risk in this thermal bridge that may occur, especially when the indoor-outdoor conditions are adverse.

**Figure 7.** Monitored values of the possible thermal bridge in the corner pillar. Dwelling 1D data from 31 January until 6 February.

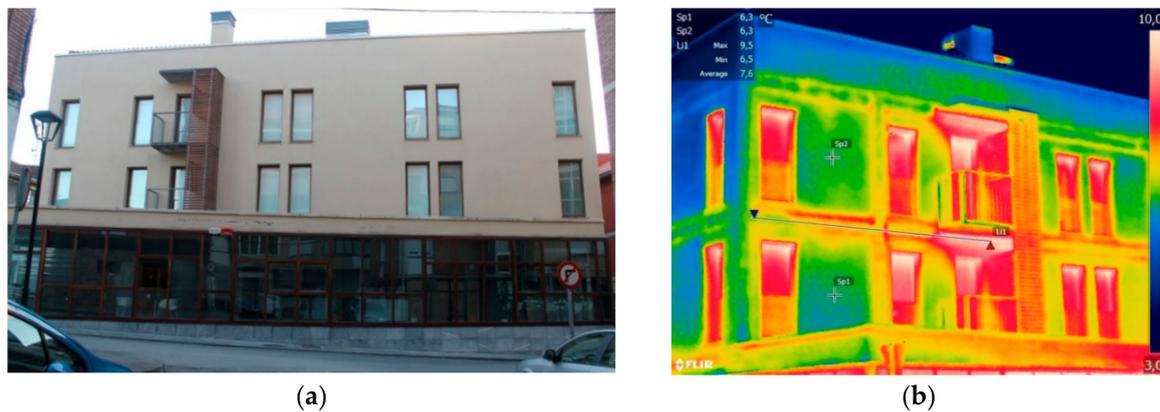
The exterior building inspection with thermal images proved that the outer surface temperatures were very similar in the four orientations of the building. Some slight differences were found between apartments, probably due to the varying indoor conditions from home to home. The outside surface temperatures indicated local increases of 1–2 °C in the front of the thermal bridges in contrast with the opaque adjacent walls. From the outside, some humid areas were found on the front of the first floor slab. On the contrary, no other evidence of humid areas was found from the outer side of the detected indoor pathologies. Examples of outdoor thermal images are given in Figures 8 and 9.

**Figure 8.** (a) West façade of the case study; (b) outside thermal image of dwellings 1D and 2D.

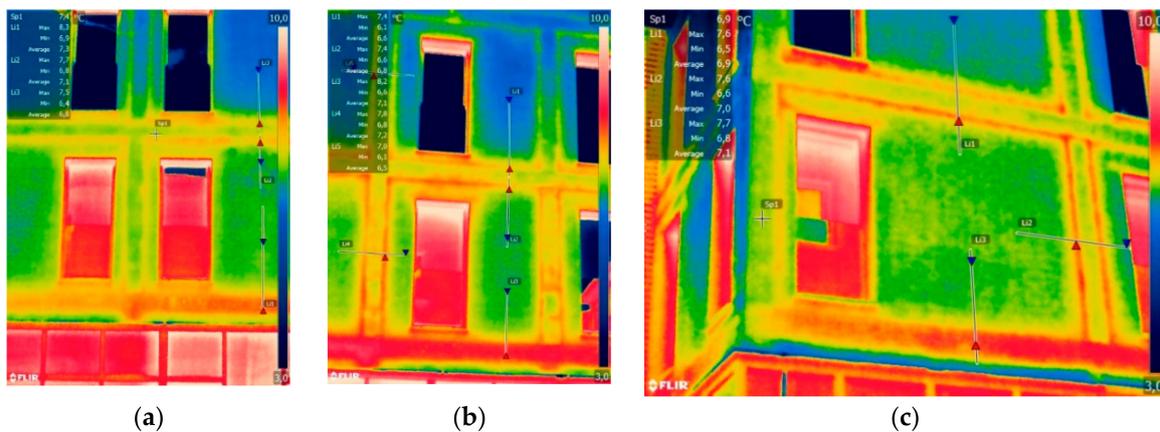
**Figure 9.** (a) North façade of dwellings 1A and 2A; (b) North façade of 1E and 2E; (c) North façade of dwellings 1A and 2A.

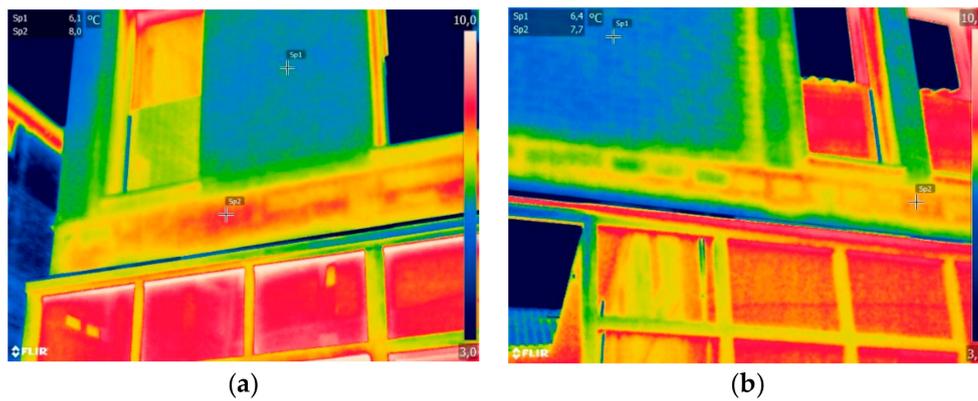
Some noticeable irregularities were found in the distribution of the cellular glass boards on the potential thermal bridges. Figure 10 shows how some boards are separated and even missing in the northeastern corner of dwelling 1C. This shows that the thermal bridging solution was not properly placed in some locations of the envelope and, consequently, that the effectiveness of minimizing the thermal bridge in these cases is seriously reduced.

**Figure 10.** (a) South façade area of the first floor slab of dwelling 1C; (b) South façade area of the first floor slab of dwelling 1D.

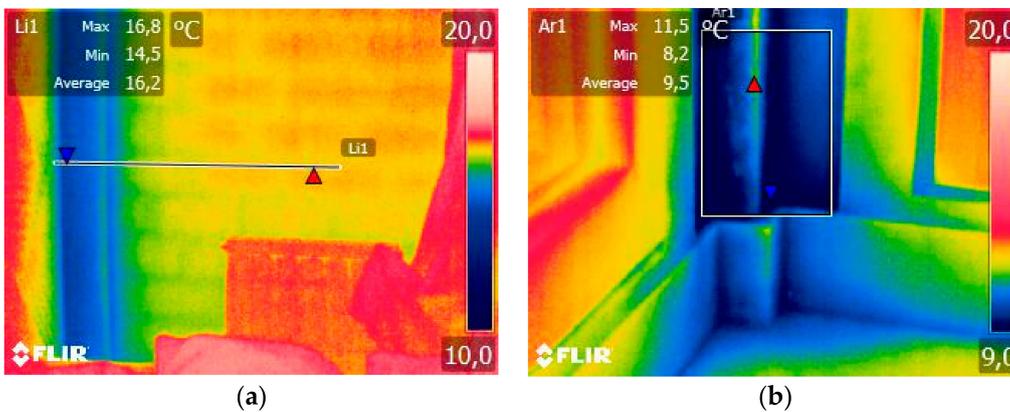
From the inside, the effect of the structural thermal bridging was observed in two ways. Some elements like a pillar, shown in Figure 11a, provoked very cold inner temperatures, but without any additional pathologies or problems. On the other hand, other areas occasioned large humid areas, such as those shown in Figure 11b. The latter were also observed during the visual inspection because of the degradation of skirting boards and window frames, with obvious expansion of the wooden pieces and bubbles in the wall paint due to evaporation.

**Figure 11.** (a) Dwelling 1A North façade pillar inside temperatures in detail; (b) dwelling 1A corner pillar inside temperatures in detail.

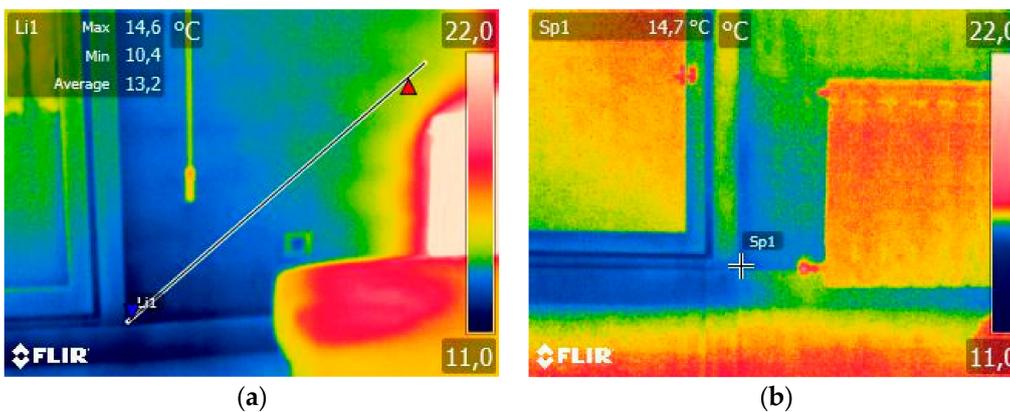
Additionally, some other minor condensation areas around the window frames were found during the inside thermographic survey. Figure 12a shows a large cold area due to evaporation in the window-wall joint, and Figure 12b shows an equivalent position, but in another apartment where there was almost no gradient of temperatures. Figure 13a reveals another case of a clear cold area due to evaporation in the window-wall joint, and Figure 13b shows a façade pillar which was fully wet at the bottom.

**Figure 12.** (a) Comparison of the North façade window-wall connection in dwelling 1A and (b) the West façade window-wall connection in dwelling 1D.

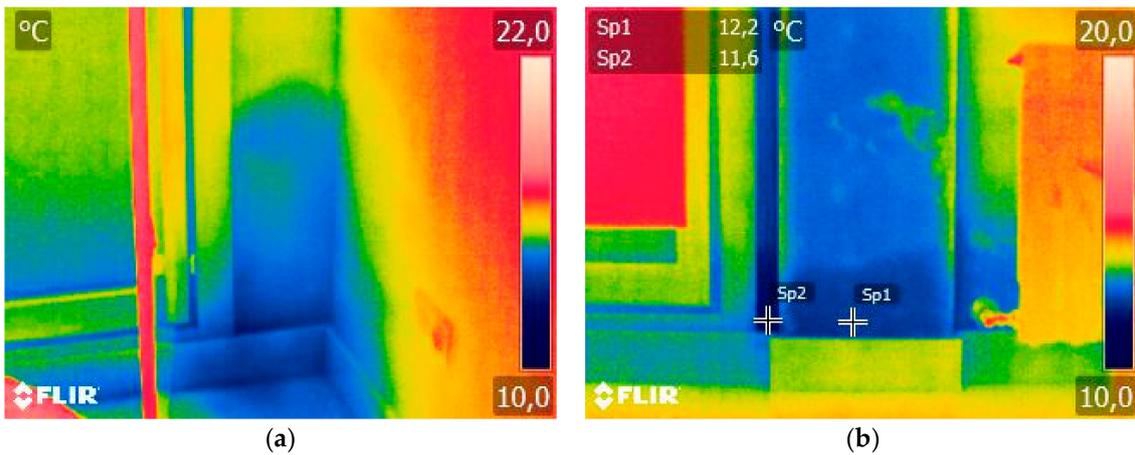
**Figure 13.** (a) North façade window-wall connection in dwelling 1E; (b) the lower part of the North façade pillar in dwelling 1D.
