Failure-Analysis Based Redesign of Furnace Conveyor System Components: A Case Study

Beatriz González-Ciordia ^{1,2}, Borja Fernández ^{1,2}, Garikoitz Artola ³

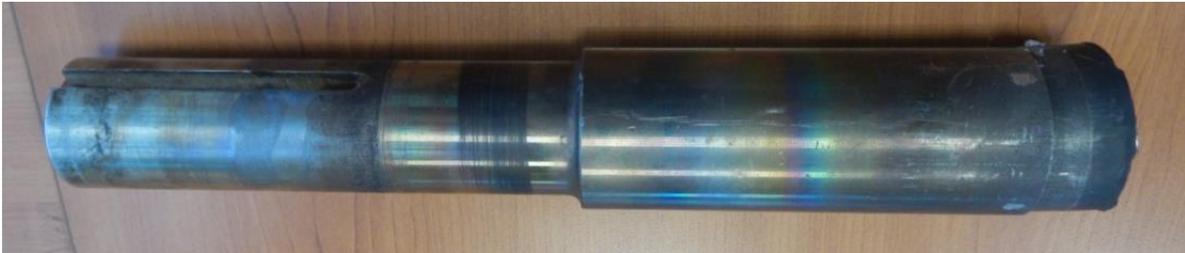
Figure 4. Sample of broken roll 1 (BR1) that was inspected.

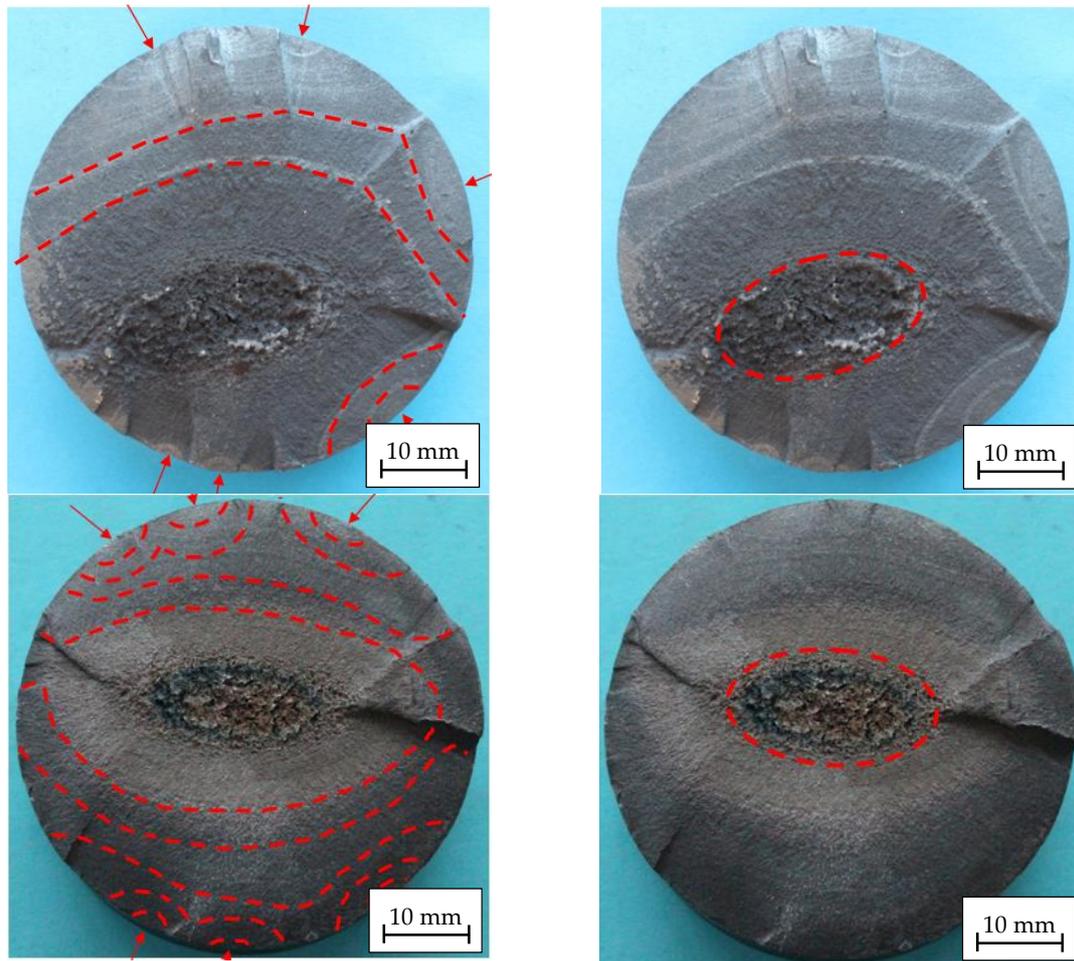
Regarding macroscopic inspection of the fracture surfaces of BR1 and BR2 (Figure 6), both samples looked very similar, indicating that the mechanical damage progress was analogous. In both cases, fractures showed several fatigue crack nucleation sites. The fatigue crack growing pattern left lighter color growing marks, which are interpreted as crack stops during bank-holidays and preventive

maintenance furnace stand-by periods. The final ductile collapse of the rollers is displaced from the geometrical section of the roll because of the different loads that the rollers must bear depending on their angular position.

Figure 6. Fracture surface of broken roll 1 (BR1) (top) and BR2 (bottom). Left. Several fatigue nucleation sites marked by arrows and crack stop lines marked with discontinuous lines. Right. Final ductile collapse surface of the roll.

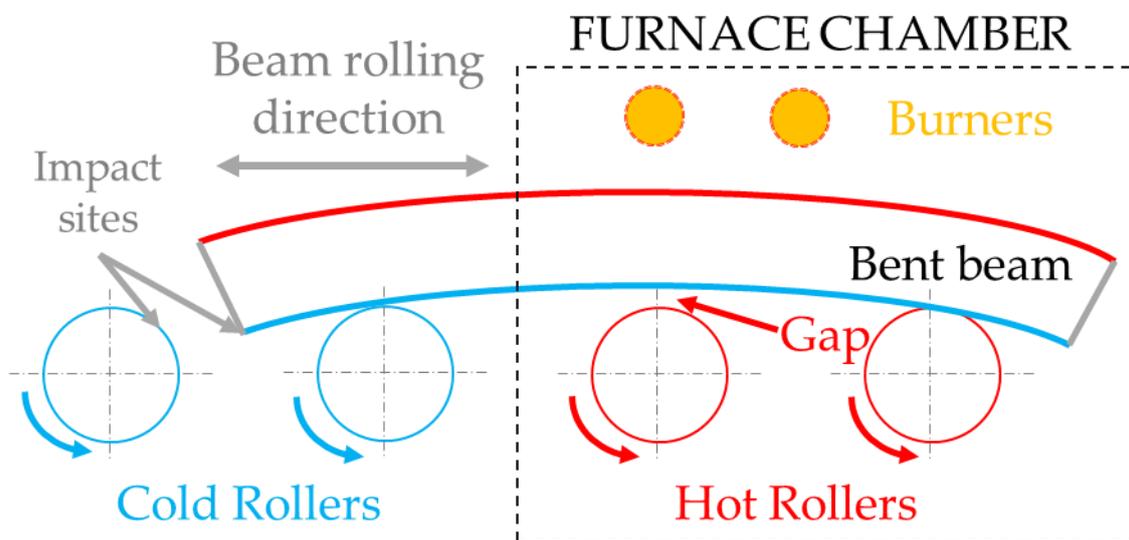
Regarding the working loads, careful inspection during service allowed identifying an unexpected vibration during the conveying movement, right when the tip of the first walking beam contacted the rolls in the back and forth trajectory. This beam worked half stroke outside the furnace, as it dragged the formats from the feeding platform to the inside of the furnace and was directly heated by the ceiling burners. While the bottom of the beam was cooled down by the contact with the cold rollers, the top of the beam was unable to cool down at the same pace and a thermal distortion was generated. It was found that the beam was bent as shown in Figure 8. This caused the vibration that was observed when the leading edge of the beam hit the rollers. It also meant the presence of a gap between the beam and its expected contact points. Consequently, the weight of the beam was not evenly distributed between three to four rollers, but between two instead. Complex deformation of machines in other processes was also studied [20], but in their case, the main cause was mechanical deformation due to process forces.

Figure 8. Scheme of the effect of temperature differences between the top and the bottom of the beam. The rollers marked as “hot rollers” correspond to the fractured ones.
