The presence of secondary creep in historic masonry constructions: A hidden problem

S. Sánchez-Beitia (corresponding author, santiago.sanchez@ehu.eus), D. Luengas-Carreño and M. Crespo de Antonio

Abstract

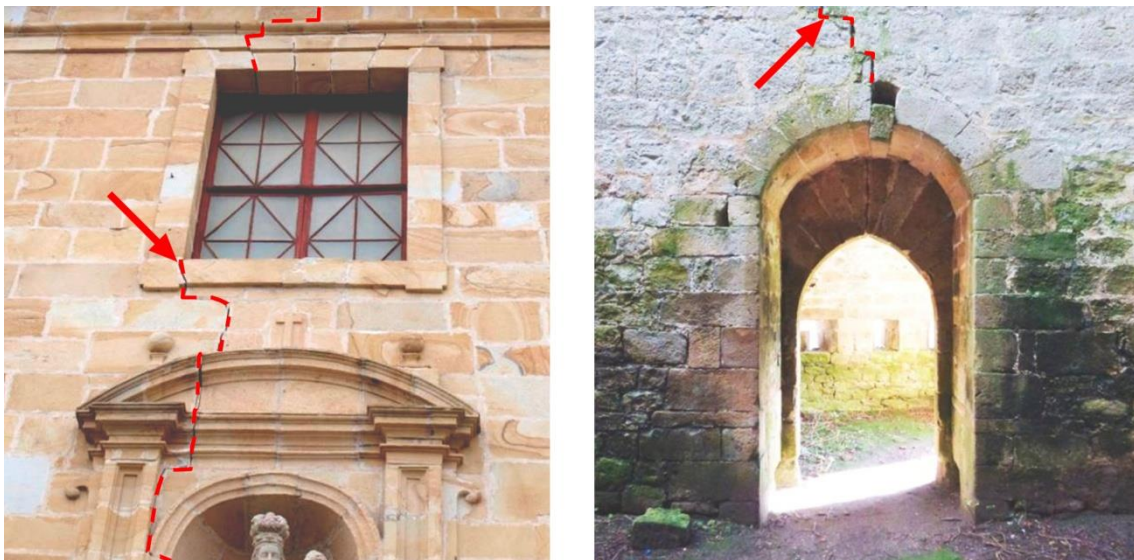
geometric changes caused by differential settling that could cause the structure to collapse. In this period can be generated other type of cracks through the mortar after differential settlements. The 500-year rule refers to the material deterioration. This concept of “deterioration” is not well explained in the literature. It should include creep, which can cause the collapse of the structure. In this phase another type of cracks can occur due to some new differential settlements, this time caused by near constructions or new urban services works. They also can be caused by long-term loads application, associated with fatigue phenomena nearby traffic and earthquakes. In religious temples, sometimes can be included the vibrations induced in belfries because of the ringing of the bells. The stress state is not uniform not constant. Additionally, a stress concentration can take place in particular zones of the structure and alterations in load level can occur due to reparations or modifications in the historical construction. Therefore, almost all masonry structures show a picture of diverse cracks originated by many reasons [8] and frequently those reasons or origins are unknown. This is a stochastic problem that appears over the building's lifetime (Fig. 1). Currently, numerous structural integrity conservation projects are being conducted on historic structures all over the world without any creep analysis. In fact, many professionals ignore the presence, the importance and the influence of creep on structural integrity.

Figure 1. Cracks through the mortar in the Church of Markina and the Tower-House of Espinosa de los Monteros, in Spain.

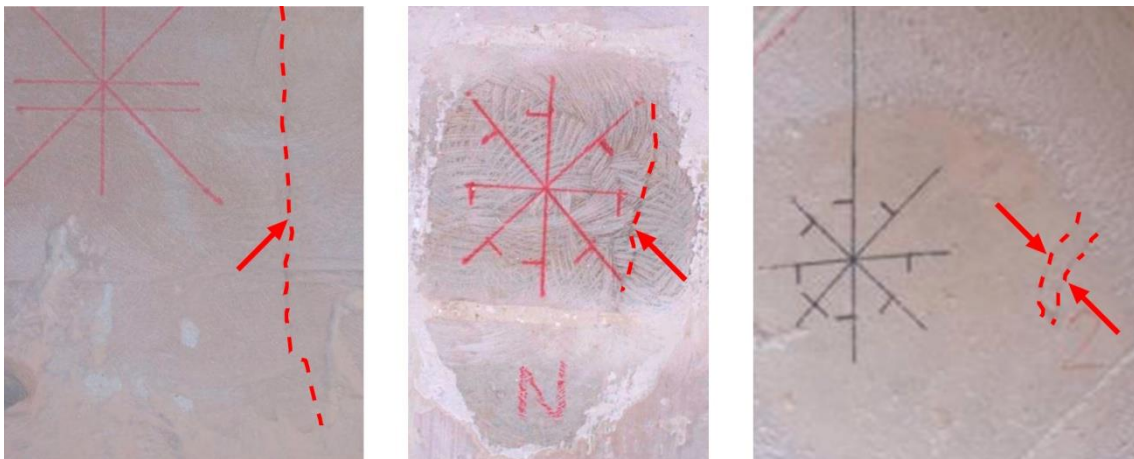
Figure 5. Cracks in Tarazona cathedral (Spain) on the left, Saint Jakobs church in Leuven (Belgium) on the center and Palma de Mallorca cathedral (Spain) on the right.

As mentioned above, a historical construction can have two types of cracks. A detectable crack type when it reaches high lengths and progresses through the mortar and the stone blocks. And a second type of hidden cracks under the patina, which can also be detected, as it was demonstrated (Fig. from 4 to 8) by a light previous polishing. The length of these cracks has not been measured in these real cases because the graphic material available is old and does not permit it. In these cases, the type of crack is more or less vertical according to the solicitation in the block, with low

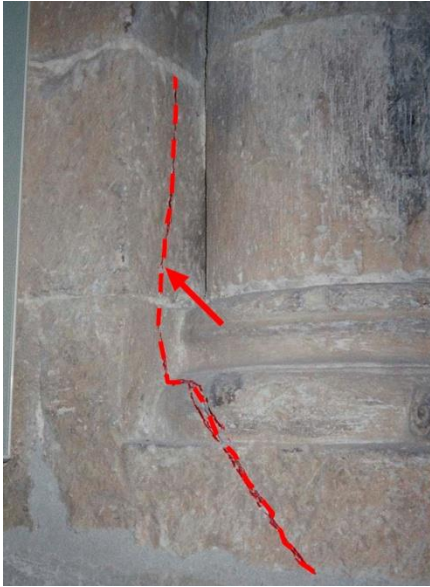
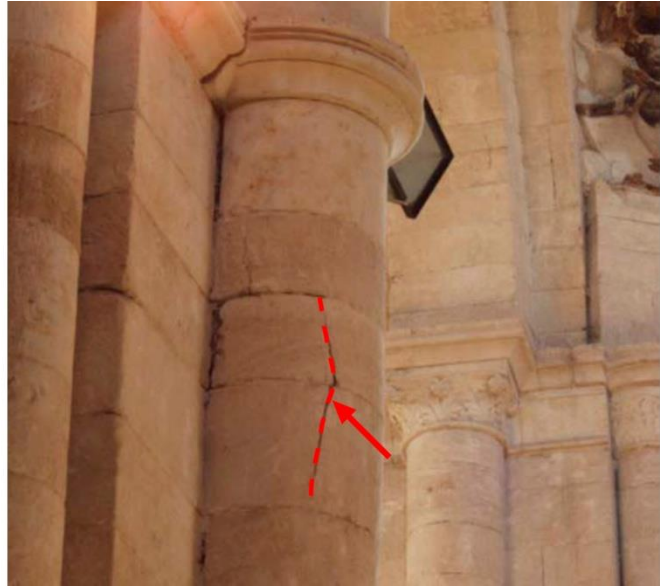
Figure 6. Some cracks in the top part and in the bottom part of a pier in the Colegiata Church in Toro city (Spain).

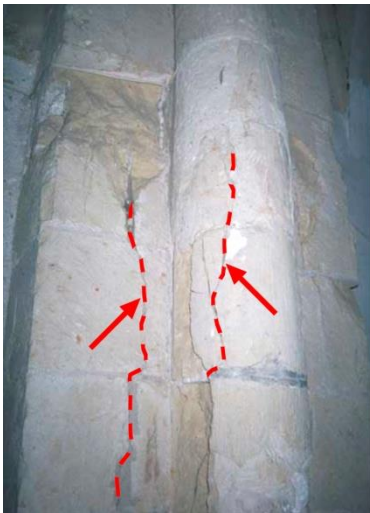
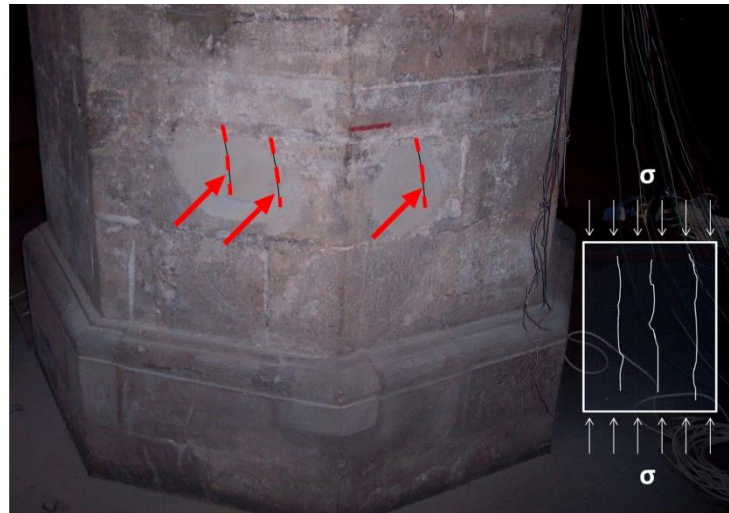
Figure 7. Some cracks in Turégano Church (Spain) on the left and Santa María del Mar Cathedral in Barcelona (Spain) on the right.

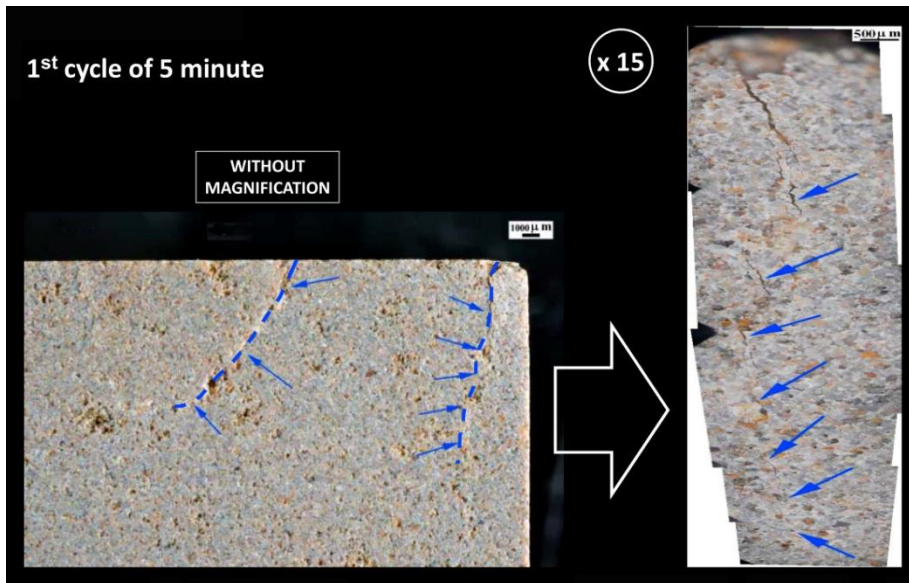
After the first 5-minute interval, two cracks were generated on the B side of the first block (Fig. 11). The two cracks could be measured using quantitative metallography, measuring 12 millimeters the longest crack. After the second interval, both cracks increased in length (Fig. 12), the longest crack measured 22 millimeters. The process was repeated for several times until a new crack was generated on other block side (Fig. 13). The new crack was located on the A side and it was 15 millimeters in length. After this interval, the longest crack of the B side increase to 31.4 millimeters. The test was stopped after the eighth interval, to avoid the breakage of the block (Fig. 14).

Figure 11. Generated cracks on the top part of the B side of the first block after the first cycle of 5 minutes, with different magnifications.

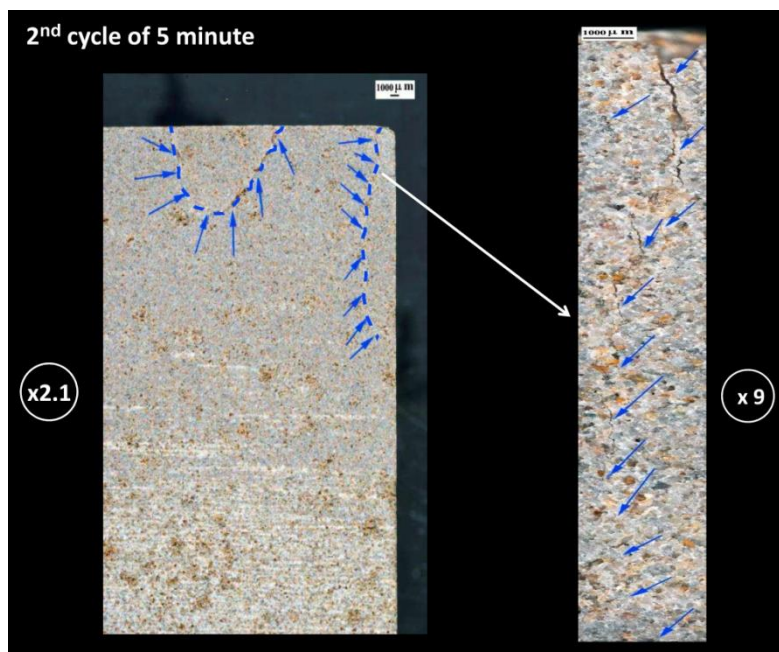
Figure 12. Generated cracks on the B side of the first block after the second cycle of 5 minutes, with different magnifications.

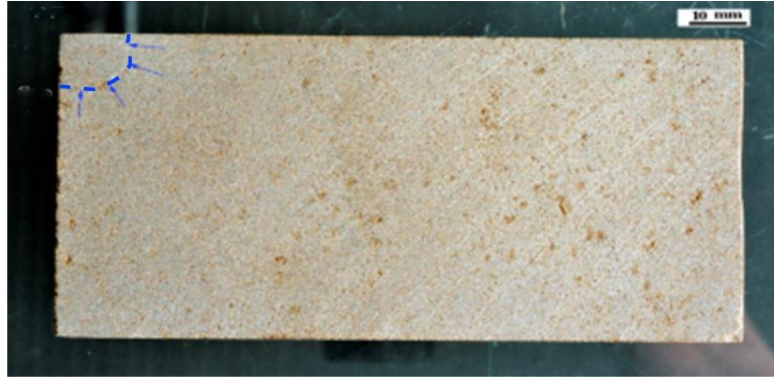
Figure 13. Generated cracks on the A side of the first block after 8 cycles of 5 minutes. The block is rotated 90 degrees.

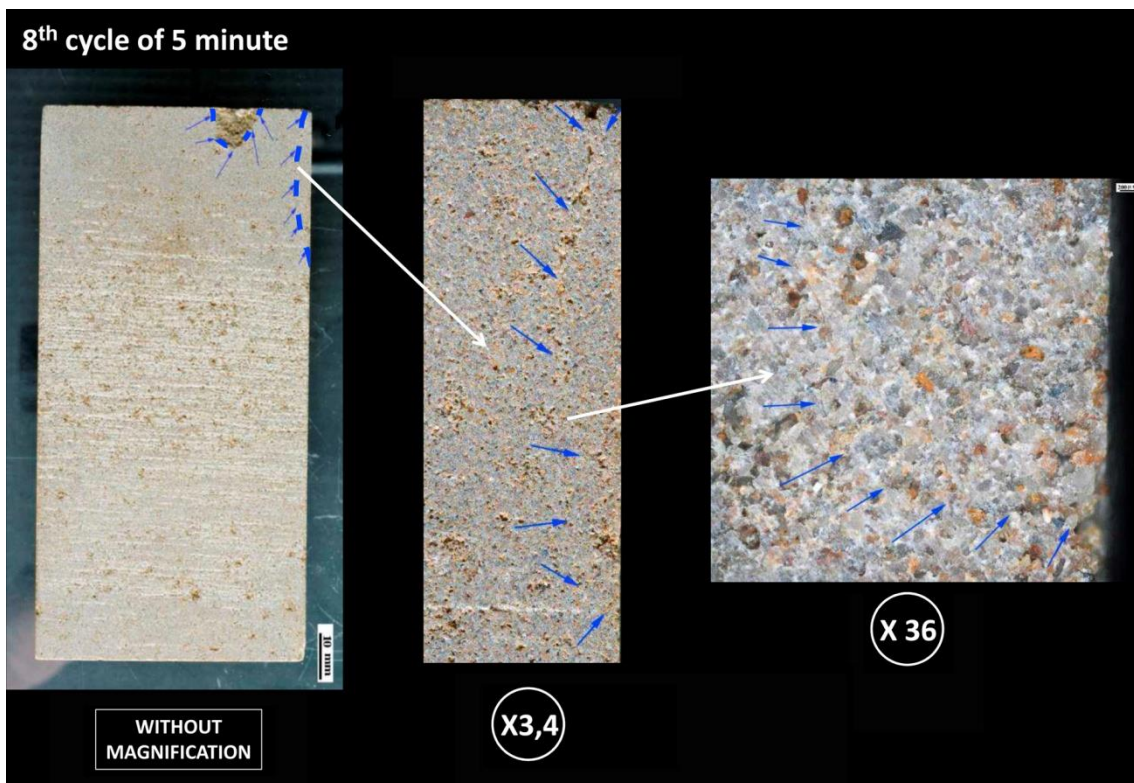
Figure 14. Final cracks on the B side of the first block, with different magnifications.

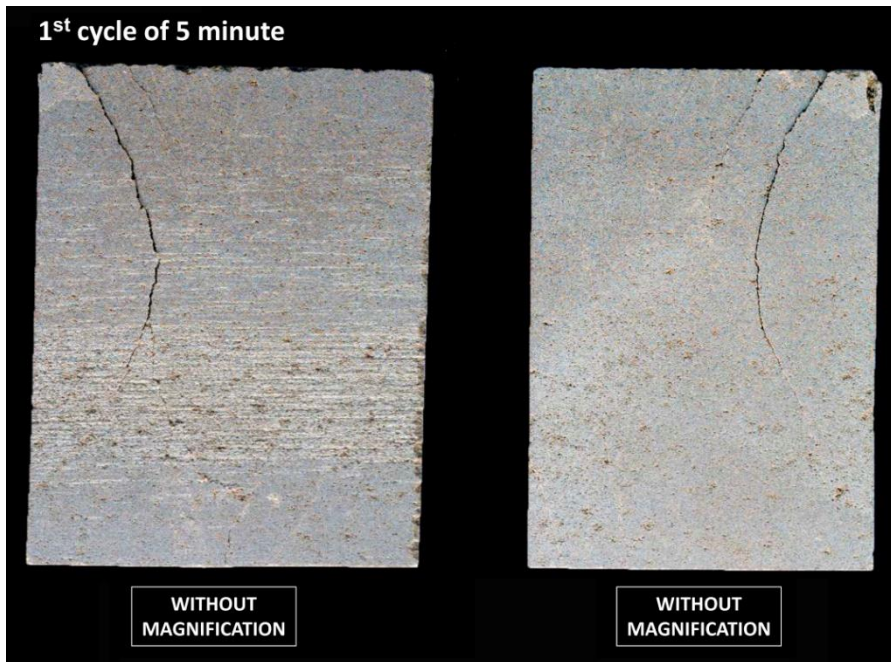
In the second test, after the first interval, 122 millimeters length crack appeared, which covered all the surface of the block (Fig. 15). Therefore, the length of the longest crack is 122 mm, coinciding with the height of the sample. In the third test, one crack was also detected. This crack progressed in the same way as in the first test. In Figure 16 the final situation of one of the faces in the third block checked can be observed. In that moment the crack coincides with the length of the simple. In this final moment a similar crack developed in the adjacent face. In all cases the number of cracks and their length could be quantified.

Figure 15. Cracks of the second block tested.

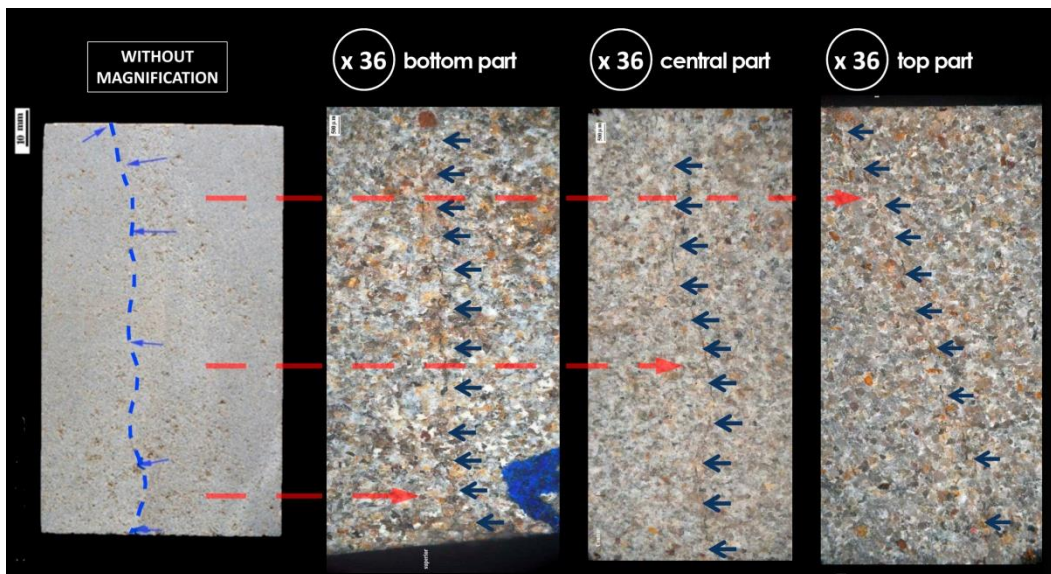
Figure 16. Crack on the B side of the third block tested and the magnification in three parts.

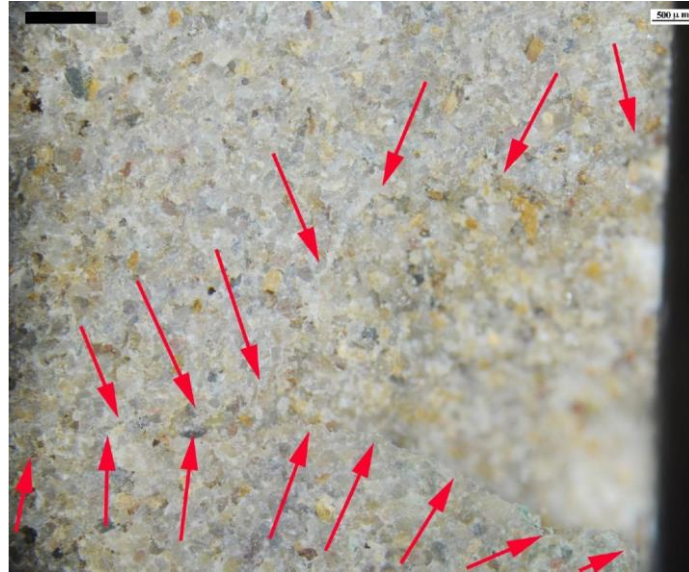
The conditions in the fourth test were different. Each load interval (5 minutes) applied a constant compressive load (25 MPa) during 4 minutes and afterwards a cyclic load of 25 MPa +/- 2.5 MPa with a 5 Hz frequency for a minute. For 16 test intervals (80 minutes test) the appearance of cracks was NOT observed. In order to force the appearance of those cracks, the process was continued increasing the frequency from 5 to 10 Hz. In the first interval, 6160 microns long crack appeared. In the following 17 intervals the same crack reached a length of 7800 microns, being finished the test (Figure 17). No more cracks were observed during the test.

Figure 17. Photomicrograph of 25 magnification of the fourth block tested
