In-situ analytical study of bricks exposed to marine environment using Hand-Held X-ray fluorescence spectrometry and related laboratory techniques

Punta Begoña Galleries (Getxo, Basque Country, Spain)

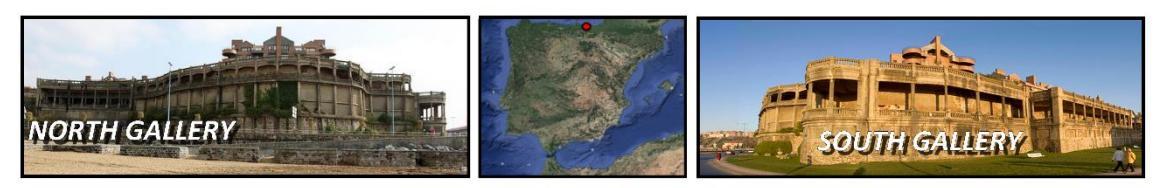
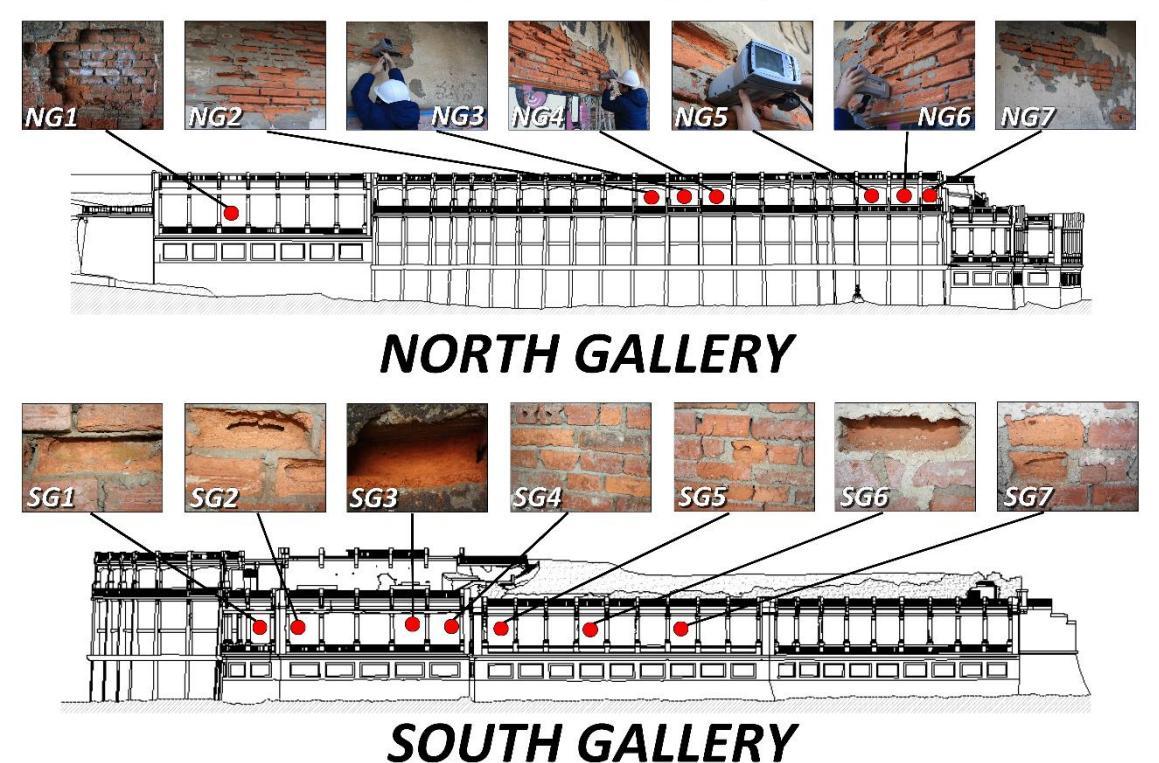
brick areas from their Northwest and Southwest Galleries (NG and SG).

¹⁹⁹ Fig. 1. Punta Begoña Galleries (Getxo, Basque Country, north of Spain) and the analyzed

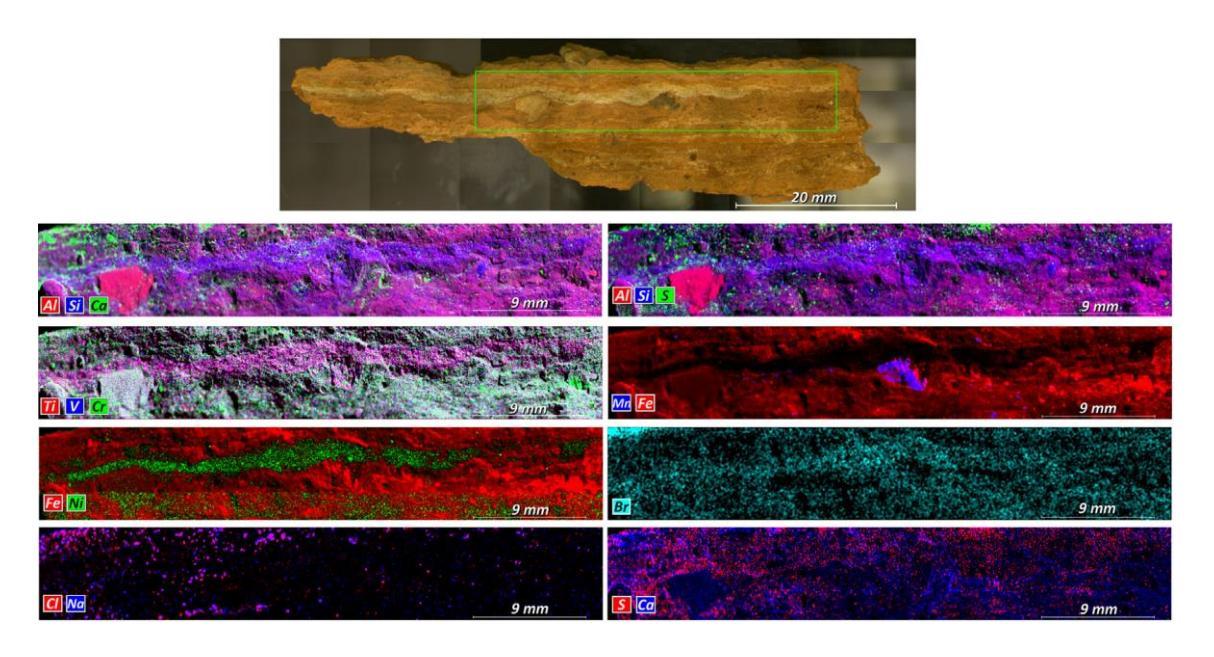
317 After single point analyses, a fragment of one of the most damaged brick was selected 318 (NG1) in order to perform an imaging study by means of µ-ED-XRF. A section of the 319 brick was mapped in order to confirm if elements associated with marine aerosol and 320 other pollutants have penetrated to the inner areas of the brick (see Fig. 4). The size of 321 the mapped area was 7.41 (height) x 45 (width) mm and each pixel (1301956 in total, 322 16x16 µm in size/each) was acquired during 10 ms. In order to reduce the time of the 323 mapping acquisitions and considering that a good resolution was obtained, one frame 324 count (cycle) was considered. In the mapped section, a whitish accumulation or vein is 325 observable in the central part of the brick section (see Fig. 4). In the whole section of the 326 brick, (alumino) silicates are widely distributed (see Al and Si maps in Fig. 4) indicating 327 clearly its presence in the original clays used. With the imaging study, it can be confirmed 328 that Fe, a natural component of the bricks, is homogeneously distributed in the brick, as 329 it was pointed out in the in-situ HH-ED-XRF studies. Regarding the presence of metals, 330 it is evident the high correlation between Ti, V and Ni (see the coincident distribution of 331 Ti-V (pink) and Ni (green)), which are concentrated in the central vein of the brick. 332 Moreover, inclusions of Mn were also detected in the bulk of the brick.

333 The μ -ED-XRF study also revealed interesting results related with the elements present 334 in the marine aerosol. According to the Na-Cl map (pink) presented in the Fig. 4, the high 335 correlation between both element suggest that halite (NaCl) is crystalized inside the pores 336 of the bricks. The identification of this salt in the inner parts of the bricks suggest a high 337 penetration of this salt to the inner areas of the bulk material. These salt crystallizations 338 can contribute to physical stress in the brick structure promoting fissures, cracks and 339 disintegrations of the brick. The imaging study also confirms that Br is homogenously 340 distributed (see its map in light blue in Fig. 4), confirming the natural origin of Br in the 341 brick and discarding a possible input of this element coming from the marine aerosol, as 342 was proposed at the sight of HH-ED-XRF results. Finally there is also a high correlation between Ca and S distribution (see Fig. 4) suggesting the presence of gypsum 343

- 344 (CaSO₄·2H₂O)/anhydrite (CaSO₄) in the inner parts of the bricks, confirming in this was
- 345 the sulfation process of the calcium carbonate of the bricks. Gypsum is more soluble than
- calcium carbonate, accelerating in this way the dissolution and disintegration process of
- the bricks.
- 348

Fig. 4. μ-ED-XRF imaging of one of the analyzed brick observing the elemental
distribution of different elements.
