Fiber Bragg Gratings, IT Techniques and Strain Gauge Validation for Strain Calculation on Aged Metal Specimens

Abstract: This paper studies the feasibility of calculating strains in aged F114 steel specimens with Fiber Bragg Grating (FBG) sensors and infrared thermography (IT) techniques. Two specimens have been conditioned under extreme temperature and relative humidity conditions making comparative tests of stress before and after aging using different adhesives. Moreover, a comparison has been made with IT techniques and conventional methods for calculating stresses in F114 steel. Implementation of Structural Health Monitoring techniques on real aircraft during their life cycle requires a study of the behaviour of FBG sensors and their wiring under real conditions, before using them for a long time. To simulate aging, specimens were stored in a climate chamber at 70 °C and 90% RH for 60 days. This study is framed within the Structural Health Monitoring (SHM) and Non Destructive Evaluation (NDE) research lines, integrated into the avionics area maintained by the Aeronautical Technologies Centre (CTA) and the University of the Basque Country (UPV/EHU).

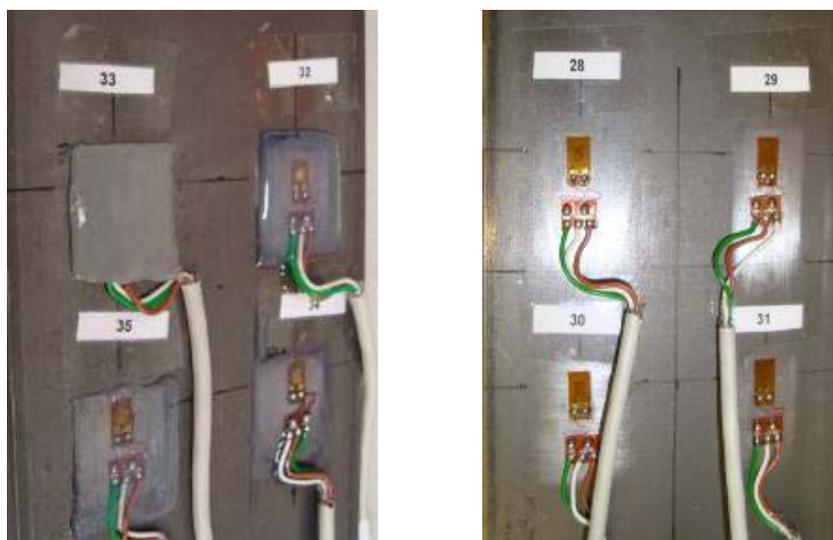
Figure 1. This figure shows instrumented strain gauges on both sides of Specimen 3.

A strain gauge consists of four parts: grid, support, housing and dots. It is necessary to follow these steps for implementation: surface cleaning, marking the areas of bonding, surface sanding, conditioning, preparation of the strain gauge, gluing, welding wires and cables, wiring and environmental protection [5]. Gauges 28 to 35 on specimen 3 are shown on Figure 1.

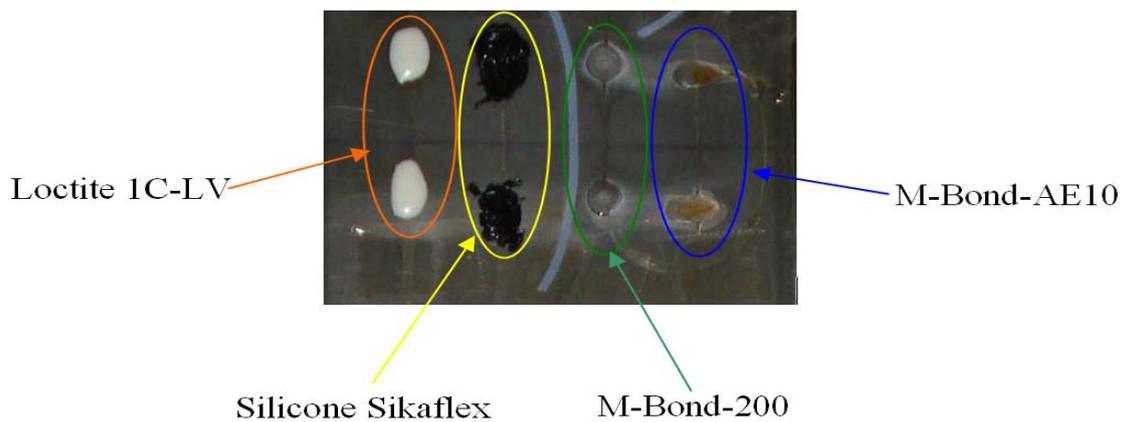
Figure 2. Four FBG sensors glued on Specimen 3 with four different adhesives.

In each specimen two optical fibers with five FBG sensors each one, one optical fiber per side, were bonded. Each specimen was treated as follows: four FBGs of one optic fiber were bonded to the specimen on one of the sides, leaving the fifth inside a Teflon tube for measurement of temperature variations [6]. On the other side of the specimens, five FBGs were applied with the most widely used adhesive, M-BOND-AE-10, made of epoxy resin and a curing agent. As seen on Figure 2, other adhesives used were SILICONE Sikaflex, M-BOND-200, LOCTITE 1C-LV and M-BOND-AE-10. The schemes of instrumentation performed is shown on Figure 3.

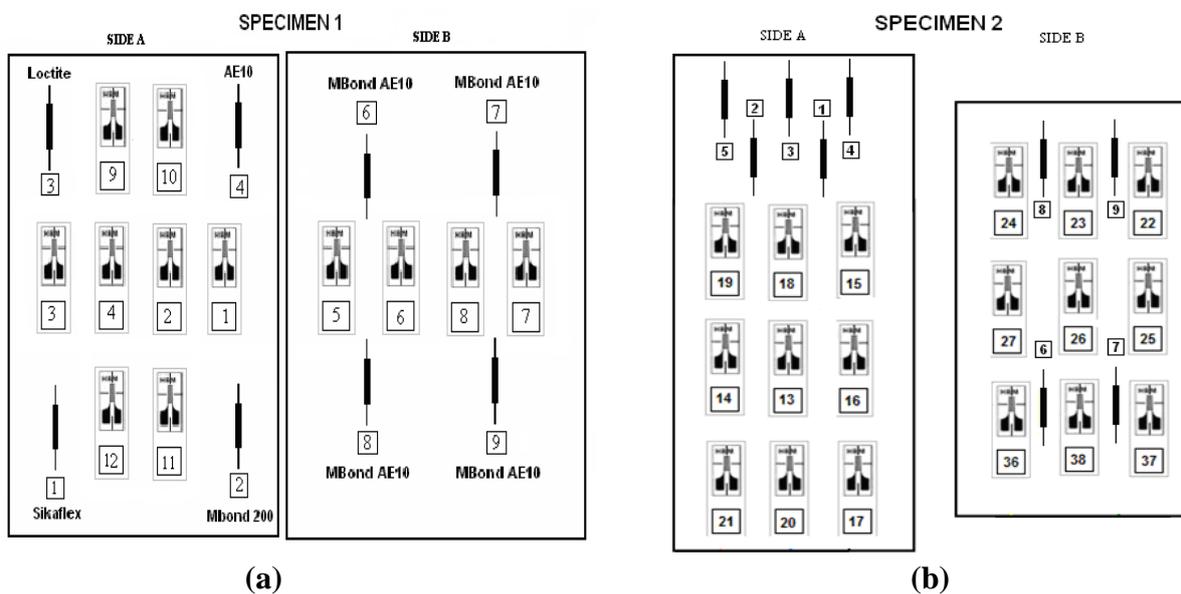
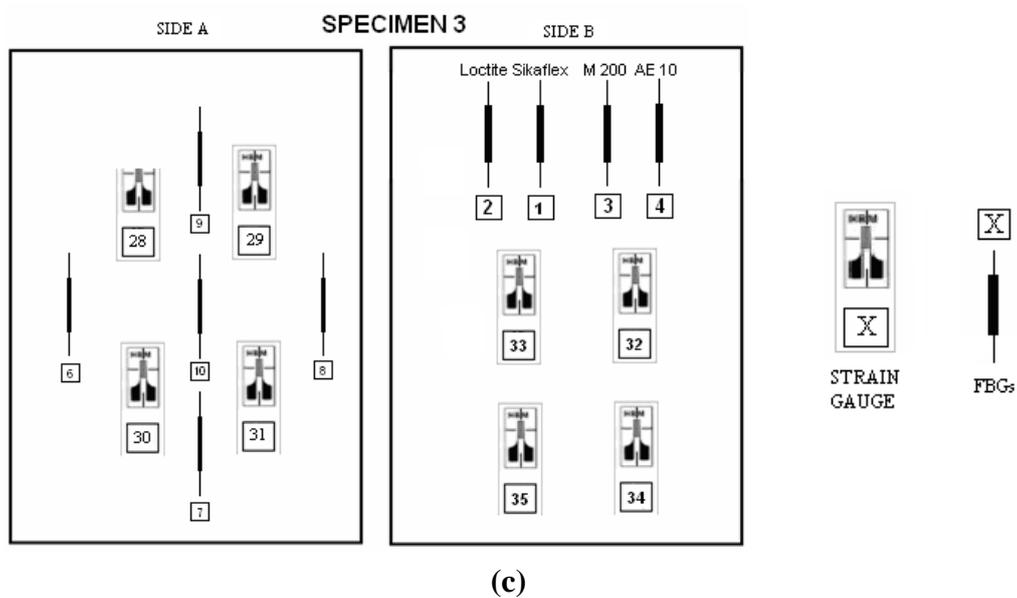
Figure 3. Schematic showing the lay-out instrumentation of strain gauges and FBGs on specimen 1 (a), specimen 2 (b) and specimen 3 (c).

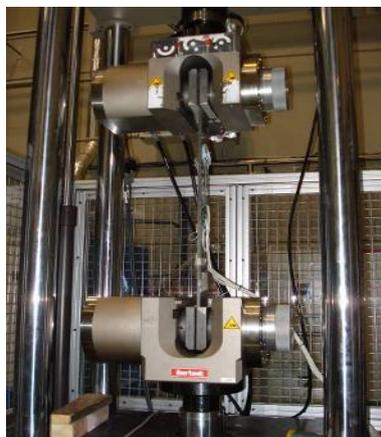
Figure 4. T/C machine used on tests.

The equipment used to perform the test has been a Traction/Compression machine that the CTA has in its facilities at the Technology Park of Alava (Spain). This equipment is shown on Figure 4.

This machine applies the scheduled stresses or strains through four hydraulic actuators at a maximum force of 500 kN. Load levels chosen for the tests were such that there is no risk of causing plastic deformations on specimens and test safety was not compromised.

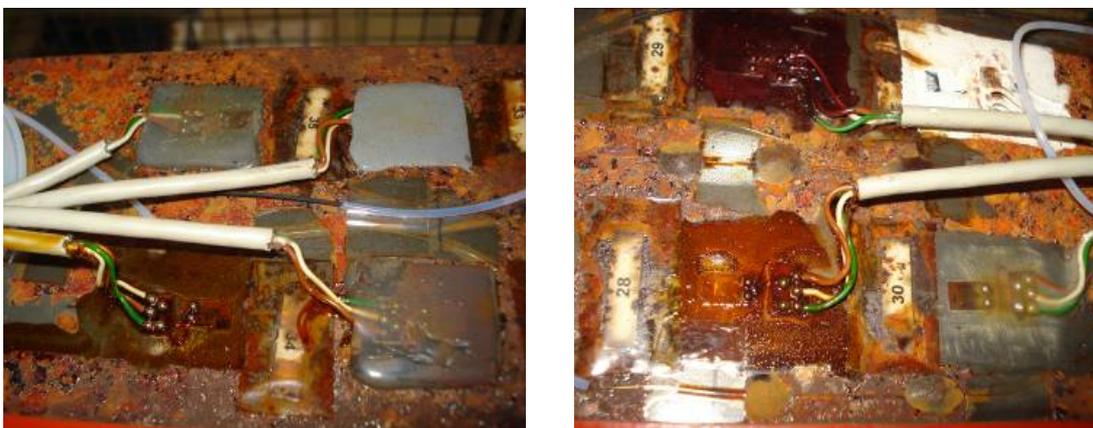
Figure 5. State of the gauges and FBGs after aging on climate chamber.

Static loads have been applied on steps of 20 kN until 200 kN on traction, and steps of 0.5 kN to 5 kN on compression. After the first series the specimens 2 and 3 were aged for 60 and 30 days respectively, leaving specimen 1 without aging. The state of the specimen aged is shown on Figure 5.

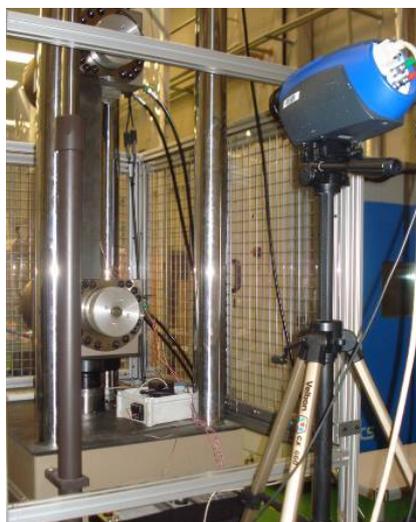
Figure 6. Layout of thermography tests.

after aging. Lay-Out of the test is shown on Figure 6. The model of the imager used in the tests is SILVER 480M with the following characteristics:

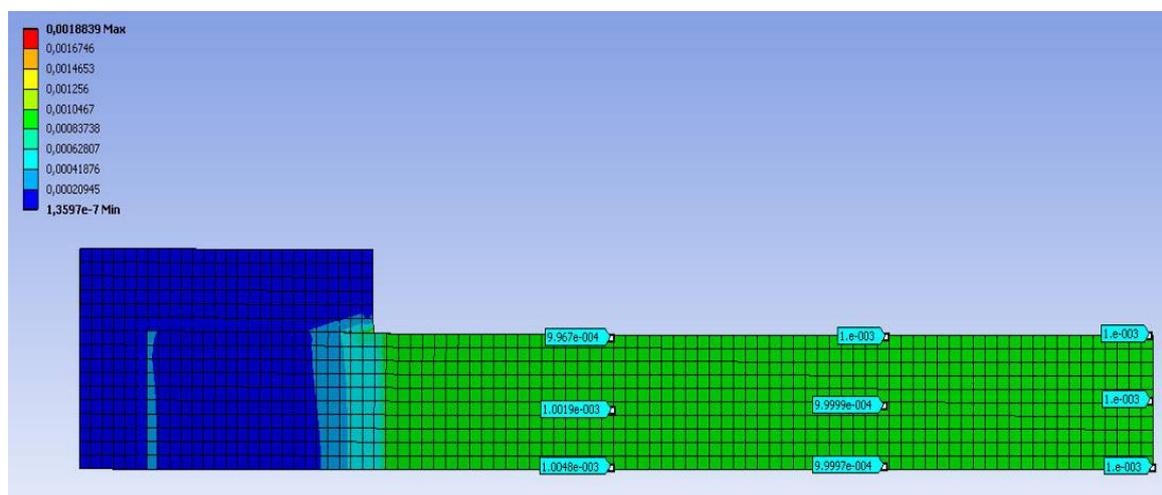
Figure 7. FEM strain analysis. The image shows a quarter of the specimen; results of other three quarters are identical due to the double symmetry of the specimen.

There were two studies, one studying deformations and other one calculating strains (Figure 7). The studied tensile effort has been 200 kN simulating the jaws of the T/C machine tying the specimen 100 mm from each end. The expected deformation for the induced load is 1,000 $\mu\epsilon$, obtaining values between 996 $\mu\epsilon$ and 1,005 $\mu\epsilon$.

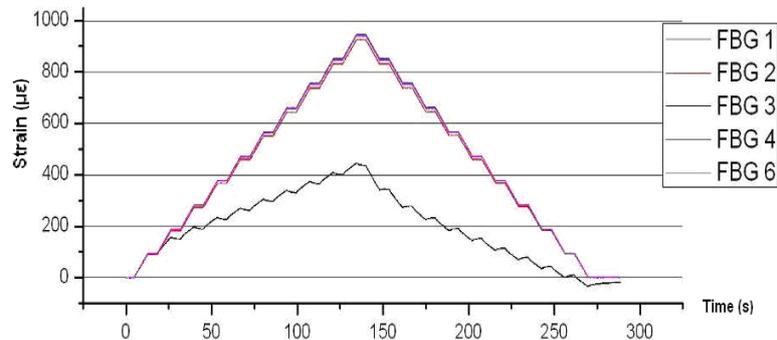
Figure 8. Specimen 1. Test before aging. 200 kN Traction stress. FBGs 1 to 6. Note that FBG5 is used for temperature compensation.

Figure 8 shows the results of FBGs 1 to 6 of specimen 1. As shown, FBG 2, 3, 4 and 6 are around 95% of value obtained from ANSYS FEM models. The Sikaflex glue used in FBG 1 did not give proper readings.

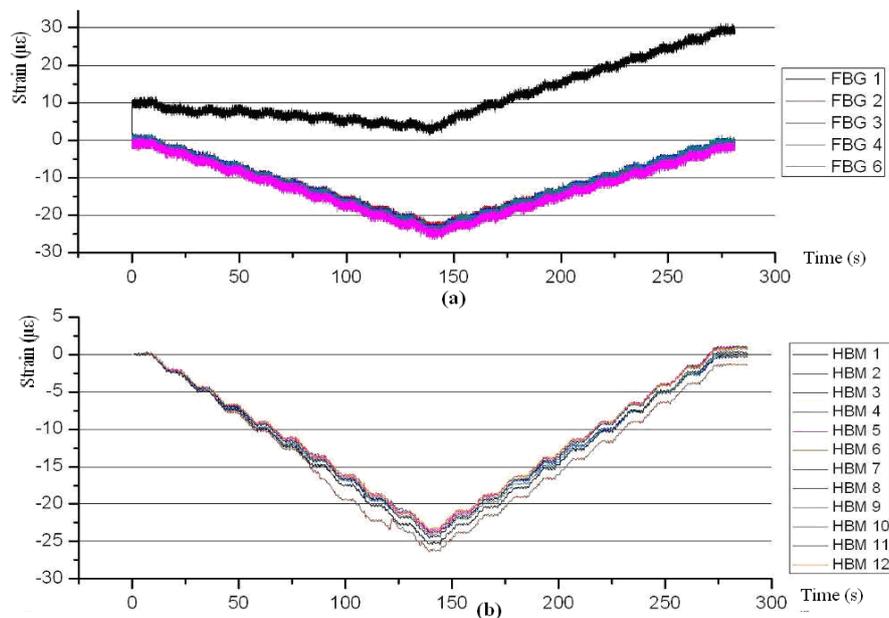
Figure 9. Specimen 1. Test before aging. 5kN Compression stress. FBGs (a) and strain gauges (b).

For compression efforts (Figure 9), FBG sensors generate much more noise than strain gauges, especially if the stresses are small. The readings of Sikaflex glue can be ignored, since the zero of the beginning of the test is $10 \mu\epsilon$ and proportionality of microstrains is altered if the load is increasing or decreasing. With respect to the gauges the results obtained are very similar with both the TAUCON and HBM acquisition system. However, the noise generated by HBM is much lower than TAUCON. Strain gauge number 2 obtained worse readings than the other gauges; the reason of this misreading is the model of the gauge, CEA-06-125UW-350.

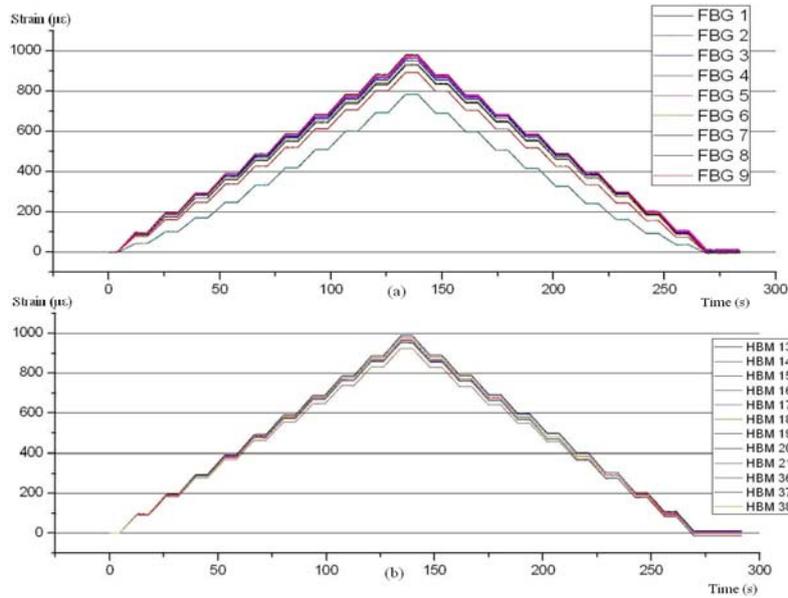
Figure 10. Specimen 2. Test before aging. 200 kN Traction stress. FBG (a) and strain gauges (b).

The results of the first tests on specimen 2 can be seen in Figure 10. All readings are as expected, except the FBG 4 and the strain gauge 17. These two sensors are located one above the other and the

difference in readings with the other sensors is less than 15%. This may be due to a slight deviation in the alignment in the jaws of the specimen in the T/C machine, since the FBG 5 and gauges 14, 19 and 21, located on the opposite side, give readings slightly above the rest.

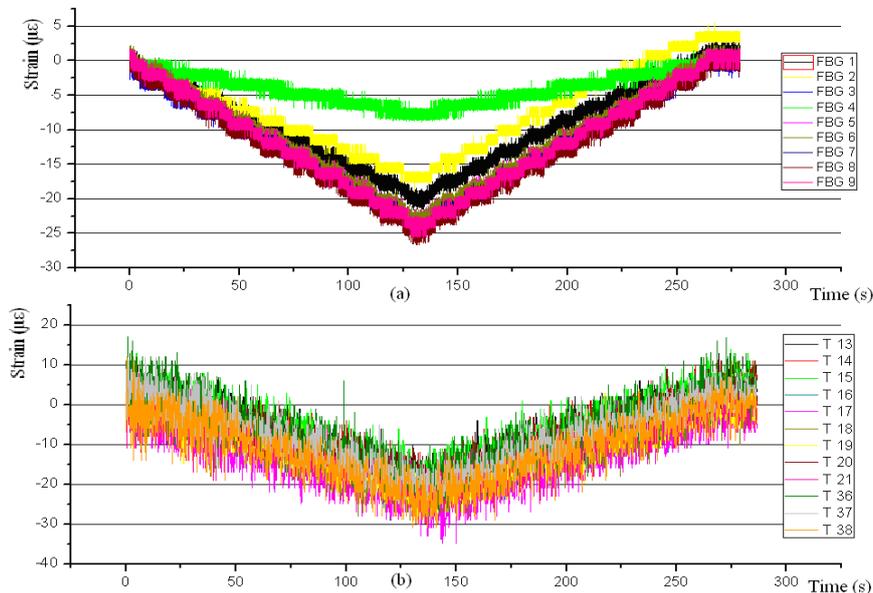
Figure 11. Specimen 2. Test before aging. 5 kN Compression stress. FBGs (a) and strain gauges (b).

Figure 11 shows the FBG of specimen 2, subjected to compression, providing erroneous results. The worst case is given by FBG 4, being also wrong the FBG 1 and 2 results. As for gauges, observed noise is rather high; this is due to the Taucon acquisition system. HBM tests gave the same results but with less noise. Note that gauge T15 does not start on zero microstrain, this lecture thus being invalid. The error is due to the model of terminals used, CEG-60D IY.

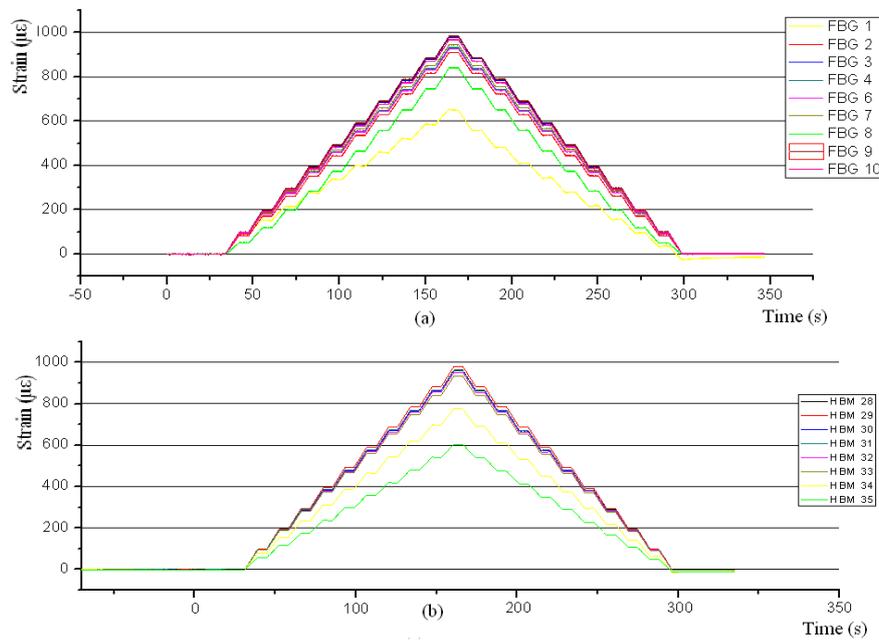
Figure 12. Specimen 3. Test before aging. 200kN Traction stress. FBG (a) and strain gauges (b).

In the tensile tests on specimen 3 (Figure 12), for the four FBG sensors glued on side 1 all the adhesives provide accurate readings, except Sikaflex, on FBG 1. FBG 8 has been glued with M-BOND-AE-10 and the reading was significantly lower than the rest. This error may be due to an incorrect implementation, since the sensor was on the edge of the specimen and its positioning was very difficult. The readings of the gauges 34 and 35 are below than the rest. The item they have in common is the protection. This protection is from the same manufacturer in both cases, although different models, RTV-3140 and RTV-3145.

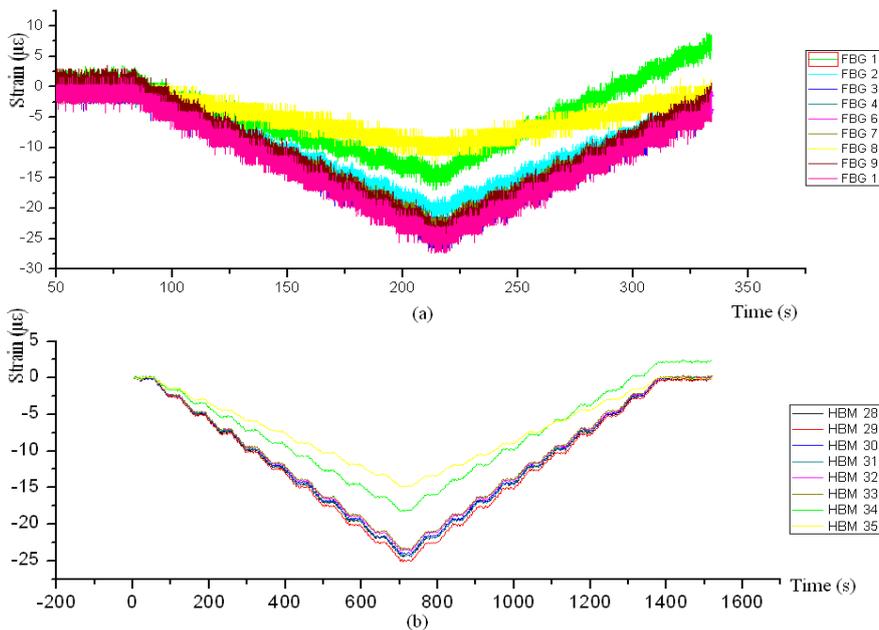
Figure 13. Specimen 3. Test before aging. 5kN Compression stress. FBGs (a) and strain gauges (b).

Figure 13 shows the results of tests of the specimen 3 under compression load. As in traction, protection of gauges 34 and 35 is ineffective for this type of test. In FBGs 1 and 8, there are higher readings than the rest. As mentioned previously these high readings are due to the Sikaflex adhesive in FBG 1 and in FBG 8, to a difficult implementation.

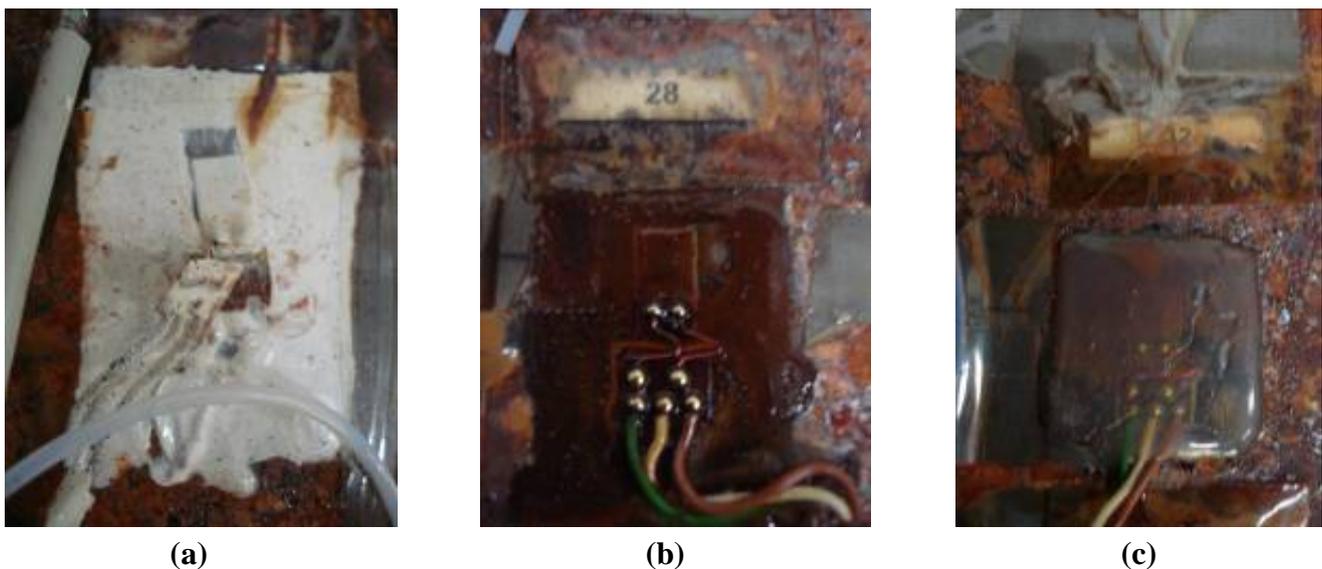
Figure 14. State of gauges after aging. The strain gauge 31 can be seen almost detached but acquiring (a); strain gauges 28 (b) and 32 (c) are not affected by aging.

After aging the specimens 2 and 3 for 30 and 60 days, respectively, at 70 °C and 90% RH, breaks and cuts appeared in both the fiber-optic networks and strain gauges. These breaks are motivated by the emergence of many corrosion points generated in the specimens, as well as the high temperature and humidity, which are an important factor in the conservation of the gauges. The state of some aged gauges is shown on Figure 14.

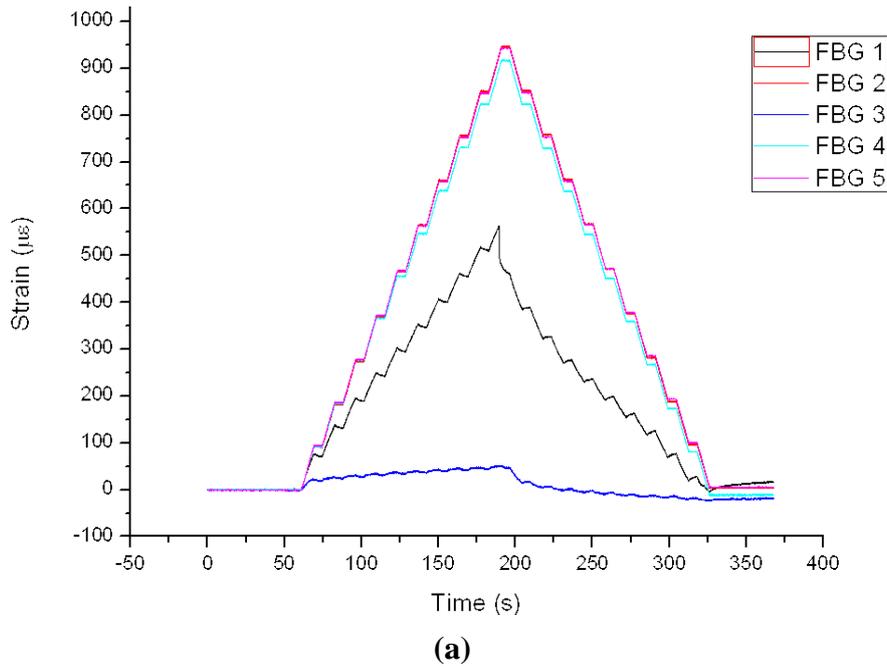
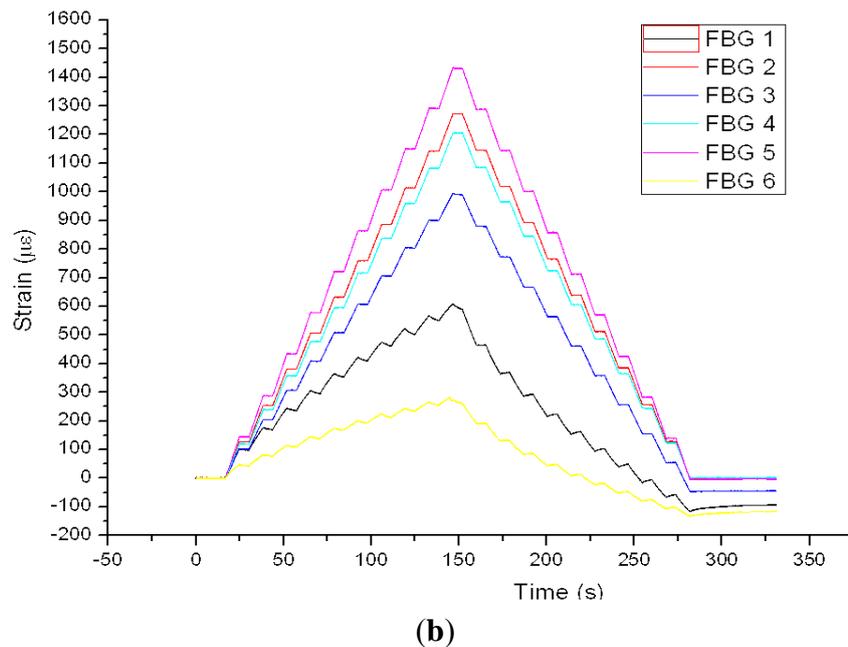
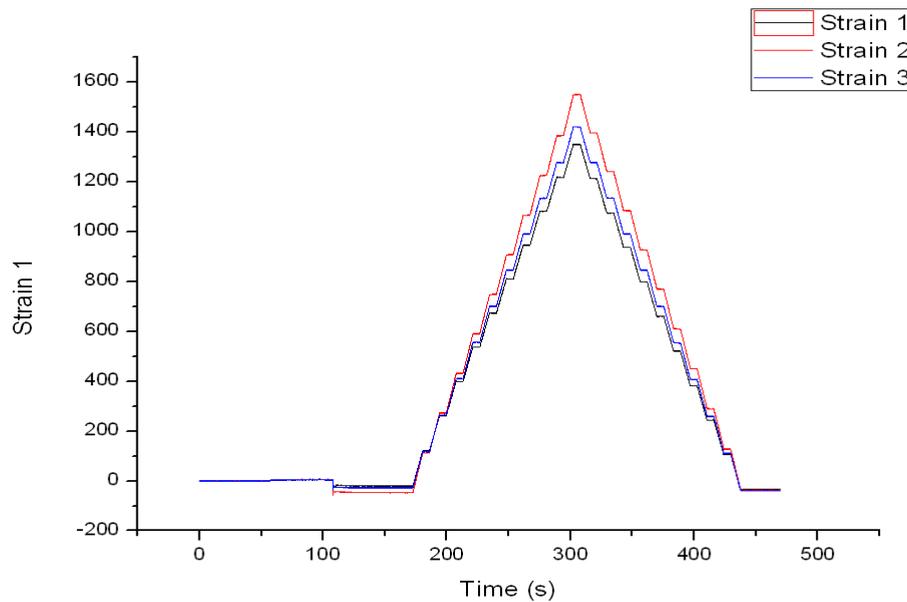
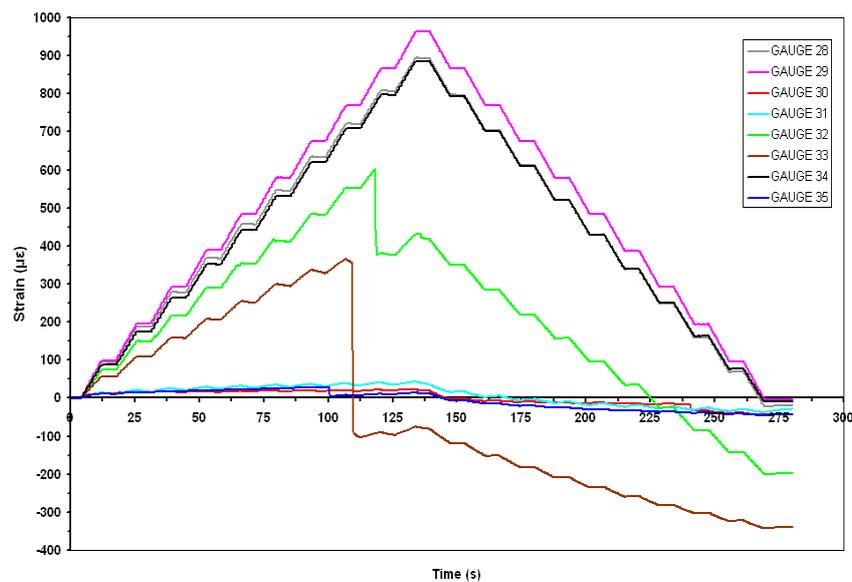
Figure 15. Test after aging. 200 kN Traction stress. This figures display FBGs on specimen 1 (a), FBGs on specimen 2 (b), FBGs on specimen 3 (c) and strain gauges on specimen 3 (d).

The Figure 15 shows the results for FBG sensors of the three specimens with traction stress and after the aging of specimens 2 and 3. The results of the tests on aged specimens 2 and 3 were significant. The FBG sensor readings have been considerably higher than those obtained before aging, and the 1,400 microstrains obtained are far from the 950 microstrains expected.

The effect of high temperature has been ruled out because the FBG model tested is capable of withstanding temperatures up to 120 °C. Therefore, the factor that caused the negative effect on the FBG is the high humidity.

With regard to the protections of strain gauges, it is noteworthy that the best results have been with M-COAT-B protection, the result being exactly the same before and after aging. The results of the

protections M-COAT-A and PU 140 have been slightly lower after staying in the climate chamber. Protections M-COAT-C, M-COAT SG250-D and SG250 have been proven unsuitable for long exposures to extreme conditions. In the case of strain gauges 32 and 33, their protection did not properly protect gauges. In fact, strain gauges 32 and 33 stopped working properly during the test.

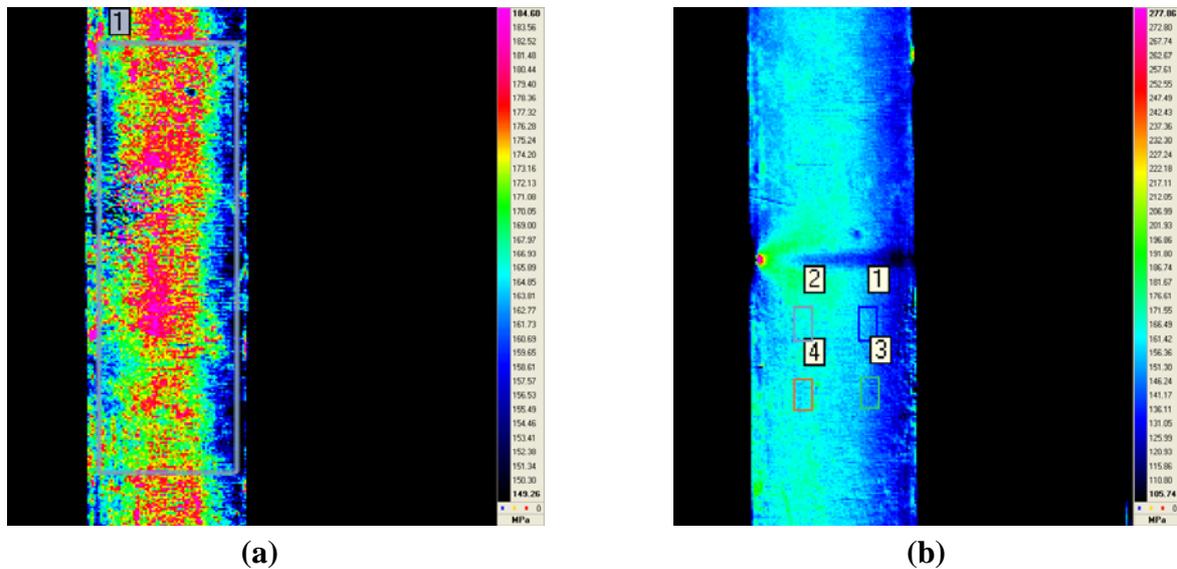
Figure 16. Thermograms acquired during the IT tests. In (b) can be seen a slot created in the opposite side for detect inspection.

The position of the four gauges used is shown on the second thermogram of Figure 16. The comparison between gauges and IT techniques is shown on Figure 17.

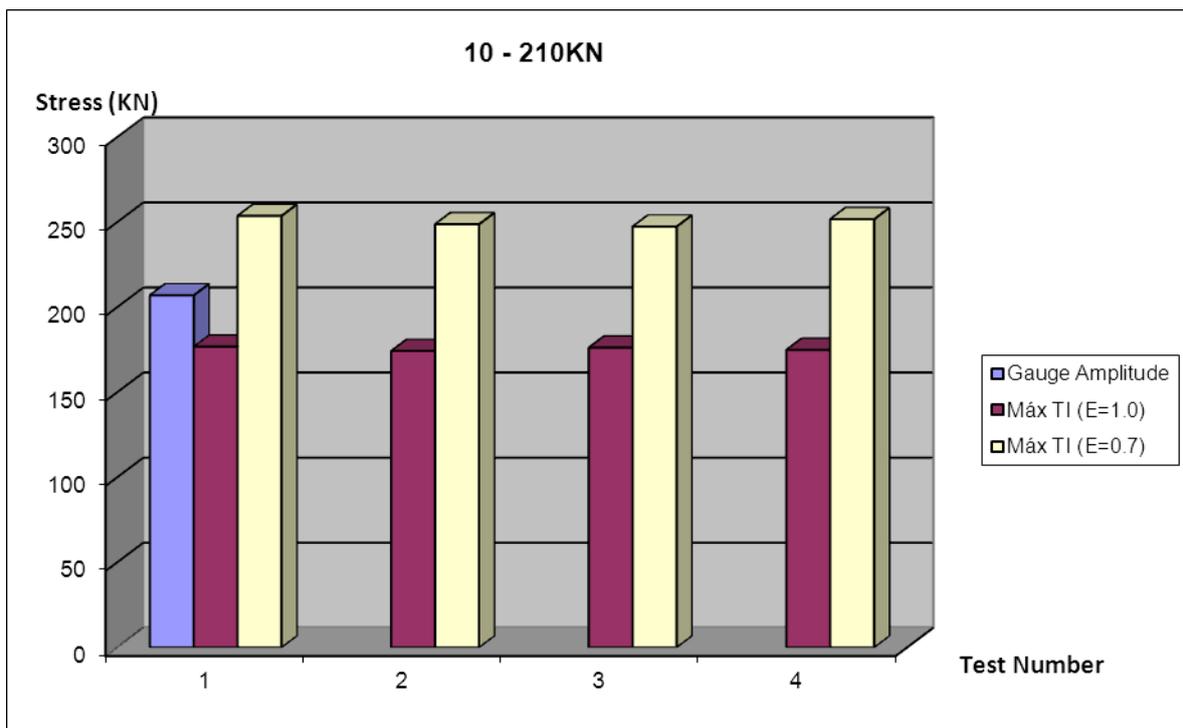
Figure 17. Stress comparison between strain gauges and IT techniques.

The readings of tensile-fields obtained using IT techniques inspections are not as accurate as FBG's. It was noted that the emissivity of the material has a major effect when calculating stresses. Average errors are about 15% for emissivities between 0.7 and 1. The load applied to the specimen and the read by the strain gauges has been 210 kN, however the calculated load for an emissivity of 0.7 has not reached 180 kN and the corresponding emissivity 1 has exceeded 250 kN.
