# TRIBOCORROSION OF HIGH-STRENGTH LOW-ALLOY STEELS AND COATINGS USED IN OFFSHORE APPLICATIONS

Ph.D Thesis  
In Materials Engineering

**Ainara López Ortega**

November, 2018

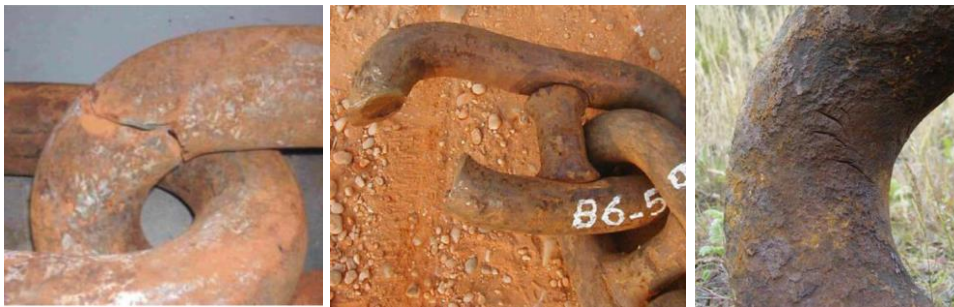
Fig. 2.4 Chain failure by corrosion-fatigue crack propagation in the crown (left [36] and middle [37]), and fatigue crack initiation in the crown (right) [37]

- **Corrosion-fatigue:** Fatigue damage accumulates in mooring line components as a result of cyclic loading. As consequence of the low frequency generated by waves (0.1-0.5 Hz) [34,35], there is plenty of time for corrosion to occur, and the phenomenon shall be therefore referred to as corrosion-fatigue.

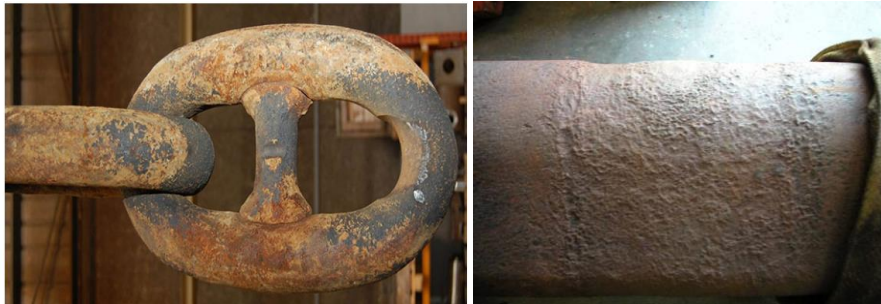
Fig. 2.6 Chain links showing severe wear in the inter-link contact (left) [51], and wear and pitting corrosion (right) [2]

- **Wear and abrasion:** The cyclic loads generated by environmental factors can lead to wear, and fatigue-wear, which can result in premature failure of components. Chain wear is more severe in the inter-link contact, particularly in the upper chain links [1,42,47] and in the sea floor or thrash zone [2,9,22,33,47]. The high wear in the less heavily loaded leeward lines is attributed to a greater inter-link rotation occurring in the thrash zone [26,27,33]. Furthermore, sand and other foreign materials can be trapped in the inter-link contact, aggravating the abrasion between links [1,30,49,50]. Some studies have reported wear rates up to 3-4 mm per year in chain links [22,26]. The main wear mechanisms found in the interaction between links in mooring lines have been found to be adhesive wear, abrasive wear, and surface fatigue wear [22,47]. The considerable reduction of the chain section results in a loss of strength, and the links might not resist the imposed load failing prematurely.

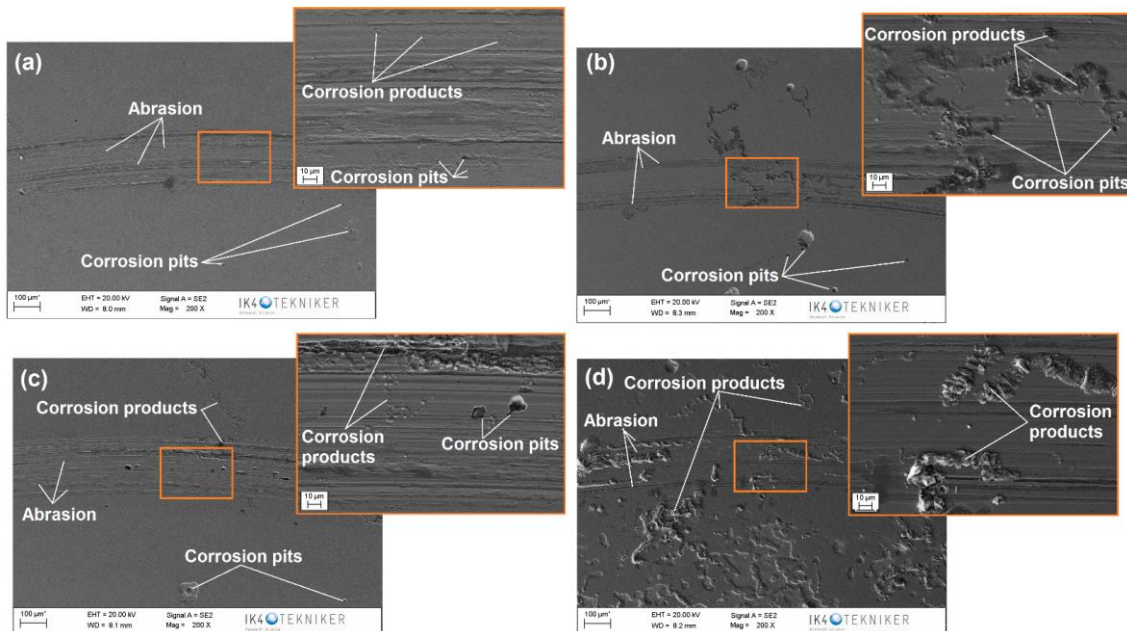
Fig. 5.3.6 SEM images showing the topography of the wear tracks of the R4 steel grade obtained in the tests with rotation just during sliding at (a) 50 and (b) 100 rpm, and the rotating tests at (c) 50 and (d) 100 rpm

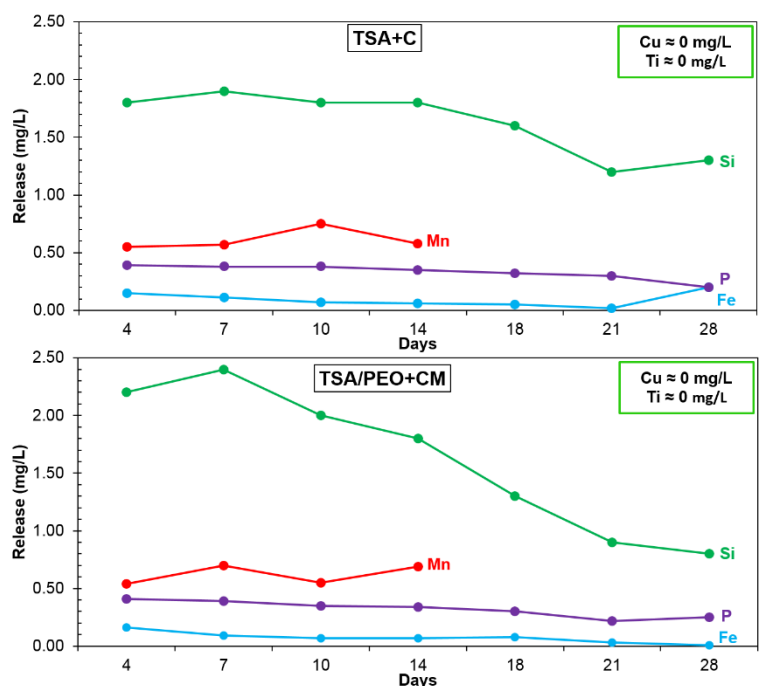
Fig. 5.7.10 Metal release in mg/L obtained from the leachates of the TSA+C and TSA/PEO+CM coating systems agitated during 28 days in synthetic seawater. The release of copper and titanium was negligible in both samples.

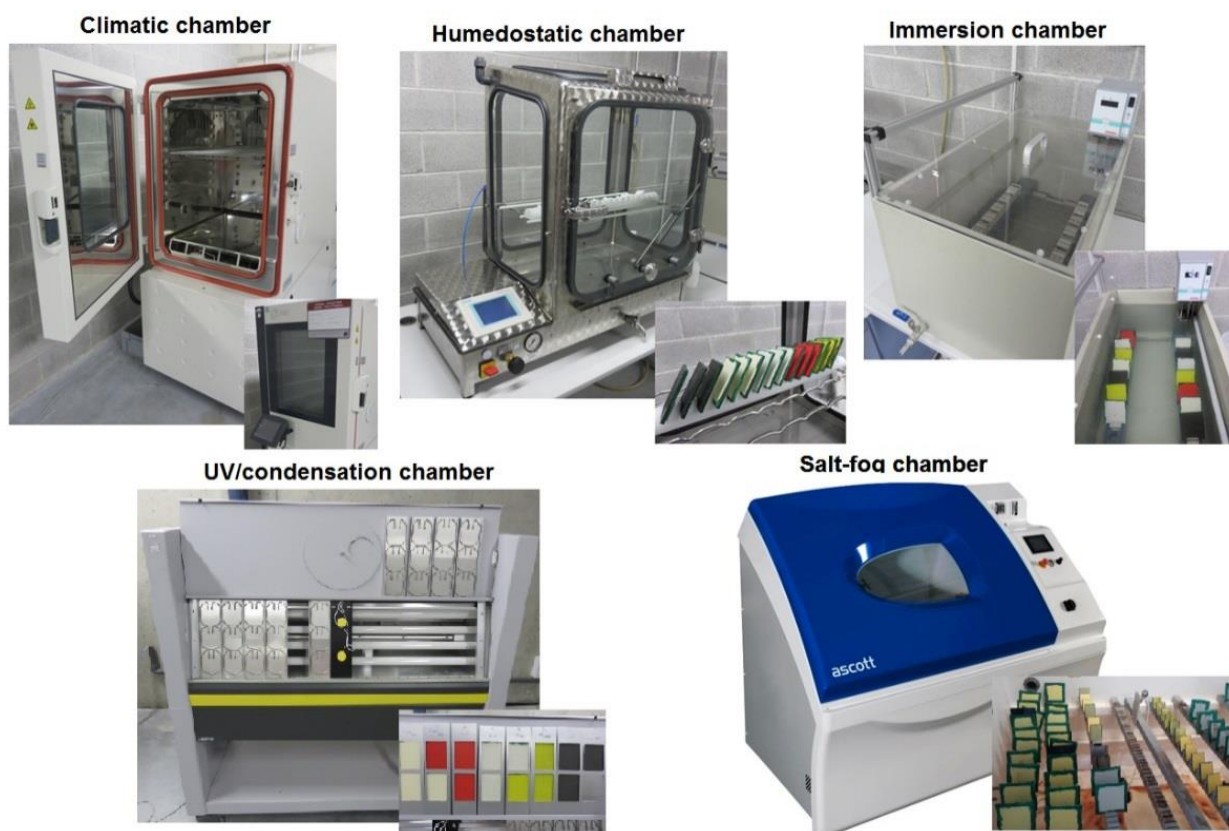
Fig. A.1.3 Climatic chambers employed in the ageing tests

The climatic chambers employed in the evaluation of coatings in chapters 5.5 and 5.7 are presented in Fig. A.1.3. The immersion tests were performed in a Julabo ED

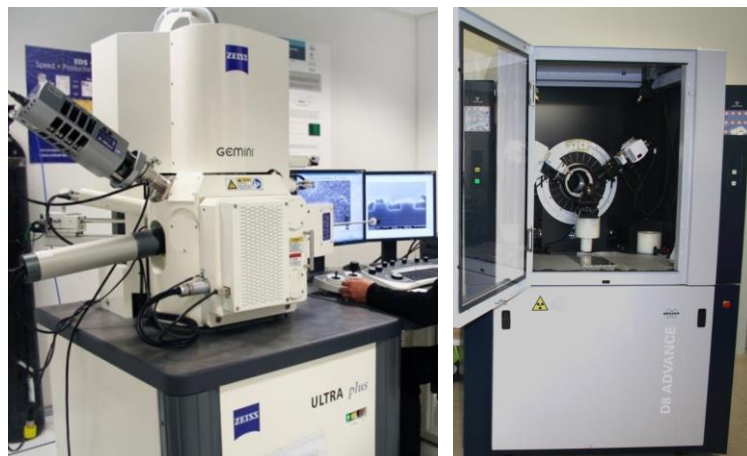
*Fig. A.I.6 ZEISS ULTRA plus SEM microscope (left) and D8 Advance X-ray diffractometer (right)*

The equipment used in this work was the ZEISS ULTRA plus Field Emission Scanning Electron Microscope with EDS and BSE microanalysis from OXFORD INCA synergy [19] (Fig. A.I.6). The equipment has a controlled field emission source with incorporated GEMINI® patented column, for high resolution and analysis from ZEISS Company.

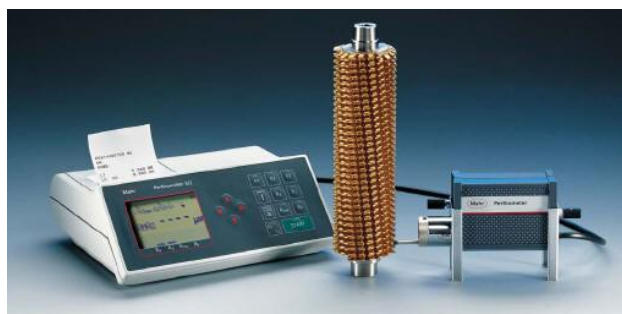
Fig. A.I.7 Perthometer M2 profilometer of Mahr

In this work, the Mahr Perthometer M2 [21] was used to measure the roughness of different surfaces (Fig. A.I.7). This equipment has a maximum measuring range of 150  $\mu\text{m}$ , with a maximum cut off length of 17.5 mm. The evaluation and selection of the measurement length can be made according to different standards (ISO, JIS, CNOMO). For the calculation of the arithmetic average roughness ( $R_a$ ) values, the equipment followed the DIN EN ISO 4288 and DIN EN ISO 4287 standards [22].
