Assessment of conservation state of gothic wall paintings: from scientific diagnostic to a new monitoring approach

Report to complete for the International PhD degree

Ilaria Costantini

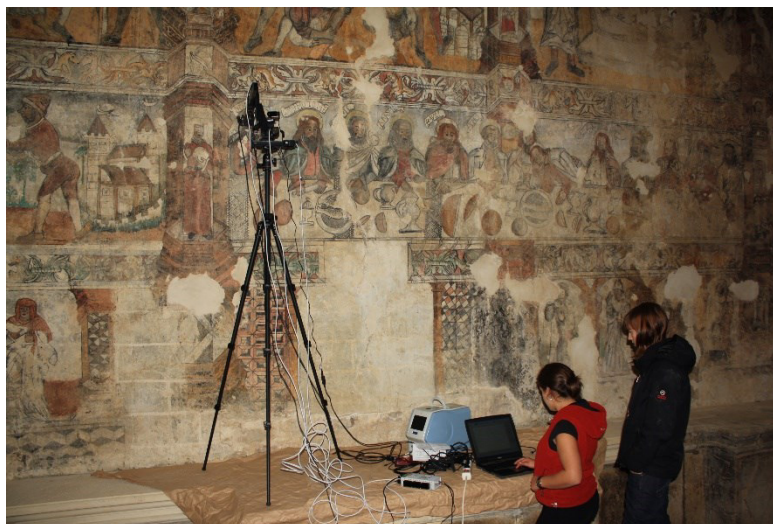
Figure 1.4: *In situ* Raman analysis of the medieval wall paintings located in the Saint Andrew Church (Biañez, Basque Country).

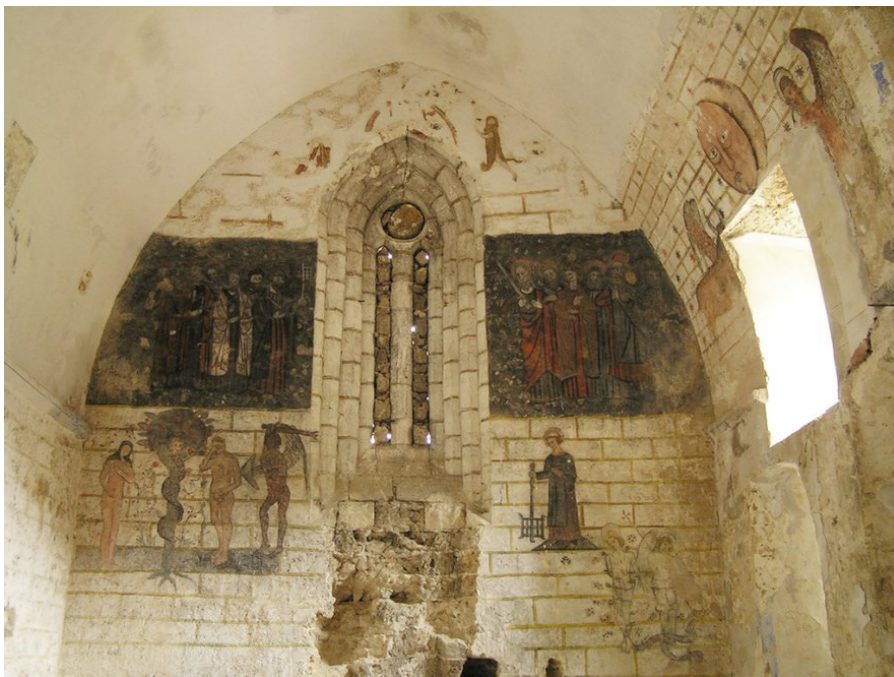
Figure 3.4: Painted apse wall of Saint Stephen's church.

The scenes that are well preserved are located in the apse wall divided in two groups by the proto Gothic window and represent several religious subjects: *the Apostolate*, *the Temptation of Adam and Eve* and the *Expulsion from Paradise* and images of *Saints* (Figure 3.4). The paintings are one of the few examples of Gothic painting present in the Basque territory and require special attention in order to be preserved since their conservation is at risk.

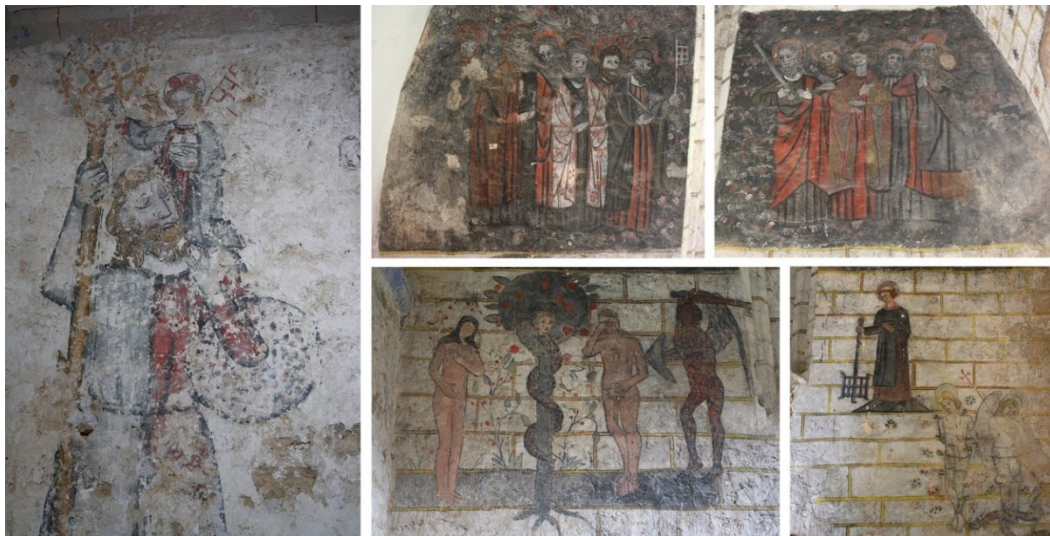
Figure 3.5: Wall paintings discovered and investigated in the Saint Stephen's church.

Currently, only the paintings in the apse wall and some of the lateral naves were discovered (Figure 3.5). The cycle of paintings shows different religious themes: above the proto Gothic window, which divides the apse wall, a badly damaged scene

was attributed to a *Deesis*, below the *Apostolate* divided into two groups of six people by the window. On the left, in the lower part of the wall, a particular scene from an iconographic point of view is found: the depiction of the *Original Sin*. On the left side a snake with a human head is twisted around the tree of life, and on the right side the figures of Adam and Eve. On the right, in the same scene, it is possible to see a figure covered with feathers, except the face, that represents an angel. The painter wanted to represent in the same scene three different moments: *the Temptation of the Snake*, *Adam and Eve that Realize their Sin and Try to Cover Themselves up*, and, finally, *the Expulsion from the Paradise* by an angel.

At the bottom on the right, we find the representation of Saint Lawrence, who holds in his right hand the grill, symbol of his martyrdom. This is the only example of this saint preserved in the late medieval painting in Álava. Further below, on the left, there are two figures representing Saint Sebastian pierced by arrows, and Saint Michael, more deteriorated, with a spear while he strikes a snake.

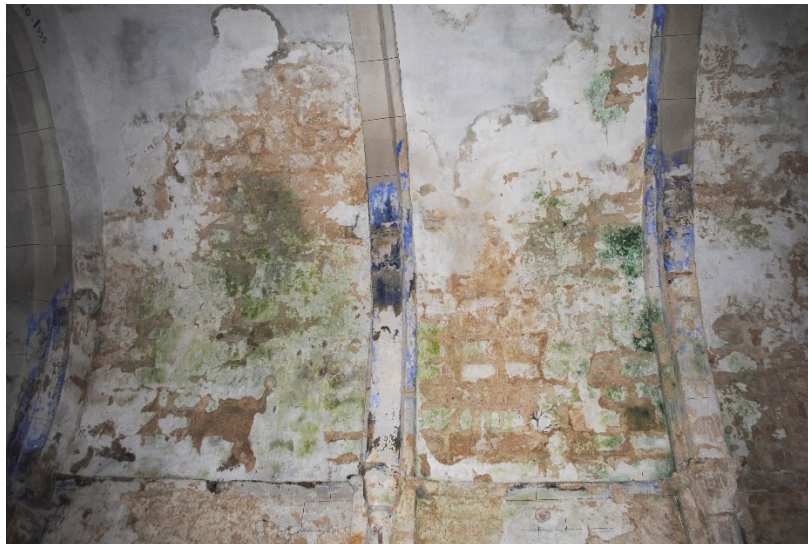
Figure 3.6: Degradation process caused by infiltration water and presence of biological patinas.

The church of Ribera de Valderejo is in critical condition and actually it is closed to visitors for security reasons. The church is located in a natural park and there is not industrial activity in its surroundings. Thus, the damages must be considered mainly as the result of the natural decay. Due to the state of abandon of the church, the infiltrations of the rainwater and snow are causing the partial collapse of the roof and this makes a particular scenario for the formation of saline efflorescence products inside and outside the masonry. Moreover, the building is almost completely surrounded by vegetation. Therefore, there are visible aesthetic, chemical and structural damages caused by both, microorganisms and macroorganisms (plant roots) that are stifling and destroying this interesting building (Figure 3.6).

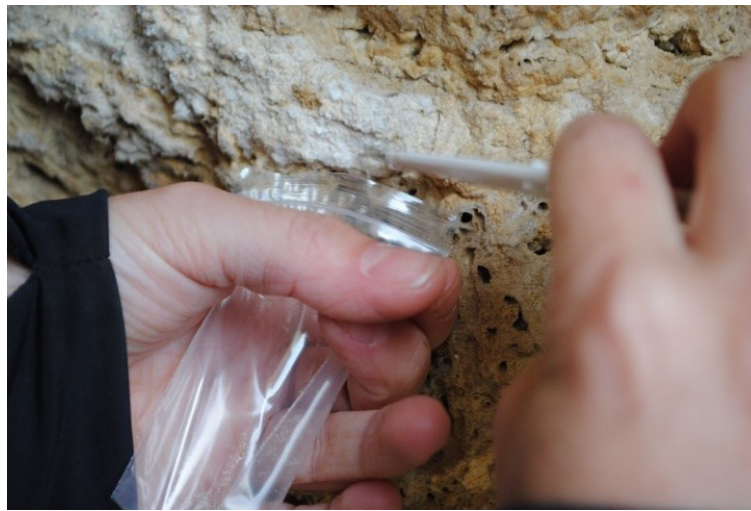
Figure 3.8: Sampling of salt efflorescences present in the structural walls.

In addition, in order to study the composition of some salts efflorescence, some samples were collected to be analyzed in the laboratory to understand the effects of the surrounding natural environment on the onset of these secondary products. These samples were collected using a scalpel and stored in a plastic sample bag (Figure 3.8). The analysis in the laboratory was carried out both on efflorescence as it is and in the form of pellets.

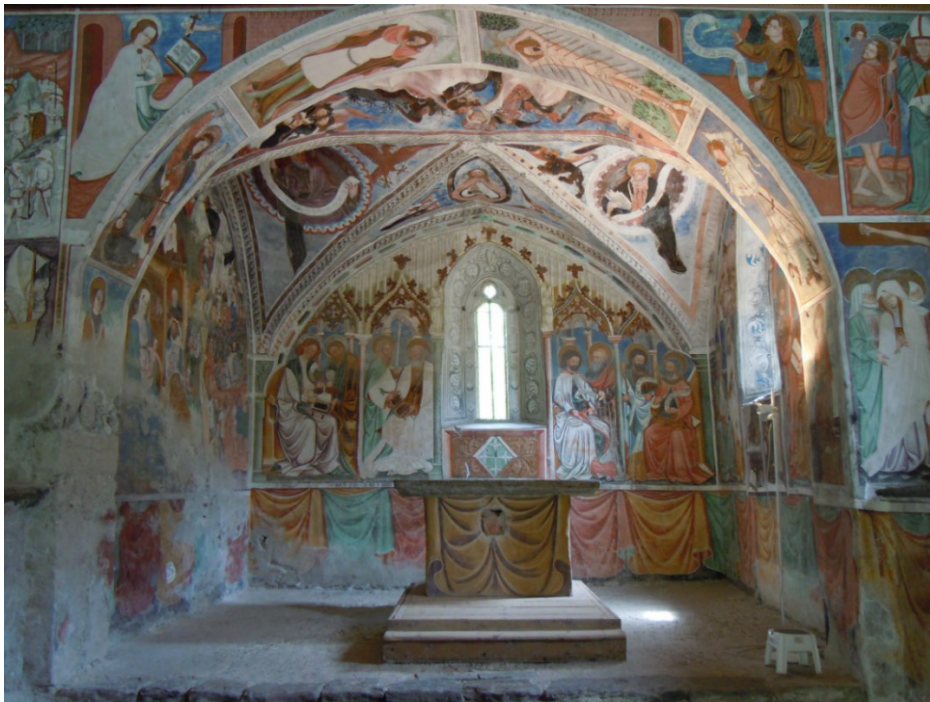
Figure 3.10: Interior of Saint Stephen's chapel of Montani.

The interior of the chapel of Saint Stephen is completely covered with paintings, realized with the fresco technique, belonging to two different periods: the north wall, the presbytery and the triumphal arch are of Lombard origin (Figure 3.10), belonging to a period between 1430-1440, while the walls to the south and west were painted by a Swabian shop: next to the Montani coat of arms, on the west wall, there is the date of the cycle of frescoes, 1487 (the same year in which the church was consecrated) [2].

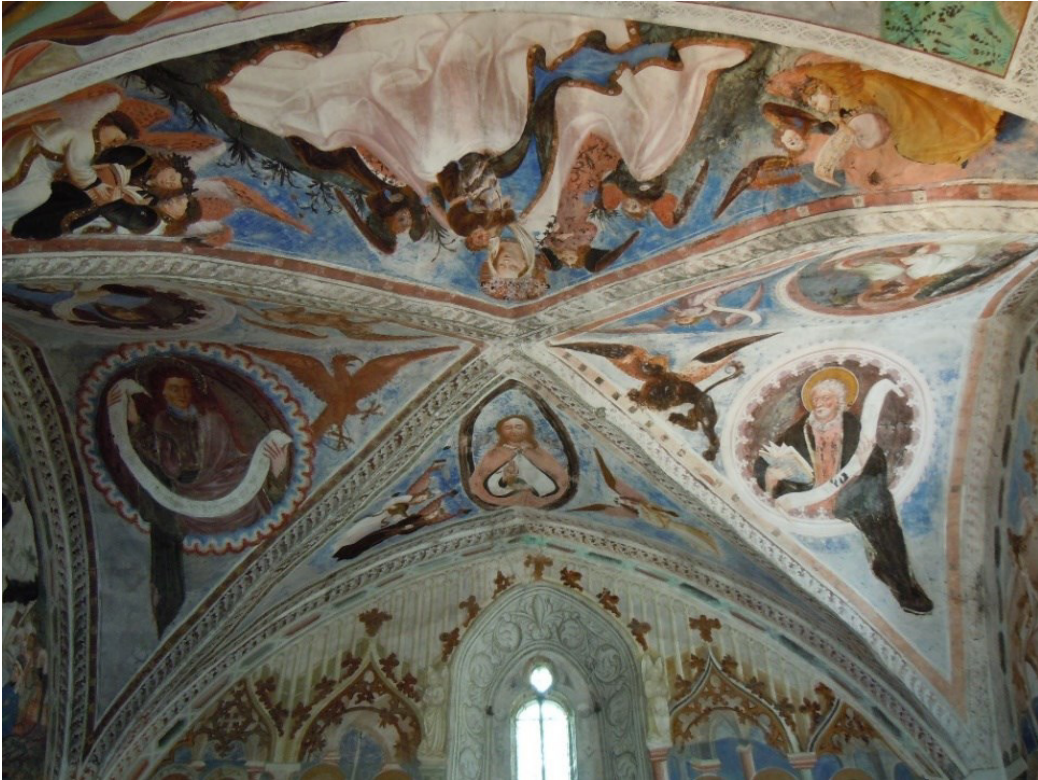
Figure 3.11: Vault of chapel where the blackening of paintings is evident.

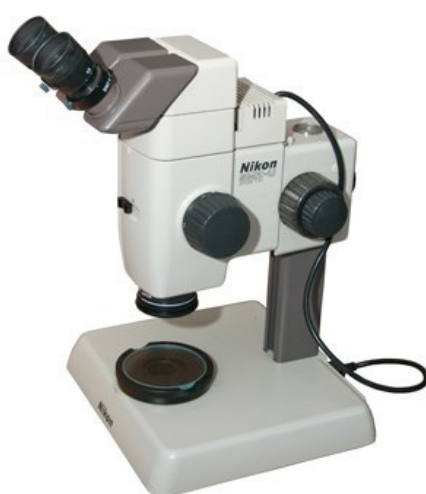
Figure 4.1 SMZ-U microscope.

The analytical study of mural paintings samples was often assisted by their visual assessment at microscopic scale. Thanks to the support of Dr. X. Murelaga Bereicua from the Department of Stratigraphy and Paleontology (UPV/EHU), high quality images of the fragments under analysis were acquired by means of the SMZ-U microscope (Nikon, Japan) coupled to the Nikon Digital Sight DS-L1 camera (Figure 4.1).

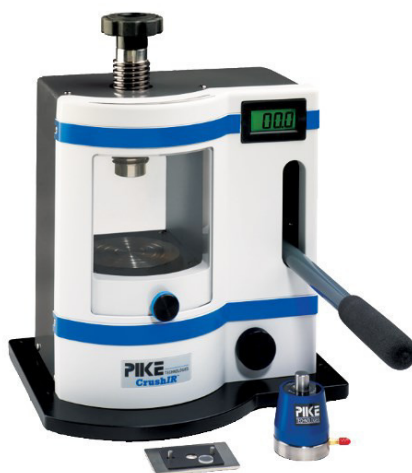
Figure 4.2: CrushIR hydraulic press.

In order to perform semi quantitative analyses with Raman spectroscopy, salt samples were mixed thoroughly in an agate mortar. Some salt pellets were prepared using a CrushIR hydraulic press (Pike technologies, USA, Figure 4.2). The press, specifically designed for making high quality KBr pellets, ensures excellent reproducibility thanks to the combination of digital pressure reading and adjustable pressure setting (maximum value: 13.6 tons/cm^2). The instrument is equipped with a PIKE Evacuatable Pellet Press having a pellet holder with a diameter of 13 mm.

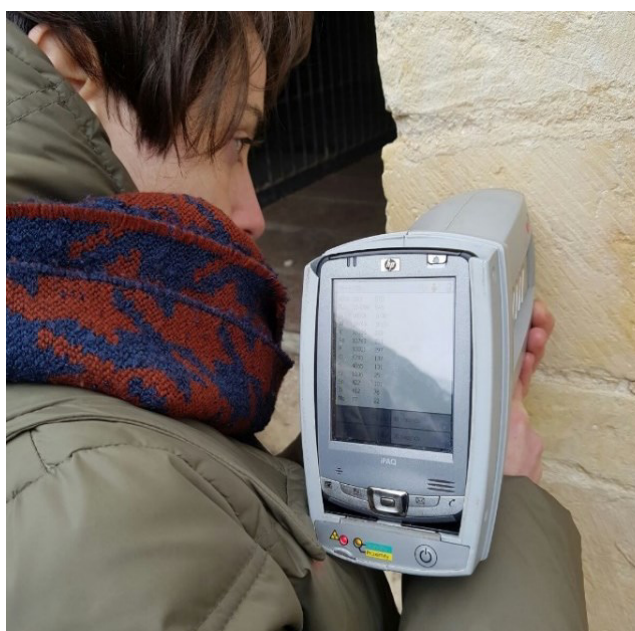
Figure 4.4: Use of portable ED-XRF instrumentation on the structural walls of Saint Stephen's church (Ribera de Valderejo, Álava).

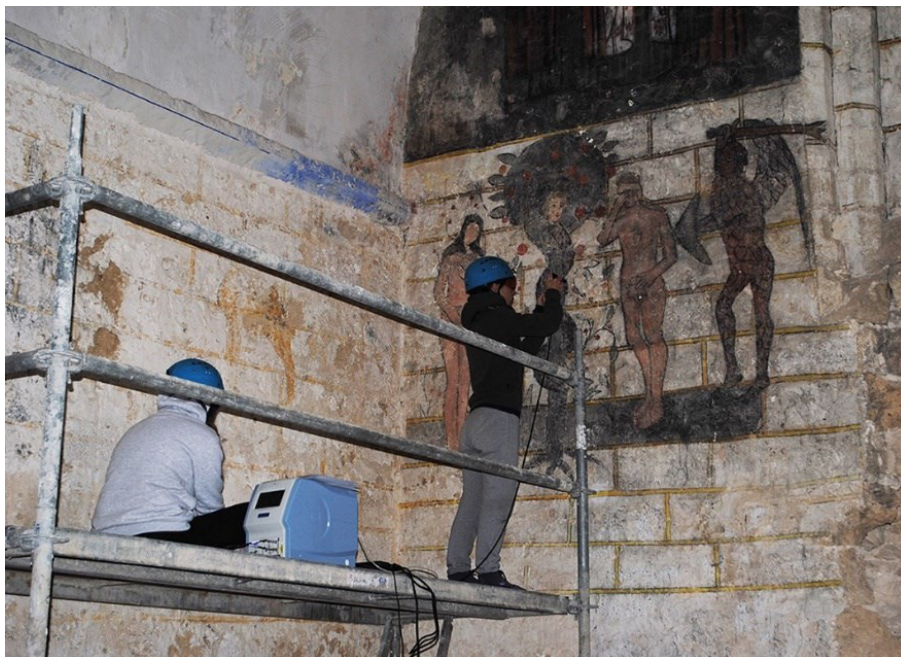
Figure 4.5: Use of portable InnoRam™-785S spectrometer (785nm) spectrometer within the Saint Stephen's church in Ribera de Valderejo (Álava, Spain).

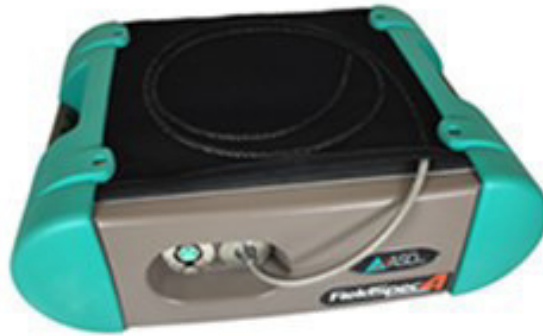
Figure 4.6: ASD High Resolution FieldSpec4 spectroradiometer

Reflectance measurements of all samples were carried out using the ASD High Resolution FieldSpec4 spectroradiometer (Analytical Spectral Devices Inc., Boulder, USA, Figure 4.6) equipped with a bare optic fibre for remote mode operations. The light source consisted of a halogen lamp (ASD Illuminator) placed at 30 cm of distance from the samples. The angle between the incident light and the sample, and that between the sample and the detector fibre was 45° in both cases. The fibre has an acceptance cone with an angle of 25° and was placed to a minimum distance of the sample to minimize the measurement surface. This device works in the 350-2500 nm wavelength range and uses three detectors for the different spectroscopic ranges: 350-1000 nm (silicon photo-diode array for Vis-NIR), 1001-1800 nm (InGaAs photo-diode for SWIR1) and 1801-2500 nm (InGaAs photo-diode for SWIR2). The spectral resolution is 3 nm in the visible region and 6 nm in the near infrared region. Sensor optimization and calibration was set with a Spectralon[®] white reference scanned once before each sample, and each spectrum is the result of the average of 10 scans. Spectra were collected with RS3 software (ASD Inc.), analysed with ViewSpecPro software (ASD Inc.) and compared with those found in the bibliography.

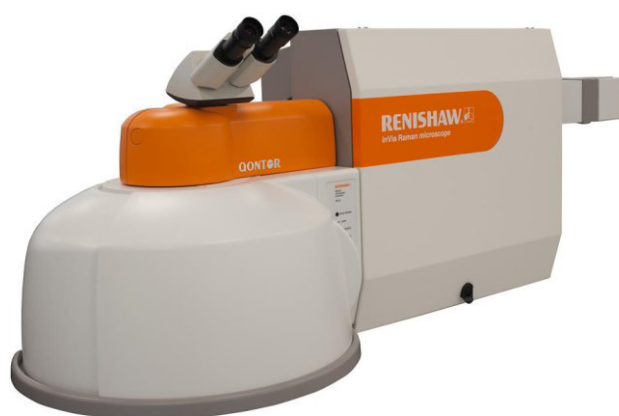
Figure 4.7: InVia Confocal Raman spectrometer.

The inVia Confocal Raman microscope (Figure 4.7) is equipped with a 514 nm (maximum power of 50 mW) and a 785 nm (maximum power of 350 mW) excitation laser, a DMLM Leica microscope (Bradford, UK) and a CCD detector. The spectrometer works in a spectral range between 65 and 3800 cm^{-1} with a mean spectral resolution of 1.2 cm^{-1} . On the one side, StreamLine technology was employed to generate high definition molecular images of specific samples. Briefly, the motorized stage of the microscope coupled to the Raman spectrometer moves the sample beneath the lens so that the line of laser-light is rastered across the area

under analysis. Afterwards, from the collected spectra, chemical images are generated by taking into account the position of main band of the compound of interest. In both cases, the Renishaw Wire 3.2 (Renishaw, UK) software was used for data collection and analysis.

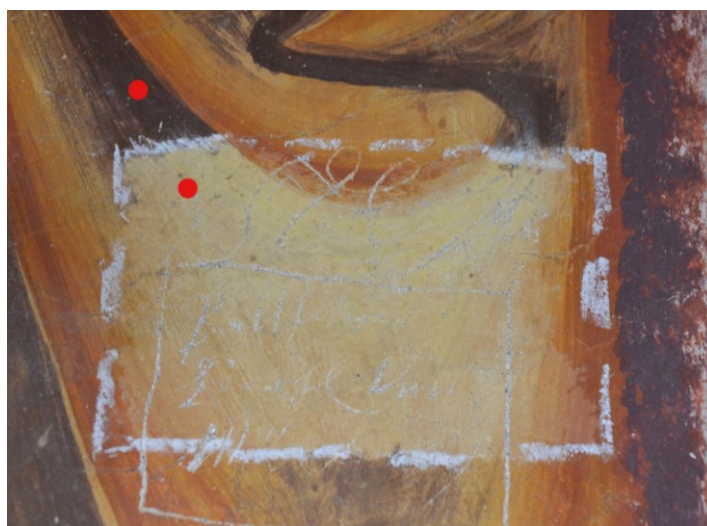
Figure 5.6: Detail of yellow area partially cleaned with the traditional method of white-lead reconversion and points (in red) of XRF analysis where lead was detected and where Raman spectroscopy only found lead tin yellow.

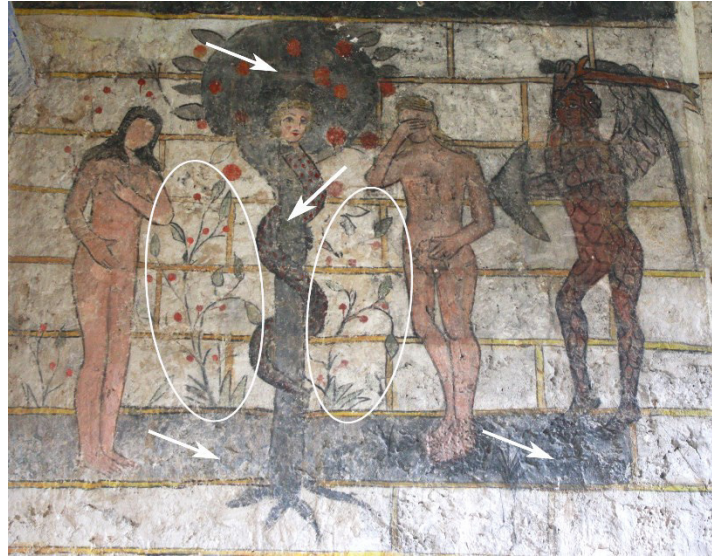
Figure 6.1: Representation of *Original Sin* in the apse area in which are visible grey areas (pointed by arrows) and green areas (pointed by circles).

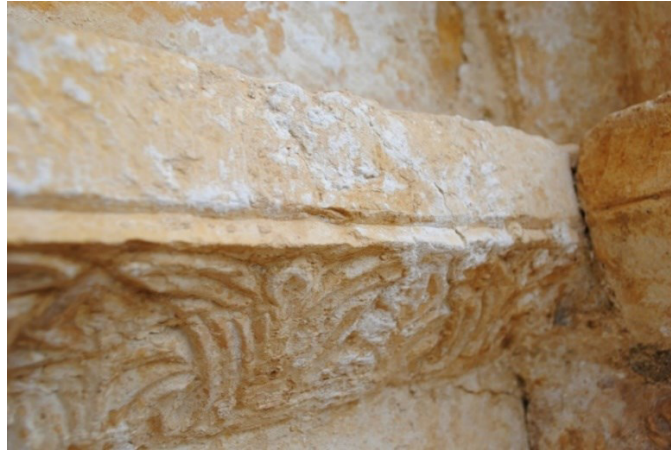
Figure 7.3: Evidence of salt crusts on the portal stone.

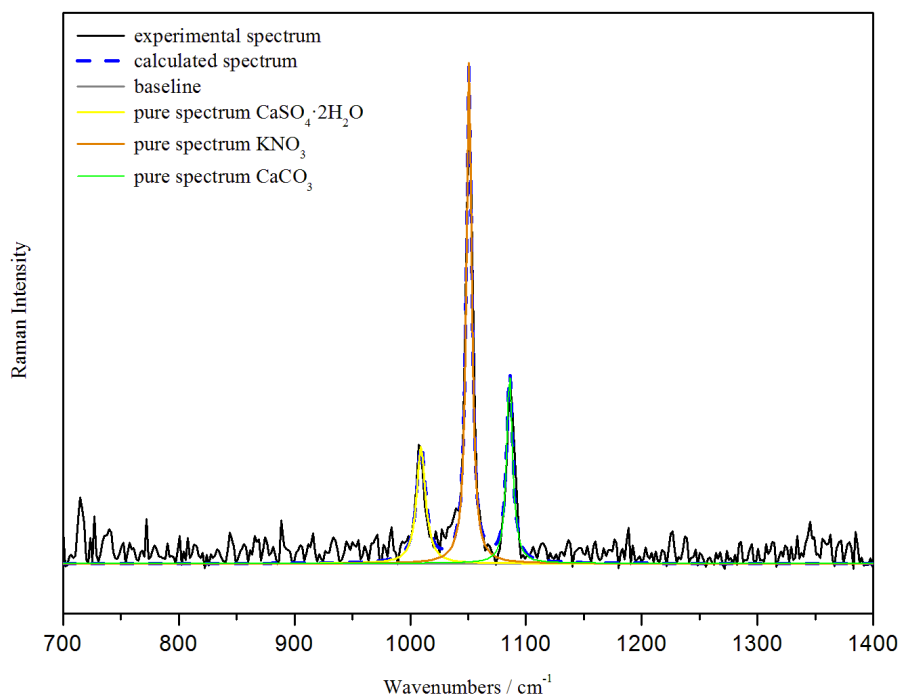
Figure 8.1: Spectral adjustment of Raman spectrum recorded on a pellet of real salt composed by a mixture of calcium carbonate, gypsum and potassium nitrate.

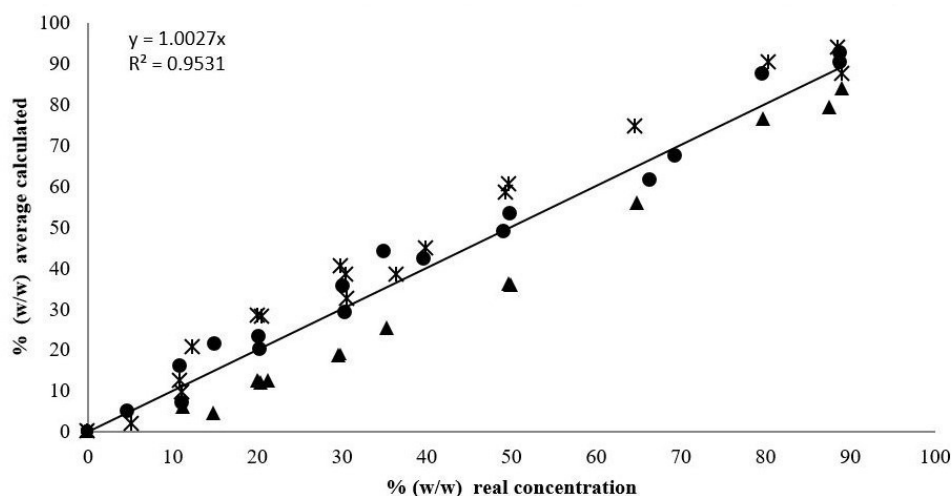
Figure 8.4: Trend line built with real concentration of the pellets used for external calibration and the average of concentration calculated by PALME software of calcium carbonate (CaCO₃), gypsum (CaSO₄.2H₂O) and potassium nitrate (KNO₃).
