Article

Airtightness Analysis of the Built Heritage—Field Measurements of Nineteenth Century Buildings through Blower Door Tests

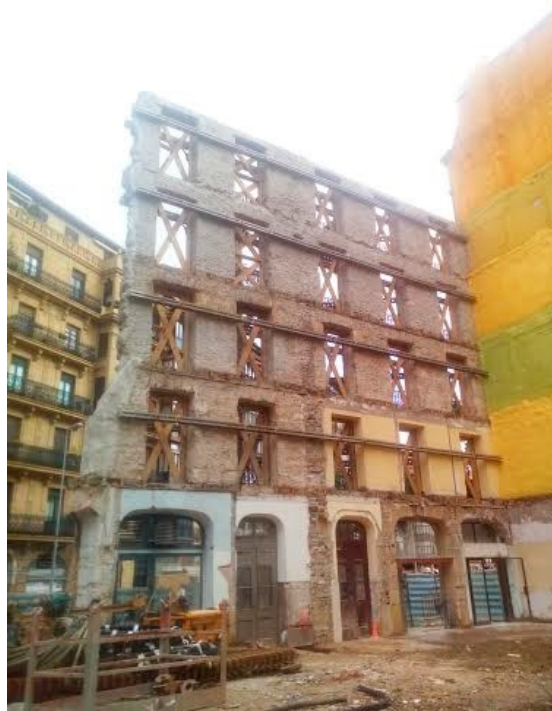
Figure 2. The elements of a typical load bearing stone wall, visible in detail during the building renovations of Easo street 1 and 2 cases.

Regarding the construction systems, it has to be mentioned that all of them are very similar, except for buildings C and E whose inner structure was replaced with contemporary refurbishments. Figure 2 shows a conventional facade under renovation composed of a load bearing stone wall and joints with the wood floors. Load bearing facades often consist of a combination of many different materials. In the present study, we found heavyweight walls made of an outer layer of sandstone blocks, and a mixed masonry of limestone and sandstone on its inner side. These walls usually include gypsum sheathings on the inner surface. In some other cases, load bearing facades consisted of brick masonry,

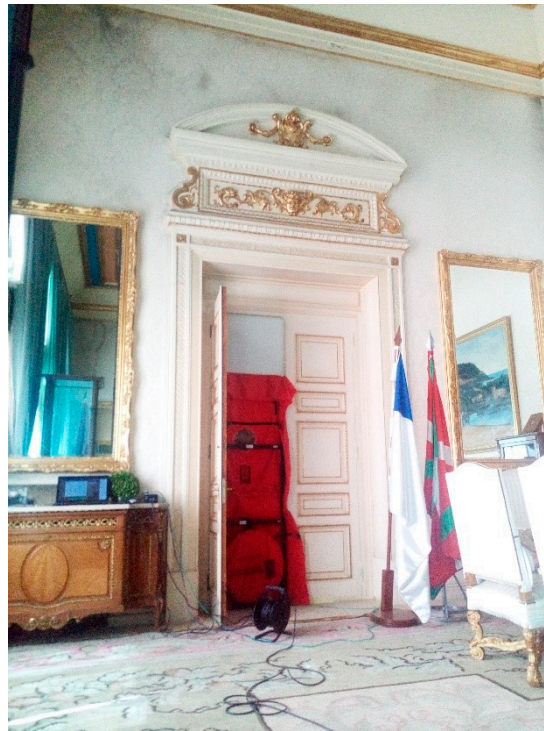
Figure 4. Use of the Minneapolis BlowerDoor equipment in the 31.F sample of the City Council building of Donostia-San Sebastián.

The third stage contained all the issues directly related with the BDT and its preparation. The tests were performed with a Minneapolis Blower Door Model 4, as shown in Figure 4, following the procedure of the Method 1 defined in ISO 9972 [13]. This stage can be considered as the most complex, because of the large amount of equipment required and all the steps that needed very careful consideration to successfully conduct the tests.

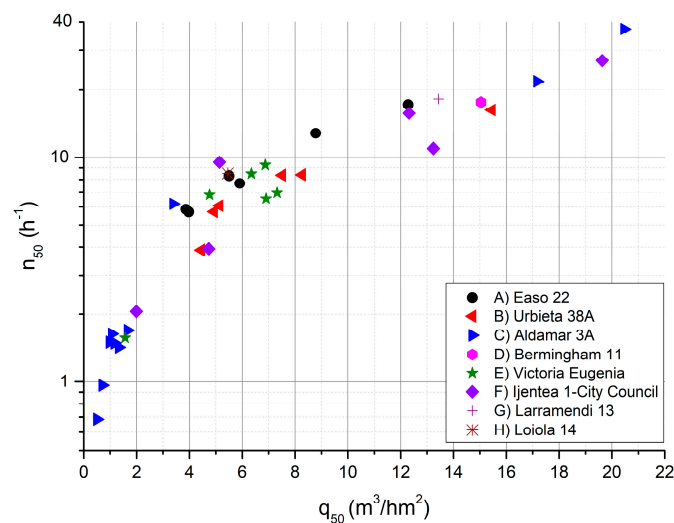
Figure 5. Distribution of the air tightness test results of the analyzed units by means of air permeability and air change rate at 50 Pa.

A general overview displays a considerable deviation of the results and a wide gap between the maximum and minimum airtightness. Despite the diverse results, two thirds of n_{50} vary from 3 h^{-1} to 20 h^{-1} , a 67.6% of the total. This general result points to a relevant deviation from the findings of other studies [27–35]. None of them have presented such low airtightness, except from several specific studies of historical buildings [7,8]. Apart from the studies conducted in historical buildings, there is only one case [32] whose the average airtightness exceeds the results of the present study. So we can conclude that the airtightness of the evaluated heritage buildings tends to be lower compared to the buildings of recent times. The next section includes further assessment.

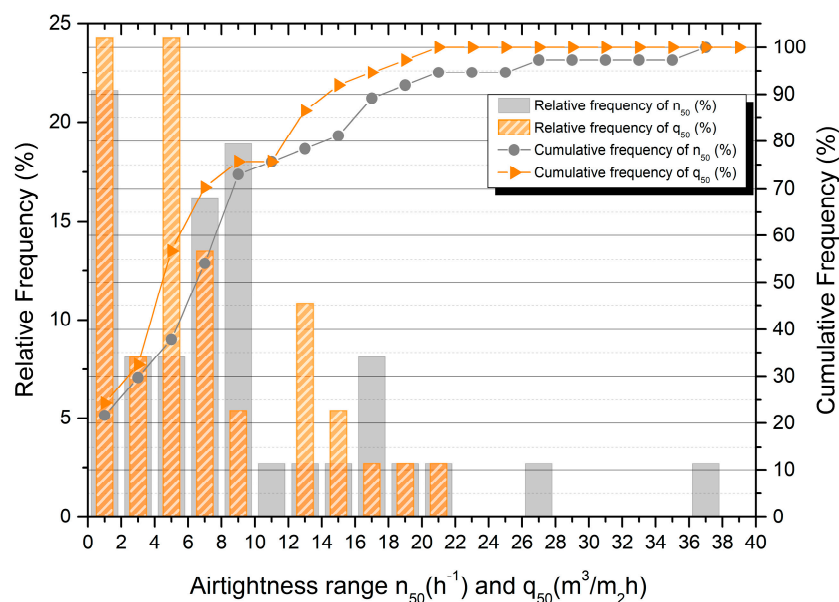
Figure 6. Statistical analysis of the relative and cumulative frequency of air permeability and air change rate at 50 Pa.

The average airtightness of all tested enclosures is $n_{50} = 9.03 \text{ h}^{-1}$. It is a high value given the objectives set by European Union regulation to reduce energy consumption in buildings. A frequency analysis of the airtightness values, Figure 6, reflects that the most frequent range of n_{50} is the $0\text{--}2 \text{ h}^{-1}$. However, this relative frequency does not faithfully represent the whole study, because this range is greatly influenced by C building's results. In this building C, the sample of tests carried out was high to confirm that the high airtightness results obtained were not isolated values and reflected the majority behavior of the rest of the zones. The other ranges between $6\text{--}8$ and $8\text{--}10 \text{ h}^{-1}$ reflect more accurately the studied typology, since those measurements reflect different buildings. The results can be sorted in three main groups: around 30% of cases between $0\text{--}4 \text{ h}^{-1}$, a 50% corresponding to airtightness ranging $4\text{--}16 \text{ h}^{-1}$ and a 20% remaining around $16\text{--}38 \text{ h}^{-1}$.

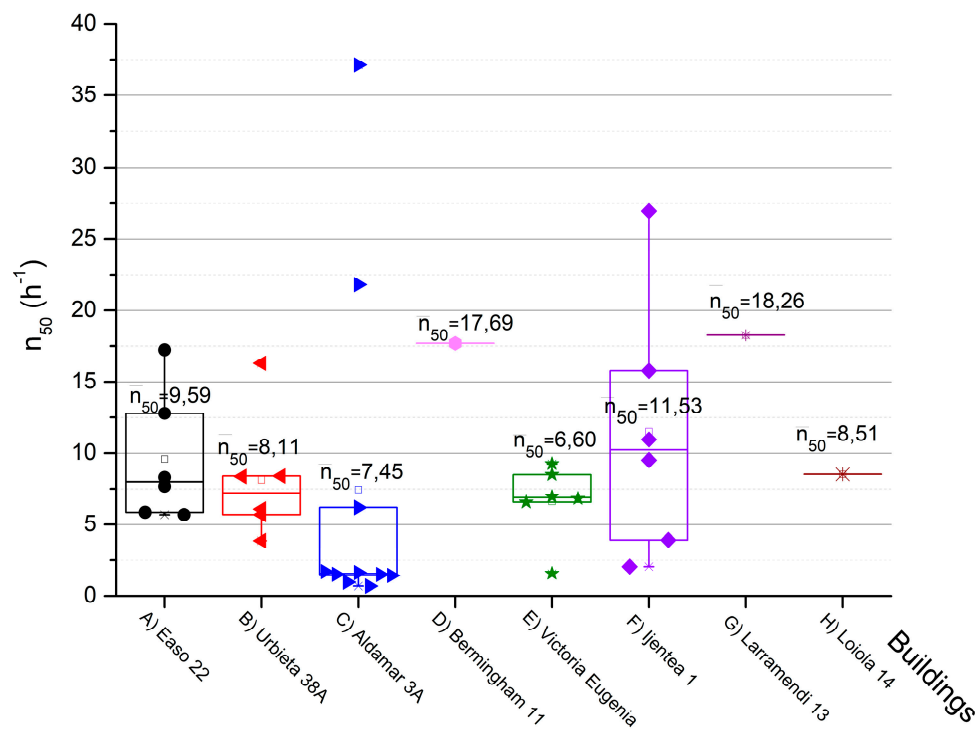
Figure 7. Box-plot of the air tightness of analyzed enclosures, classified by building.

The box plot in Figure 7 displays the results of each building. The mean values of the buildings with a large number of samples like A, B, C, E and F are between $6.60\text{--}11.53 \text{ h}^{-1}$. This shows that the average airtightness of all the buildings tested in diverse enclosures are within a 30% of variation from the study average 9.03 h^{-1} . These results show a substantial difference from the values obtained by other surveys of historical buildings [7,8]. Most likely, the main reason for this difference is the morphology of evaluated buildings. While the aforementioned studies focused on overall tests of small size buildings like detached dwellings, farms or manor houses; the present study has evaluated representative enclosures inside large buildings. In any case, the average values of previous studies are closer to the maximum values found in the current investigation.

The statistical box-plot is very useful to visualize the extreme values mentioned before. The whiskers of the chart do not reach these values and they reflect a significant difference with respect to inter quartile range (IQR) values of each building. Despite the fact that these extreme values do not correspond to the overall behavior of each building, they warn of unusual behaviors that can be found in this typology.

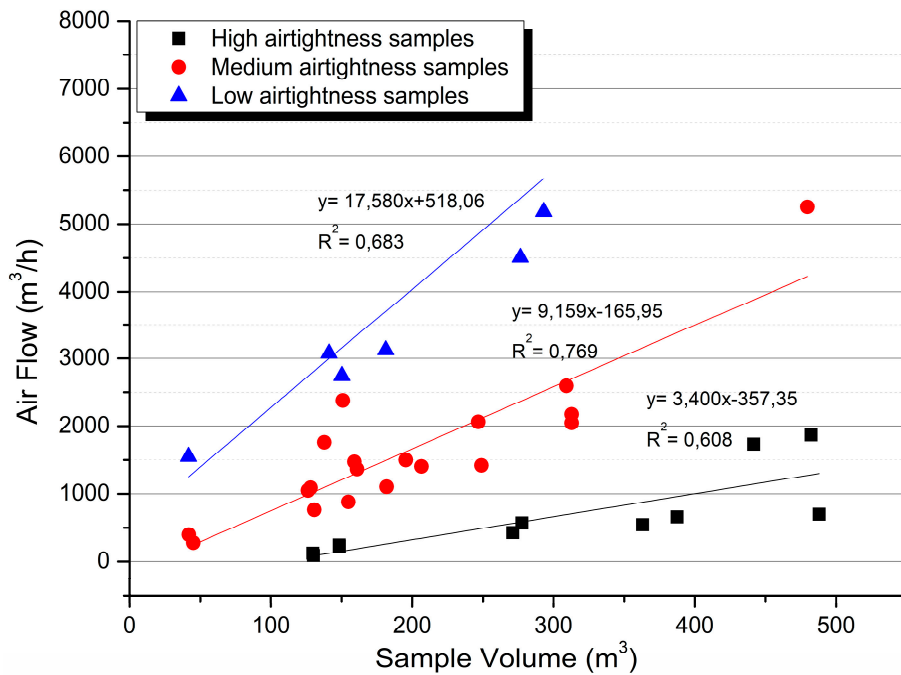
Figure 8. Correlation between airflow and volume of the tested enclosures, according to the identified airtightness levels.

The first comparison relates the measured air flow with the volume of the enclosure. The results of the global study don't present any remarkable trend. Nevertheless, if the results are examined separately according to their degree of airtightness, each group displays a suitable correlation between the air flow and the enclosure's volume, as shown in Figure 8. These three stages point to divergent behaviors in relation to different air flow resistances of envelopes. Even though the coefficients of determination R^2 are not optimum, they show a close connection between these two parameters, especially for medium and low airtightness cases.

The better adjustment of these two groups seems to indicate that the impact of the geometrical characteristics in the air leakages is greater in low and medium airtightness cases than in high airtightness enclosures. For that reason, a second correlation was checked between the air flow and the enclosure's covering. Considering the results of each group as shown in Figure 9, there is a strong interrelation between the dimensions of the enclosure and the air flow. The cases of low airtightness show a closer interdependence with the envelope surface of the enclosure that the medium airtightness cases due to the higher R^2 value. However, the cases of high airtightness do not have any relation with the total envelope surface.

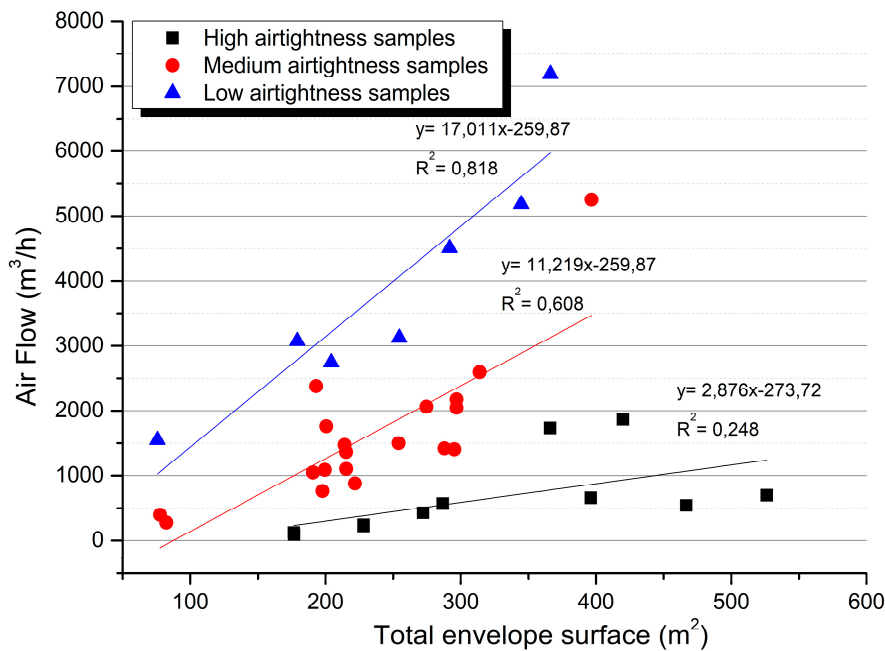
Figure 9. Correlation between airflow and envelope surface of the tested enclosures, according to the identified airtightness levels.

are not so much related with the general geometrical features of the enclosure like the volume and envelope area showed in Figures 8 and 9, but with other aspects like windows area.

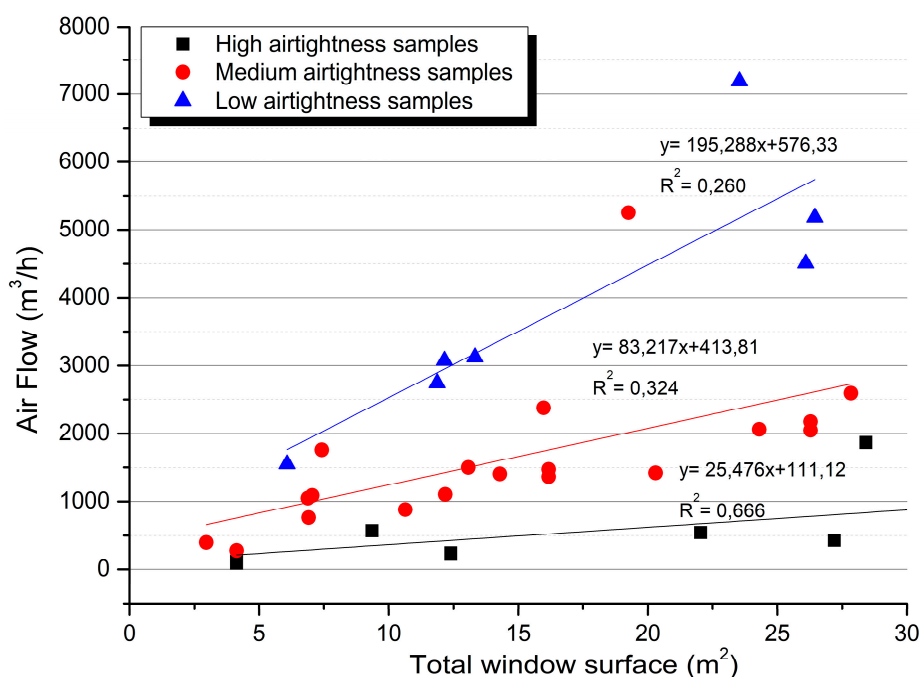
Figure 10. Correlation between airflow and window surface of the tested enclosures, according to the identified airtightness levels.

Additionally, other relationships were evaluated among the other features of the enclosure. These additional features were part of the envelope as noted in Table 6: window surface, window perimeter and window operable perimeter. In the majority of those features there was no considerable correlation. However, the high airtightness group demonstrated a very relevant correlation through the R^2 value between the air flow and the total surface of windows as can be seen in Figure 10, which corroborates again the previous judgments about high airtightness enclosures, which stated that they

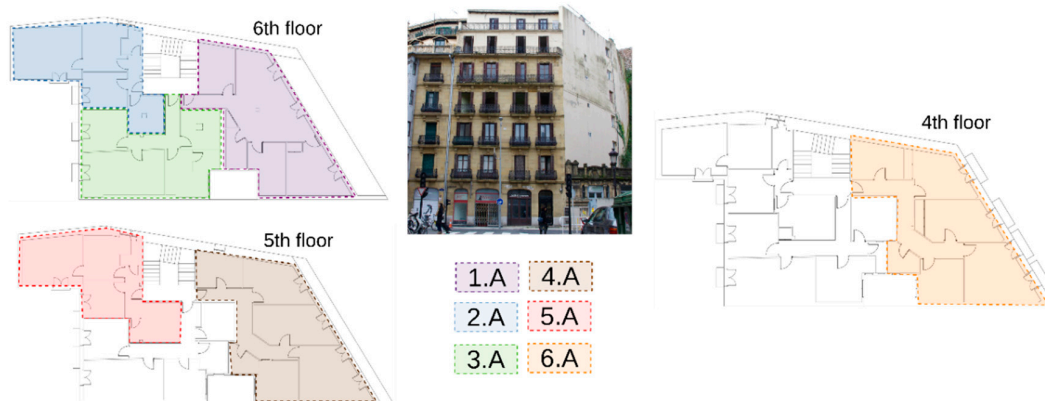
Figure A1. Floor plans of the blower door tests performed in the Easo 22 case study.

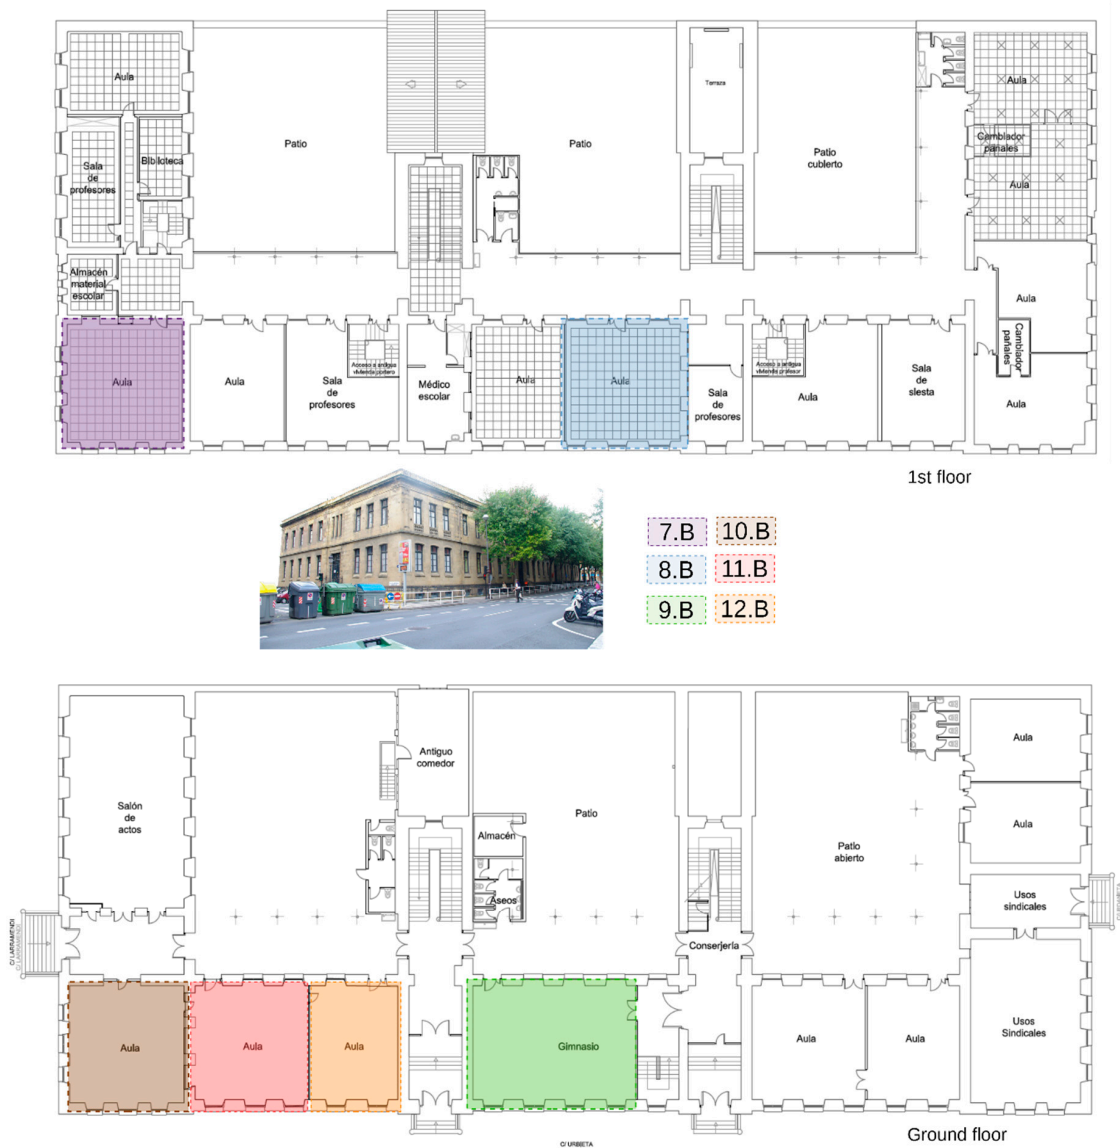
Figure A2. Floor plans of the blower door tests performed in the Urbieta School case study.

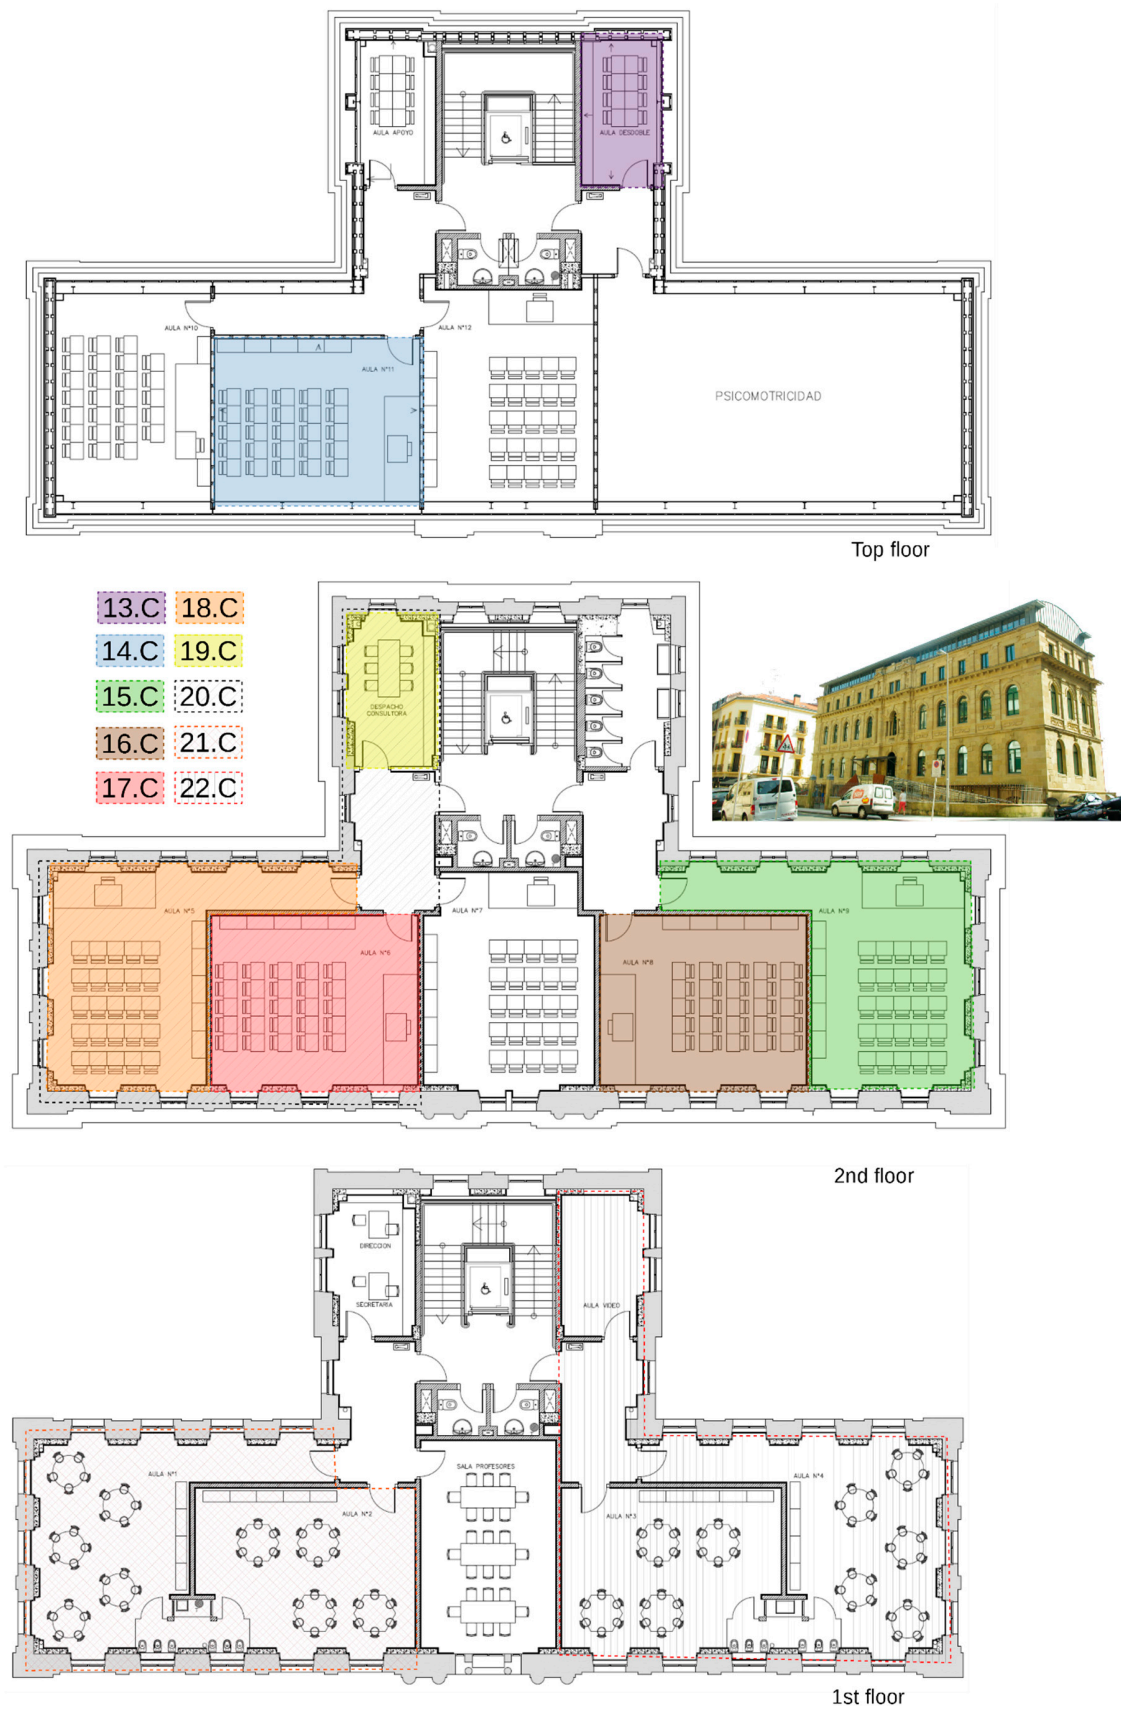
Figure A3. Floor plans of the blower door tests performed in the Aldamar School case study.

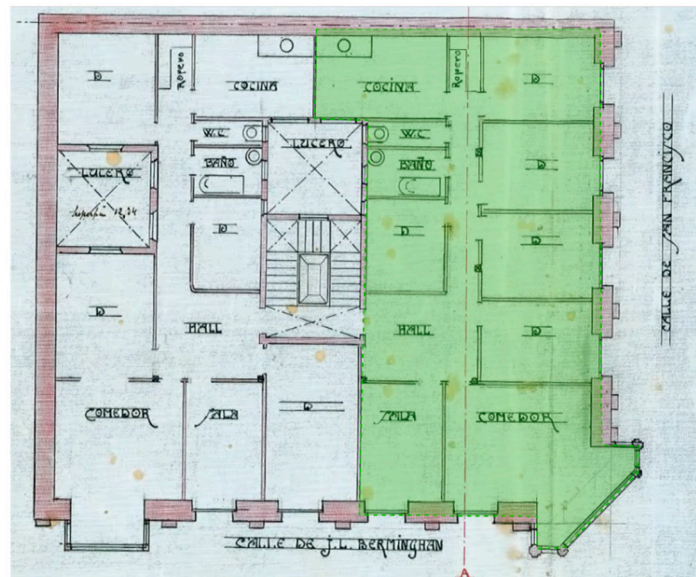
Figure A4. Floor plans of the blower door tests performed in the Birmingham 11 case study.

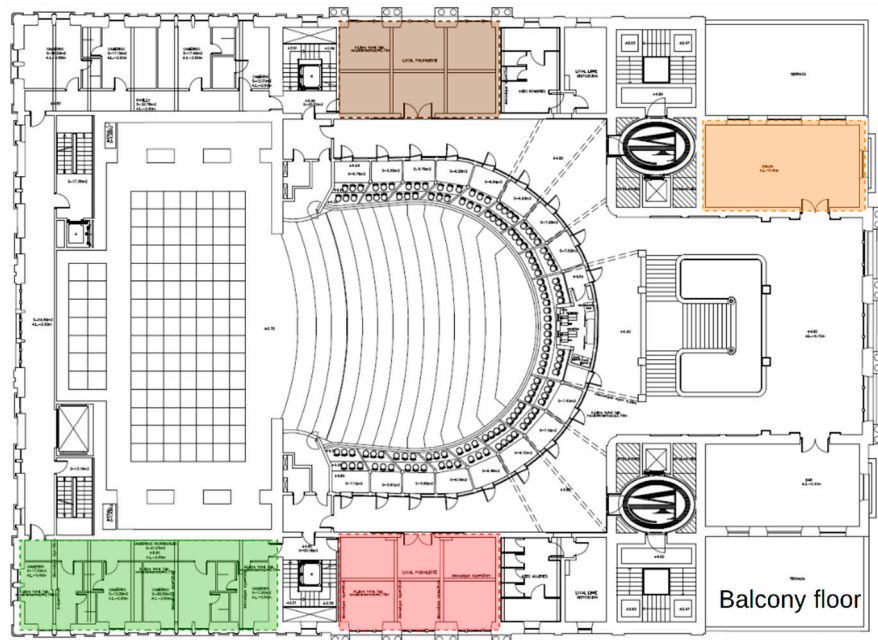
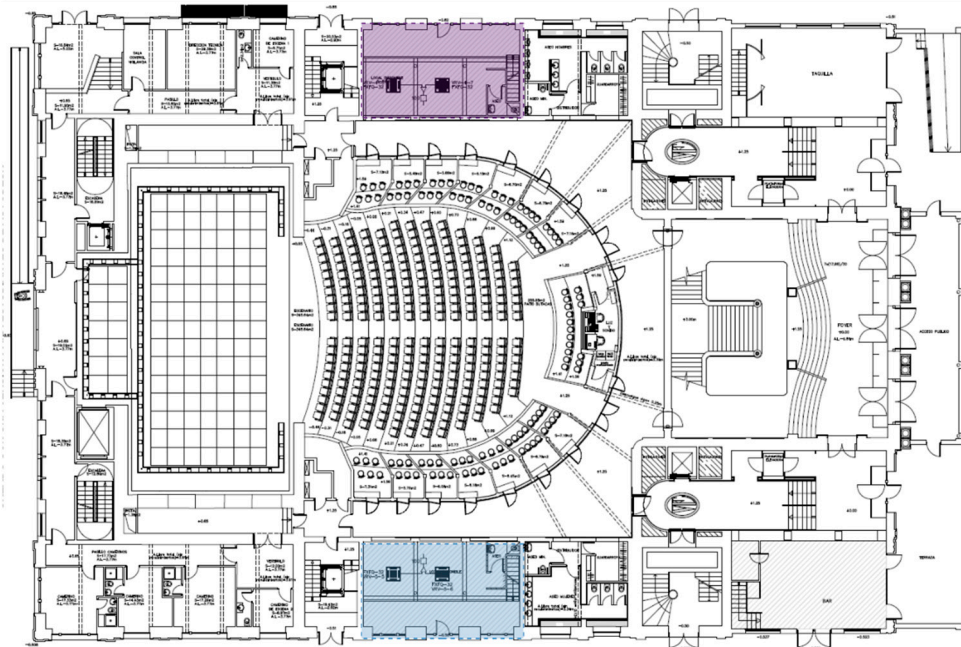
Figure A5. Floor plans of the blower door tests performed in the Victoria-Eugenia Theatre case study.

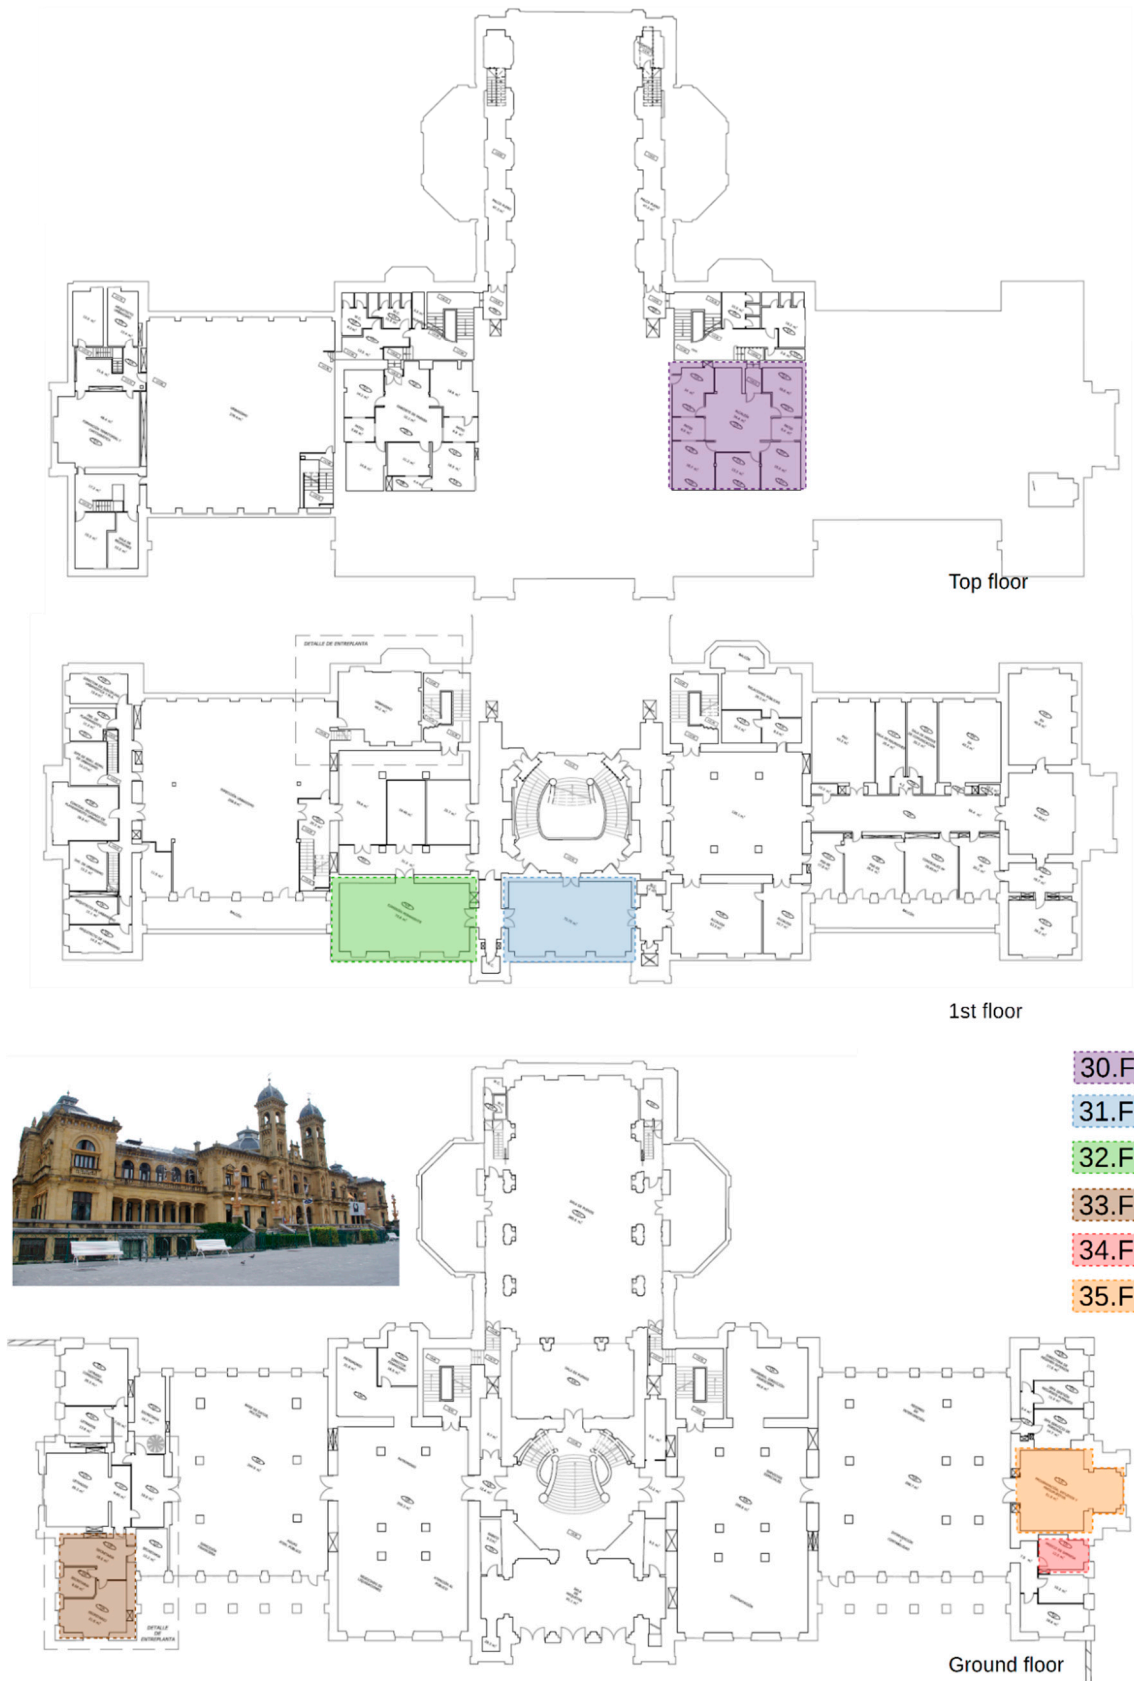
Figure A6. Floor plans of the blower door tests performed in the City-Council of Donostia-San Sebastián case study.

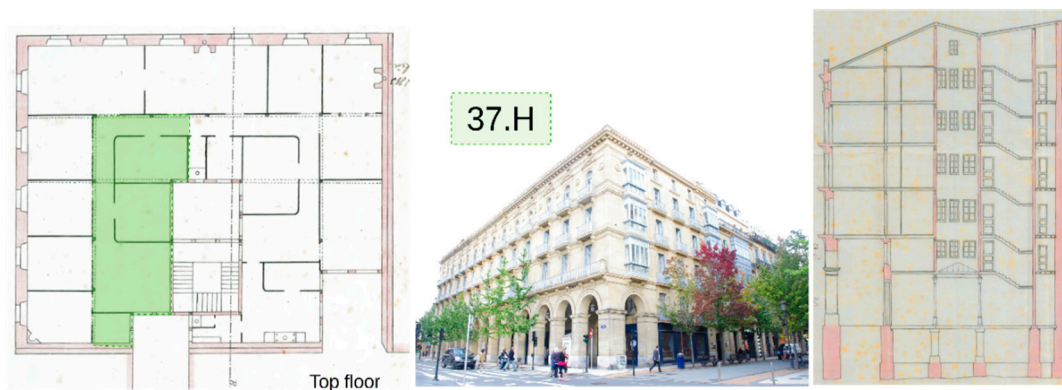
Figure A8. Floor plans of the blower door tests performed in the Loiola 14 case study.
