# A Methodology to Regulate Transformation of a City's Appearance Due to Energy Efficiency Building Renovations: A Case Study: Errenteria (Spain)

**Citation:** Lizundia, I.; Uranga, E.J.; Azcona, L. A Methodology to Regulate Transformation of a City's Appearance Due to Energy Efficiency Building Renovations: A Case Study: Errenteria (Spain). *Heritage* 2023, 6, 6112–6131. <https://doi.org/10.3390/heritage6090321>

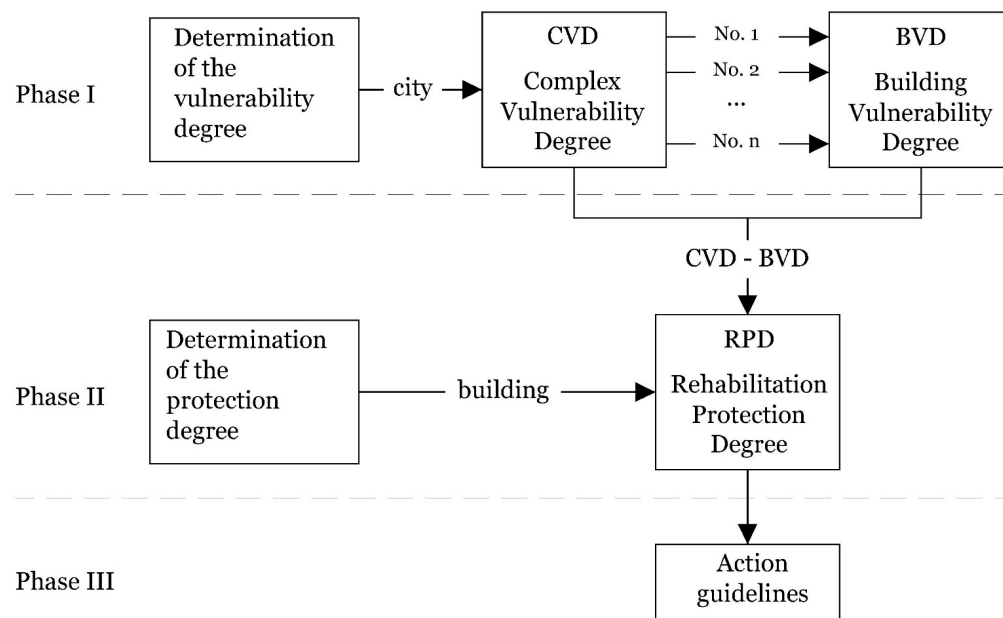
**Figure 1.** The framework of the research method.

Once the description of each building has been completed with the CVD, BVD and RPD values, in Phase III, the different intervention possibilities are studied along with the application criteria in each case, considering the particular values for each building, and specific conditions or limits may be established for some of its parts or elements that should be reflected in its respective file [28]. The different intervention proposals put forward should be a fundamental tool for technical personnel of the municipal administration when regulating renovation actions within their responsibilities. Figure 1 summarizes the different phases of the proposed methodology:

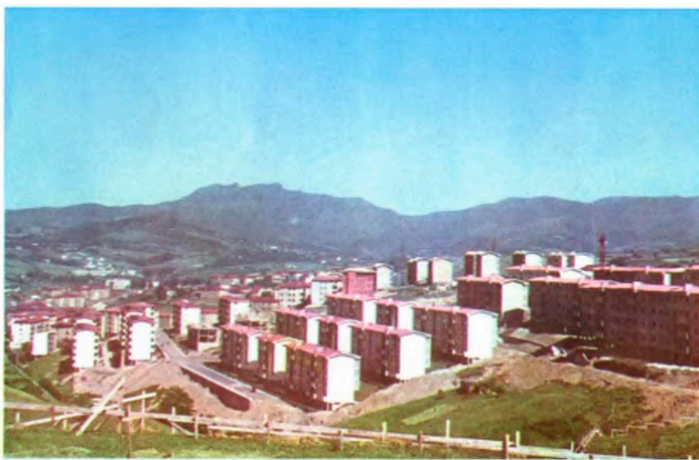
**Figure 2.** (a) Galtzaraborda, 1964 [53]; (b) Galtzaraborda, 2023 (author's archive).

Situated on a slope in Galtzaraborda, this complex includes 41 buildings spread over 21 blocks, with a total of 324 dwellings. This is a social housing project planned by the architect Vicente Saralegui in 1963 and built between 1963 and 1966. The typology comprises a commercial ground floor and 3–4 levels with two residences per floor; the buildings originally had a conventional façade with a double layer of brick, uninsulated air chamber and an exterior coating of white paint. In recent years, the façades of most of the buildings have been renovated and thermally insulated using ventilated façade or ETICS (external thermal insulation composite systems) solutions, significantly altering the white and homogenous appearance of the original complex (Figure 2). Accessibility is still a pending issue, as only one of the 41 buildings has proceeded to install a lift.

Complex no. 14 in the Galtzaraborda neighborhood, with a high alteration degree, has a CVD of 52. Virtually all of its buildings have undergone some kind of intervention. Besides the numerous energy efficiency renovations conducted in the last ten years, work to repair and clean façades has been carried out, along with changes to framing and closure of balconies over time. ETICS-type cladding with very disparate finishing solutions in terms of design, color and texture has prevailed (26 of the 41 blocks, 26/41) over non-energy-efficiency façade improvements conducted in previous years (13/41) or the ventilated façade solution (1/41). Only one of the blocks maintains its original façade sheets. Most of the residences (260/324) closed some of their balconies, in some cases even removing the façade sheet to prolong an interior room until the new closure. As a result of all this, the BVD of most of the buildings is between 37 and 53. Only four buildings slightly surpass the value of 60. Even though this is a complex without any special architectural value, its unitary, homogenous and monochromatic nature would confer upon it value as a complex that would have been very interesting to preserve. The alteration degree in a neighborhood with such a high number of buildings unfortunately means that the situation is irreversible. The total deconfiguration of the image of the Galtzaraborda project is the clearest example of the need for regulation of future energy efficiency improvement interventions such as what is proposed in this study. The RPD value as a result of the CVD-BVD combination is III for virtually all the complex's buildings, whereby the intervention criteria can only be limited to preventing major alterations in the future.

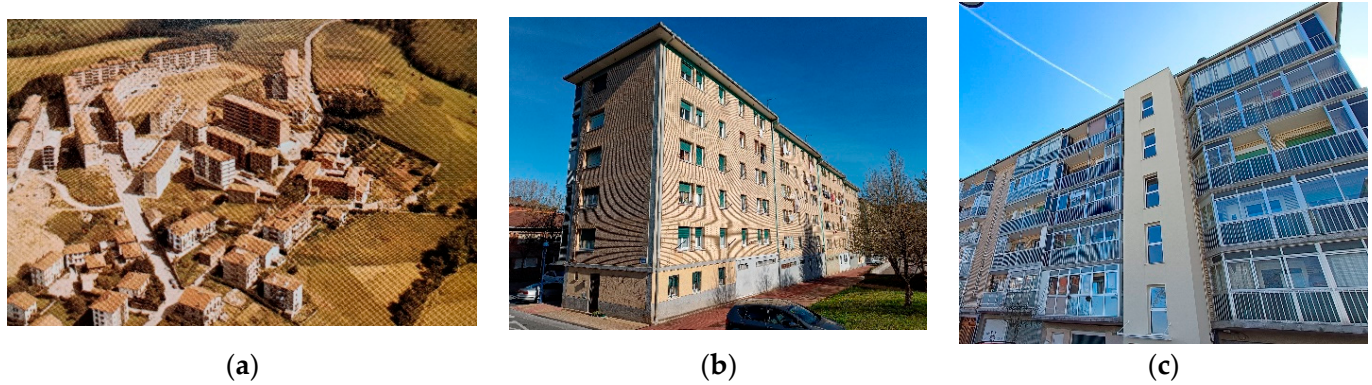
Figure 3. (a) Agustinas, 1973 [48]; (b) Agustinas, posterior facade, 2023 (author’s archive); (c) Agustinas, main facade, 2023 (author’s archive).

Situated in the neighborhood of Agustinas, this complex comprises 53 buildings spread over 14 blocks, with a total of 566 dwellings. This is a social housing project planned by the architect Rafael Llopis in the mid-1960s and built between 1968 and 1975, except for one building dated 1992. The typology is that of commercial ground floor and five levels with two residences per floor; the buildings have a conventional façade comprising a layer of exterior facing brick, uninsulated air chamber and an interior layer of brickwork. Although only integral interventions to improve energy efficiency have been carried out and most of the later façades maintain the original configuration featuring beige-colored facing brick, the installation of several lifts and a large number of balconies closed over the years on the main façades have significantly altered the original image (Figure 3).

For its part, complex no. 31 of the Agustinas neighborhood has a CVD of 67, a very high figure for a complex of 53 buildings with more than fifty years of existence. This is because, barring certain partial interventions on the façades of some blocks, most of them maintain the original skin of facing brickwork, which continues to confer upon the complex a relatively unitary and homogenous appearance. Although none of the buildings were subject to integral energy efficiency improvement interventions on their façades, the neighborhood's original image has substantially changed due to the indiscriminate closure of balconies (54% of the residences, 306/566) and the addition of new volumes for the installation of lifts on the outside of some blocks (22/53). The major change affects the

main façades, as they comprise large balconies which have been closed by means of light frames, with designs of all types, hiding the characteristic facing brickwork of the posterior layer. The BVD of the different buildings is similar to the previous case, between 30 and 53. The combination of these values with a CVD of 67 confers an RPD of IV on all blocks in the complex, implying more restrictive regulation for future interventions. The action criteria would allow occasional modifications in the composition and volumes, unavoidable when lifts are installed, and would oblige a final lining similar to the facing brick and with a similar tone, concealment of the façade fixtures and a balcony railing design similar to the original, permitting changes of material. In the case of the balcony closures, their elimination would be recommended, although this would be complicated from the legal standpoint, as the time limitation on eventual urban infringements has expired. In any case, it would oblige the design of light frames for the unitary balcony, identical for the whole complex, in the event of modification or new closures in the future. Also, bearing in mind the additional homogenous characteristics set out in Table 4, as it is a complex with homogenous original features with an RPD of IV, the new façade solutions should be identical for all the blocks from the construction, chromatic and accessibility standpoints. After a more exhaustive prior analysis, the design of a different façade solution could also be put forward, unitary and homogenous for the entire complex, with a view to improving its energy efficiency. However, the interventions already carried out and the high number of buildings, and consequently of owners, would in this case make it hard for administration and ownership to reach an overall agreement to proceed with a change of solution.

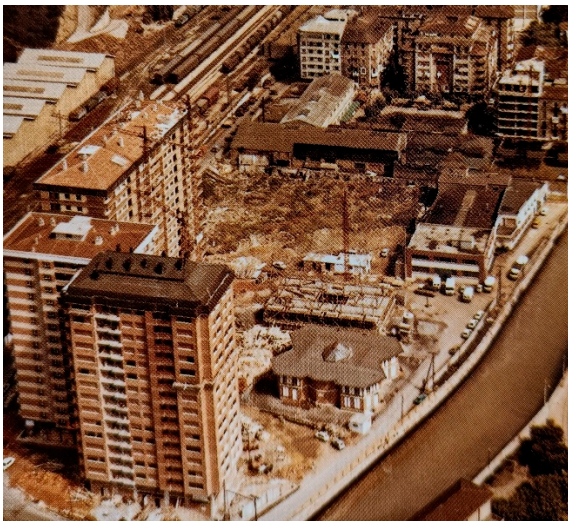
Figure 4. (a) Olibet, 1974 [48]; (b) Olibet, 2023 (author's archive).

The neighborhood called Olibet comprises six buildings spread over four blocks and a total of 427 dwellings. The six towers have 14 upper floors used for housing, as well as commercial space, storage areas and garages in the lower floors. It was built in 1974 and 1975. The architects involved were Juan María Aguirre, Joaquín Muñoz, Carlos Casla and Manuel Sancho. All the buildings originally presented a similar conventional façade solution using a double layer of brickwork and air chamber, with an exterior layer of exposed brick, except for one of them which had continual cladding. At present, the original image of four of the six buildings has been totally transformed after undergoing

energy efficiency renovation processes. Both the chromatics and the construction solutions used in the new skins were different; among those found are ETICS cladding and ventilated façades with metallic finishes (Figure 4).

In the case of the neighborhood of Olibet, complex no. 41, the resulting CVD is 27. This is a very low figure because, unlike the two previous cases, the six tall buildings which form the complex did not form part of a unitary and homogenous project and, above all, due to the radical transformation of the building's skin in four of them. Three blocks were lined very recently with a ventilated façade solution with a metal finish and another one presents continual cladding that conceals the pre-existing facing brick finish. Only two of the blocks maintain their original façade, although some balconies have also been closed. The combination of CVD and BVD in this case implies an RPD of II or III, a qualification which, given the complex's alteration degree, means that the two blocks that have not yet been renovated are free to opt for solutions with very few conditions.
