STRENGTHENING MASONRY VAULTS WITH ORGANIC AND INORGANIC COMPOSITES: AN EXPERIMENTAL APPROACH

Leire Garmendia^{a,b}, Pello Larrinaga^a, Rosa San Mateos^a, José T. San-José^{c,*}

Abstract

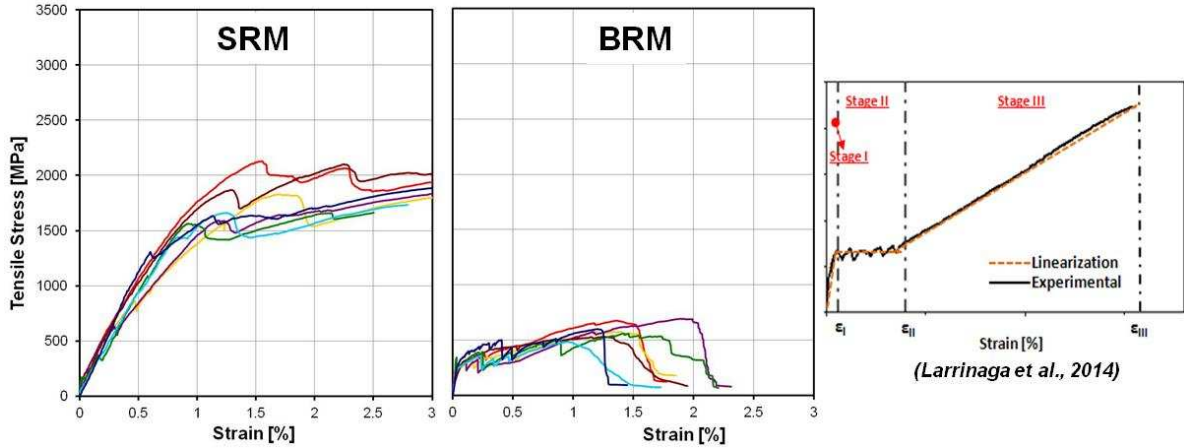
Fig. 5. Stress-strain behaviour in uniaxial tensile test of.

stage I (σ_I , ε_I and E_I) ended at the point when the first crack appeared (pre-cracking stage); stage II (σ_{II} , ε_{II}) ended when no further cracks were observed (multiple cracking stage); and, finally, stage III (σ_{III} , ε_{III} and E_{III} measured as the slope of that stage), when the crack patterns stabilized and the tensile loads increased (post-cracking stage). Therefore, as shown in Figures 4 and 5, there was a degree of load transfer from the matrix to the steel strip and the basalt textile, when the first cracks appeared in the specimens, which are represented by short drops in the loading values of the stress-strain graphs. A summary of the main results from Figure 5 are presented in Table 5.

Unlike SRM, the BRM failure mode was quite different in terms of strength (lower values), ductility (stages I, II and III and less ultimate strain were clearly identified) and stiffness (higher at the pre-cracking stage). With regard to the BRM-based composites, the curves show considerable scatter (values up to 39%). This effect could be caused by the lack of internal reinforcement (only one textile layer), contrary to the application of several textile layers [35]. Despite the scatter, the slope at stage III (E_{III}) remained similar in most of the specimens as it is showed in Fig. 5.

BRM tensile strength was quite similar from the standpoint of the textile and the composite, the ultimate measured deformation was quite low in comparison with SRM (Fig. 5). The BRM early moduli at the post-cracking stage (E_{III}) were over 40 times less stiff than its pre-cracking one (E_I). These results suggest that the optimistic specifications of the basalt textile manufacturers (Table 3) are not realistic (Table 4), which is a key point for several reasons. Firstly, BRM is composed of denser basalt rovings which implies that the whole fibre surface will not be completely wetted by the matrix (mortar paste). Secondly, the behaviour of a composite in a brittle matrix (mortar) implies that the fibres are held in the matrix solely by the presence of friction. Thirdly, as a result, when the matrix has completely cracked (stage III), only a part of the whole basalt fibres are stressed working.

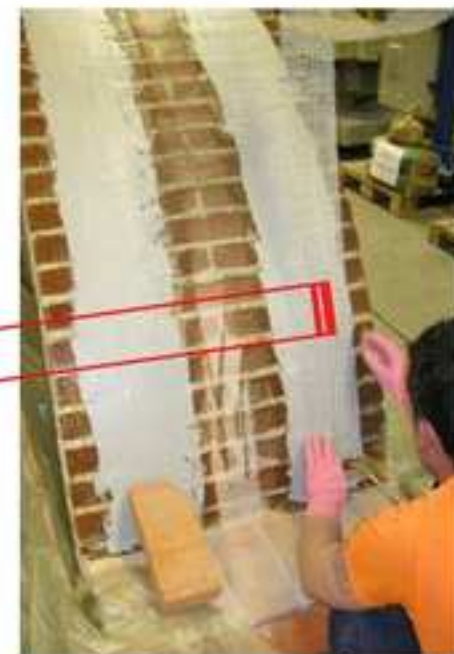
Figure 7
[Click here to download high resolution image](#)

SRP execution
