MORTAR-BASED SYSTEMS FOR EXTERNALLY BONDED STRENGTHENING OF MASONRY

Gianmarco de Felice^{1,*}, Stefano De Santis¹, Leire Garmendia², Bahman Ghiassi³, Pello Larrinaga², Paulo B. Lourenço³, Daniel V. Oliveira³, Catherine G. Papanicolaou⁴

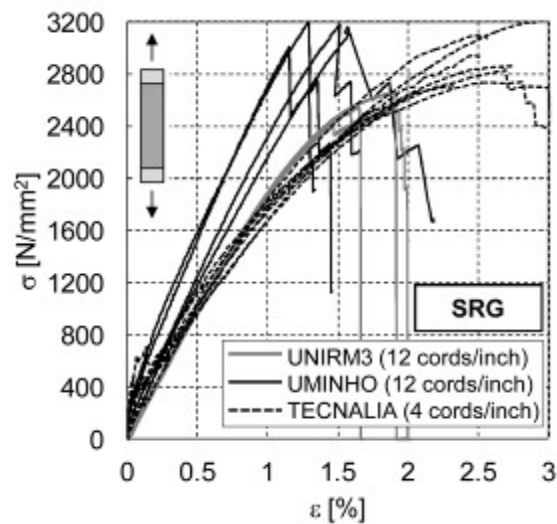
Fig. 2 Stress-strain curves of SRG specimens under uniaxial tension.

The results of tensile tests are shown in Figs. 2, 3 and 4 for SRG, CTRM₂ and BTRM, respectively. Stress values correspond to the applied resultant load divided by the fibres' area. The latter is (in the direction of loading), being the latter equal to the product of the number of layers, the specimen's width₂ and the textile design thickness in the direction of loading. The results (per TRM) present a relatively low scatter, especially for what concerns the maximum tensile stress (f_t), despite the differences in specimens' size and setups amongst different laboratories. Based on the present experimental investigation (in which slightly

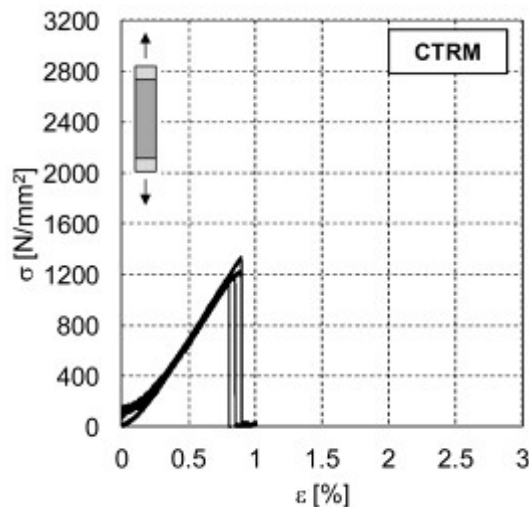
Fig. 3 Stress-strain curves of CTRM specimens under uniaxial tension.

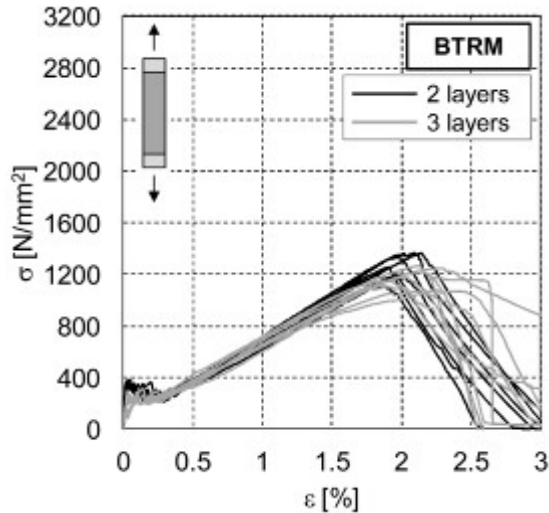
Fig. 4 Stress-strain curves of BTRM specimens under uniaxial tension.

In the present case, the tensile strength and stiffness of basalt TRM was not strongly influenced by the number of layers of textile embedded in the mortar, as shown in Fig. 4. The mechanical properties of mortar seems to affect only the initial non-cracked behaviour (which is clearly visible in Fig. 4 for BTRM specimens), while, once cracking occurs, a slight tension stiffening effect takes place without significant changes in the tensile strength of the composite. Conversely, the mortar plays a very important role in the bond mechanism as shown in the next section.

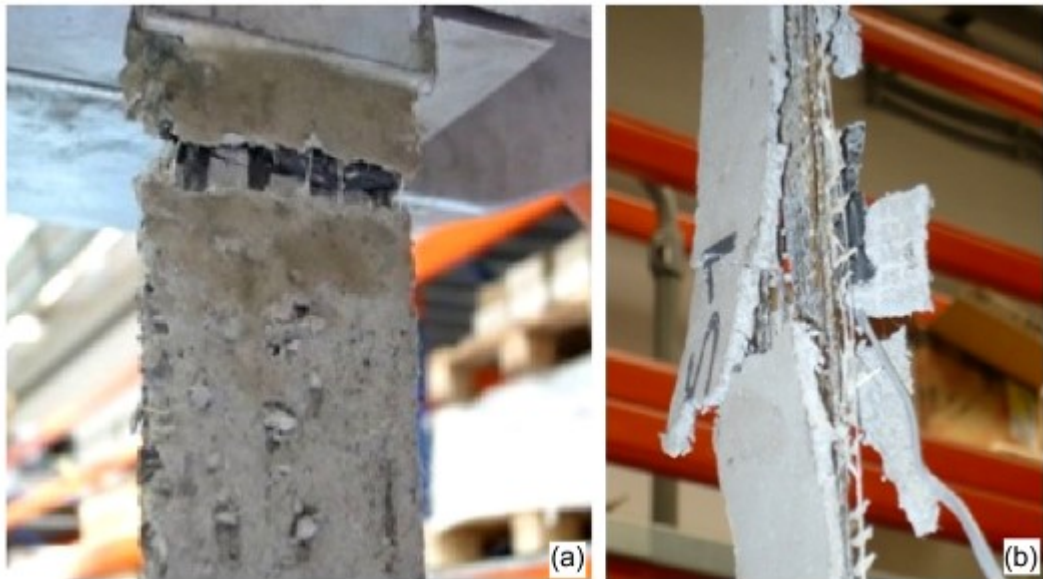
Fig. 5 Damage pattern in tensile tests: development of cracks in the vicinity of the aluminium plates in CTRM (a) and detachment of the mortar in SRG (b)

Independently from the type of textile used, and from the mortar adopted as matrix, the crack development observed during tensile tests on -TRM specimens was characterized by the presence of cracks transversal to the direction of the applied load, clearly identifiable in the response curves and visible during testing at low stress values. The crack spacing and width were dependent on the type and quantity of reinforcement and on the ~~textile~~ textile-to-matrix bond behaviour. Higher fibres' volume fractions, as well as fibres with higher stiffness, gave rise to denser crack patterns. A larger number of narrow cracks developed in SRG specimens, which may be related to a better interlocking between the steel cords (of uneven surface as they are made by twisting steel filaments) and the mortar. Improved bond conditions hinder slipping of the textile within the mortar and the development of few wide cracks. Transversal cracks sometimes developed in the vicinity of the aluminium tabs used to grip the samples (Fig. 5a), highlighting the importance of clamping in tensile testing. However, this was not evident for SRG

specimens (Fig. 5b), probably due to the higher toughness of the material, and for BTRM specimens, where the end of the specimens were strengthened and cracks only appeared in their middle third (Fig. 6).

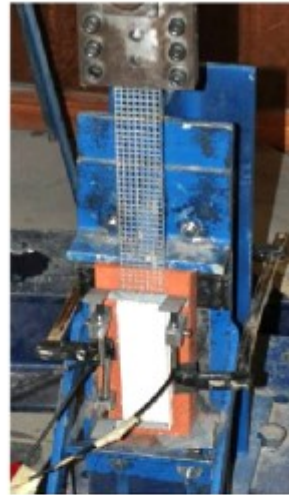
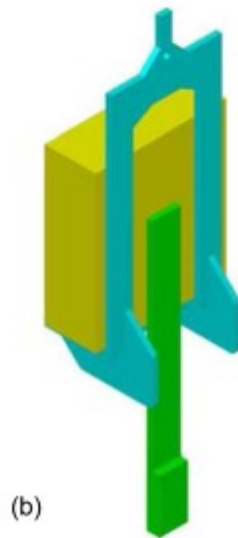
Fig. 7 Single-lap (SL) setup for bond shear tests carried out at UMINHO (a) and TECNALIA (b)

Drawing on previous experience on FRP (Valluzzi et al., 2012), four different shear bond testing setups were used: two single-lap (SL) and two double-lap (DL1 and DL2), as shown by Figs. 7 and 8. Very similar single-lap test schemes were used by UMINHO and TECNALIA, consisting of stiffened steel plates welded so as to form an angle of 90° (Fig. 7). At UMINHO, the specimens were supported appropriately to avoid misalignments in the load application and were loaded from above (Fig 7a). Tests were carried out under displacement control at a rate of 0.005 mm/s. The load was measured by a load cell while the ~~global~~ slip between the reinforcement and the brick was measured by means of two LVDTs mounted at the loaded end. At TECNALIA, the specimens rested on the bottom of the steel frame and the reinforcement sheet was loaded from below (Fig 7b). Tests were performed using a 5 kN Lloy's Universal Testing machine under displacement control at 0.008 mm/s rate. Displacements were measured by LVDTs located on both bonded and unbonded areas of the reinforcement.

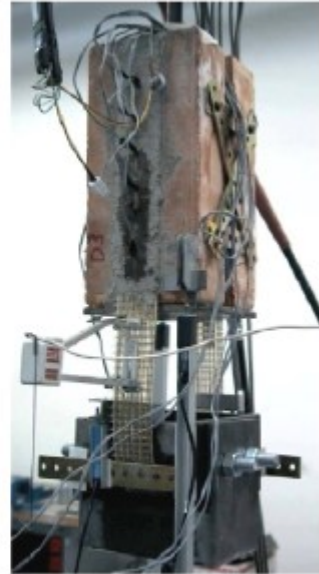
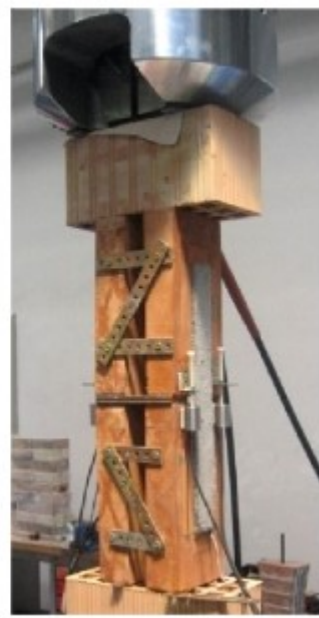
Fig. 8 Double lap setup for shear bond tests: type 1 (DL1, a) and type 2 (DL2, b)

UNIRM3 used double lap setups (DL). Specimens were built by joining together two bricks, placed parallel to each other at a pre-established distance, by means of steel plates; the reinforcement was then applied on both external faces. Setup DL1 (Fig. 8a) consisted of two or four bricks (depending on the anchorage length) pulled by the testing machine in one direction (upwards in the present case) through a steel bar welded to a steel plate (on which the bricks rested), while a continuous U-shaped reinforcement strip was pulled in the other direction (downwards) by means of a semi-circular steel saddle, having a diameter equal to the specimen width (1301 mm) so as to apply pure shear stresses on the brick-reinforcement interface. In test set-up DL2 (Fig. 8b) specimens were made out of four bricks. Two bricks were pulled upwards while the other two were pulled downwards by the testing machine. Two separate strengthening strips were applied on the external faces so as to connect two bricks by crossing the gap

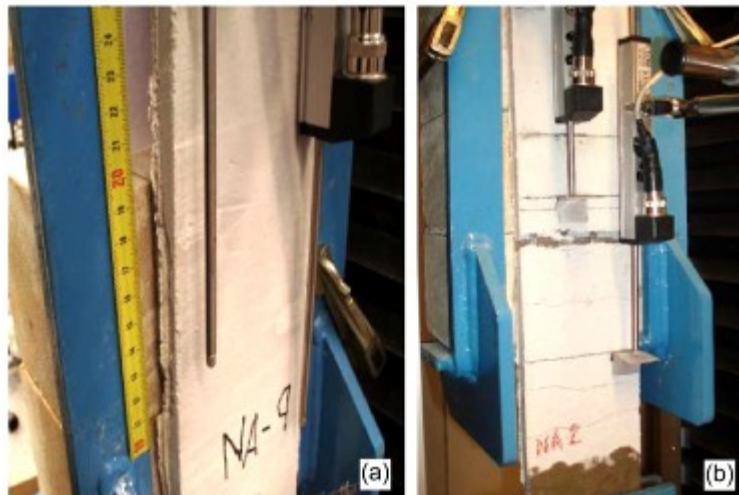
Fig. 12 Failure modes in BTRM specimens: debonding at the substrate-matrix interface in specimens with anchorage length 85 mm (a) and slipping of the fibre rovings from the matrix in specimens with anchorage length 220 mm (b)

Similarly, debonding at the substrate-mortar interface was observed in stone specimens reinforced with BTRM with shorter anchorage lengths (85 mm), accompanied by the appearance of transversal cracks also in the unbounded portion of the reinforcement (Fig. 12a). On the contrary, the development of transversal cracks outside the bonded area occurred with the longest anchorage lengths (150 mm and 220 mm); the slipping of the fibres within the mortar matrix is clearly visible in Fig. 12b. As fibres and mortar matrix are subjected to the same elongation outside the bonded area due to equilibrium, such transversal cracks can only develop once the transfer of shear stresses between the substrate and the matrix and between matrix and fibres occurs, inducing the slipping of the textile within the mortar (failure mode c) to be activated before the other failure mechanisms.

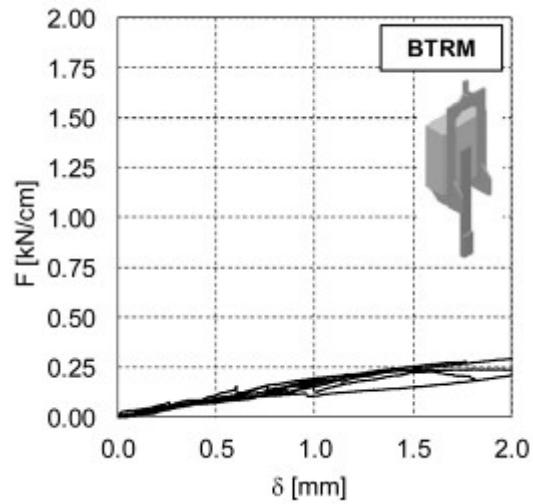
Fig. 17 Load-displacement curves for BTRM reinforcement on stone substrates

The global $F-\delta$ curves are plotted in Figs. 15, 16, 17 for SGR, CTRM, and BTRM reinforcements, respectively (note that the load are divided by the reinforcement width): SRG reinforcement showed higher loads (15% on average) and stiffness values, with a brittle failure with maximum displacement in the order of 0.2-0.6 mm, while CTRM exhibited a longer horizontal branch up to displacement values generally larger than 1 mm, which is likely to be related to the slippage of the textile within the mortar matrix, as shown by the observed failure modes reported in Table 6. As shown in Table 5, bond tests on CTRM were carried out at UNIRM3 using both DL1 and DL2 setup schemes; although the choice of the setup configuration led to in-significant differences in the results, DL2 was found to be more reliable as it ensured that pure shear stresses were developed on the substrate-reinforcement interface and produced a better specimen symmetry. Load-displacement curves were unavailable by UMINHO due to unreliable LVDT readings. Finally, BTRM applied on stone substrate showed a much lower bond strength in the order of 0.2-0.4 kN/cm and resulted to be much more deformable, reaching displacements of about 2 mm.

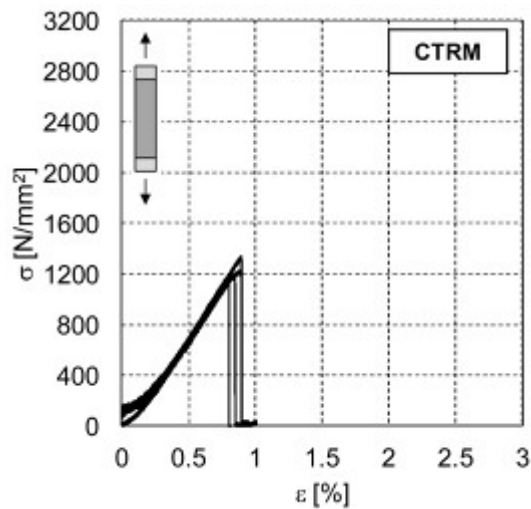
Fig. 3 Stress-strain curves of CTRM specimens under uniaxial tension.

The results of tensile tests are shown in Figs. 2, 3 and 4 for SRG, CTRM, and BTRM, respectively. Stress values correspond to the applied resultant load divided by the fibres' area. The latter is equal to the product of the number of layers, the specimen's width, and the textile design thickness in the direction of loading. The results (per TRM) present a relatively low scatter, especially for what concerns the maximum tensile stress (f_t), despite the differences in specimens' size and setups amongst different laboratories. Based on the present experimental investigation (in which slightly different setups have been used to test different composites under tension), higher strength values resulted from SRG specimens (in the order of 3000 N/mm^2), while BTRM and CTRM showed similar tensile resistance of about 1200 N/mm^2 . The tensile strength of SRG specimens was found to be close to the tensile strength of the textile itself; for BTRM and CTRM specimens, though, a significant reduction was observed. The TRM with fibrous reinforcements (of more than one layers) may exhibit lower

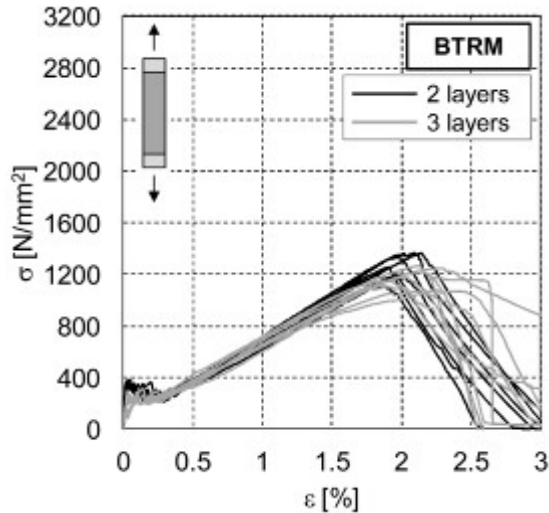
Fig. 4 Stress-strain curves of BTRM specimens under uniaxial tension.

In the present case, the tensile strength and stiffness of basalt TRM was not strongly influenced by the number of layers of textile embedded in the mortar, as shown in Fig. 4. The mechanical properties of mortar seems to affect only the initial non-cracked behaviour (which is clearly visible in Fig. 4 for BTRM specimens), while, once cracking occurs, a slight tension stiffening effect takes place without significant changes in the tensile strength of the composite. Conversely, the mortar plays a very important role in the bond mechanism as shown in the next section.

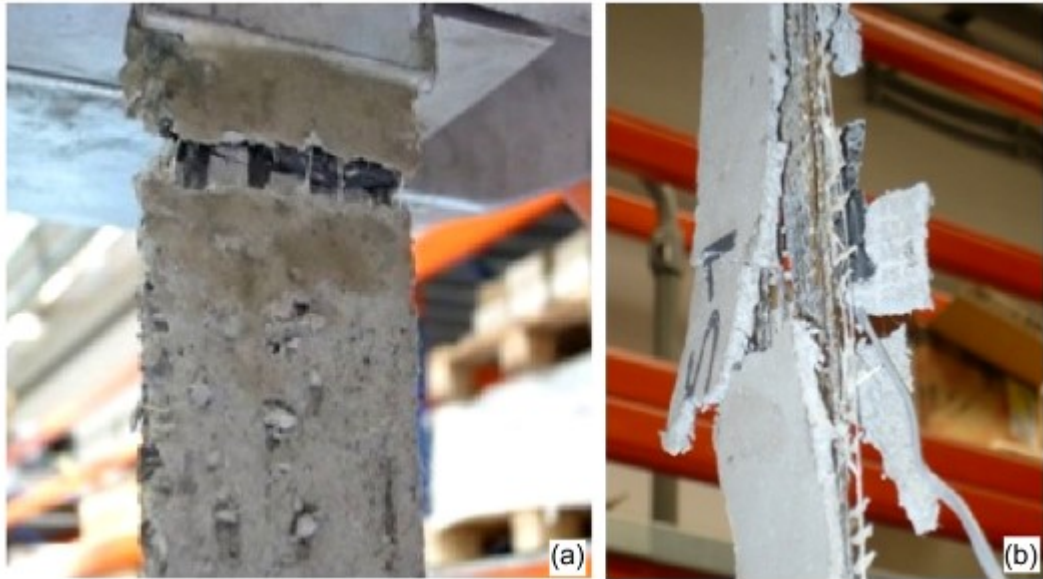
Fig. 5 Damage pattern in tensile tests: development of cracks in the vicinity of the aluminium plates in CTRM (a) and detachment of the mortar in SRG (b)

Independently from the type of textile used, and from the mortar adopted as matrix, the crack development observed during tensile tests on TRM specimens was characterized by the presence of cracks transversal to the direction of the applied load, clearly identifiable in the response curves and visible during testing at low stress values. The crack spacing and width were dependent on the type and quantity of reinforcement and on the textile-to-matrix bond behaviour. Higher fibres' volume fractions, as well as fibres with higher stiffness, gave rise to denser crack patterns. A larger number of narrow cracks developed in SRG specimens, which may be related to a better interlocking between the steel cords (of uneven surface as they are made by twisting steel filaments) and the mortar. Improved bond conditions hinder slipping of the textile within the mortar and the development of few wide cracks. Transversal cracks sometimes developed in the vicinity of the aluminium tabs used to grip the samples (Fig. 5a), highlighting the importance of clamping in tensile testing. However, this was not evident for SRG specimens (Fig. 5b), probably due to the higher toughness of the material, and for BTRM specimens, where the end of the specimens were strengthened and cracks only appeared in their middle third (Fig. 6).

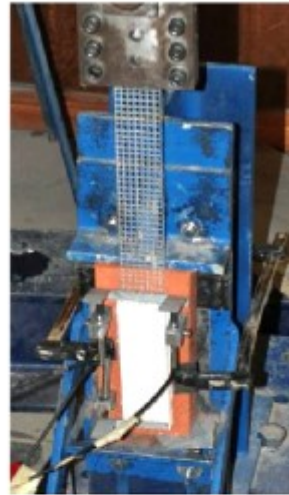
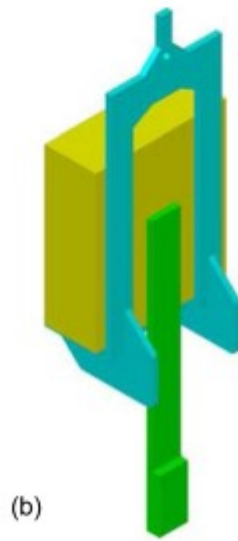
Fig. 7 Single-lap (SL) setup for bond shear tests carried out at UMINHO (a) and TECNALIA (b)

Drawing on previous experience on FRP (Valluzzi et al., 2012), four different shear bond testing setups were used: two single-lap (SL) and two double-lap (DL1 and DL2), as shown by Figs. 7 and 8. Very similar single-lap test schemes were used by UMINHO and TECNALIA, consisting of stiffened steel plates welded so as to form an angle of 90° (Fig. 7). At UMINHO, the specimens were supported appropriately to avoid misalignments in the load application and were loaded from above (Fig 7a). Tests were carried out under displacement control at a rate of 0.005 mm/s. The load was measured by a load cell while the slip between the reinforcement and the brick was measured by means of two LVDTs mounted at the loaded end. At TECNALIA, the specimens rested on the bottom of the steel frame and the reinforcement sheet was loaded from below (Fig 7b). Tests were performed using a 5 kN Lloyds Universal Testing machine under displacement control at 0.008 mm/s rate. Displacements were measured by LVDTs located on both bonded and unbonded areas of the reinforcement.
