# Energy Efficiency versus Heritage—Proposal for a Replicable Prototype to Maintain the Architectural Values of Buildings in Energy Improvement Interventions on Facades: The Case of the Expansion of San Sebastián

**Abstract:** The implementation of energy efficiency improvements in facades, such as ventilated facades or External Thermal Insulation Composite Systems (ETICS), is leading to a widespread modification of these structures. The lack of appropriate regulations to curb the destruction of the built heritage, particularly in historical centers, has been identified. In response to this issue, a project has been developed to create a prototype for determining regulations for facade interventions. The Design Science Research Methodology (DSRM) has been employed in the development of the prototype, which has been tested in a case study of the ensemble formed by the Cortázar and Oriental expansion areas in San Sebastián. The initial prototype has been outlined, corrected, and improved in an iterative process, resulting in a final prototype that enables a faster, more rigorous, and efficient understanding, characterization, classification, study, and definition of intervention cri

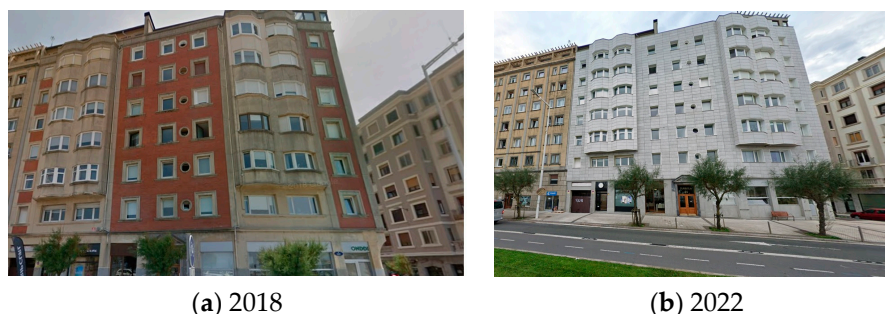
**Figure 1.** (a) View of a post-war building's facade in 2018, with facade of continuous render and facing brick; (b) 2022 view of the same building, renovated—the frontage has been covered with a ventilated facade, causing an evident distortion of the whole.

In some cases, the facade has been maintained along with a change of colour. In such interventions the facade's material and composition are not changed, though the chromatic factor is, introducing ranges that did not previously exist in this urban space or in buildings pertaining to the same architectural tendency. In other cases, the entire facade has been modified, wrapping the existing one with a ventilated facade system, so that the original facade composition is hidden, simplifying the geometry and generating a flat facade (Figure 1).

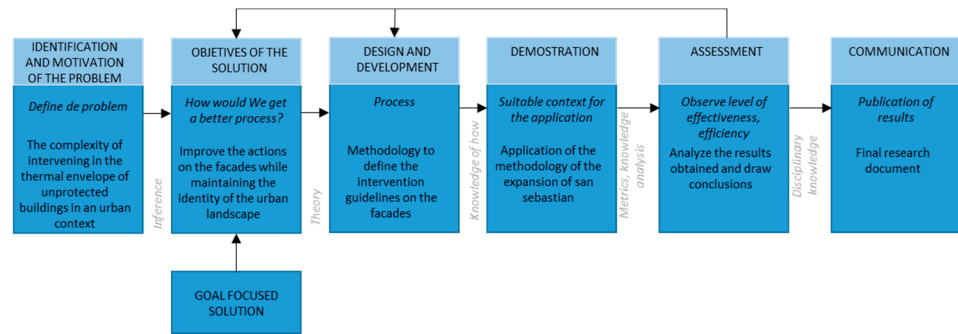
Figure 3. DSRM methodology. Simplified flow diagram.

Johannesson and Perjons [22] have noted that DSRM generates an artificial construction or 'artefact' which provides a solution to a problem, and that it can be a physical object, a set of guidelines or an ICT solution. Authors such as Van Aken [23] and Romme [24] point out that the application of DSRM can reduce the existing distance between theory and practice, due to its intrinsic ability to generate knowledge that serves to improve existing theories (Figure 3).

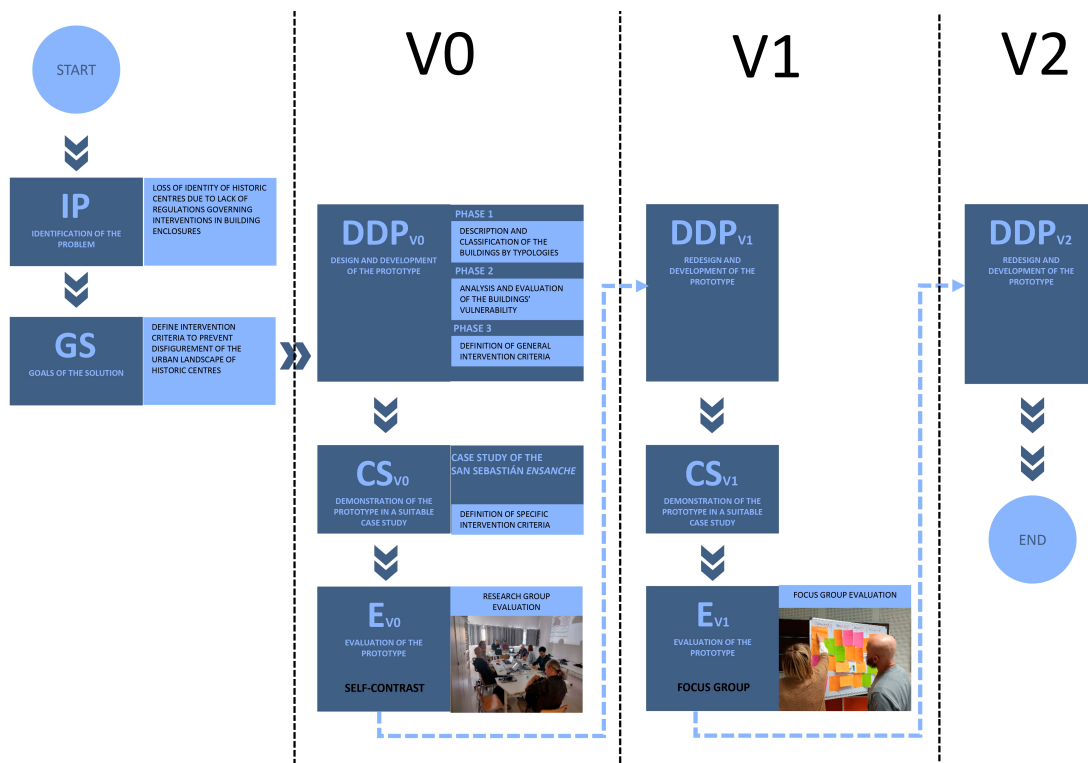
Figure 4. Diagram of the methodology adapted from the DSRM.

Figure 4 illustrates the methodology theoretically. The proposed methodology suggests several iterations of the different phases to reach the final prototype. During these revisions, the effectiveness criteria of the buildings are reviewed and contrasted among the research group members in various sessions. This contrast has led to several adjustments to the prototype, for example, in the assessment of the vulnerability of certain scenarios, thus generating successive versions of the proposed initial prototype. The final prototype

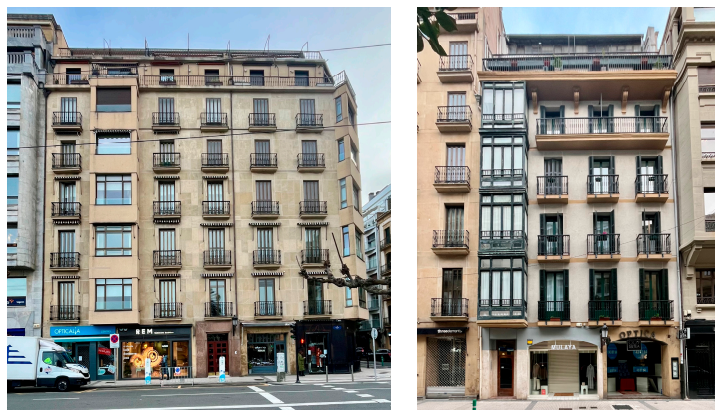
**Figure 6.** Unprotected neoclassical buildings with degrading elements.

The first sub-scenario is designated 'neoclassical'; it is the oldest, though its permanence in the *ensanche* lasts well into the 20th century. Its basic features are a smooth facade plane with a minimally cantilevered balcony, rigorous alignment of facade openings along vertical and horizontal axes (the size of all openings situated above the ground floor is identical), and a base floor with sandstone ashlar facing or a veneer of the same material. The surface of the central body of floors is usually finished with render or sandstone veneer. The render's colour can encompass all tones between natural and ochre sandstone. In Figure 6, unprotected neoclassical buildings with degrading elements are presented.

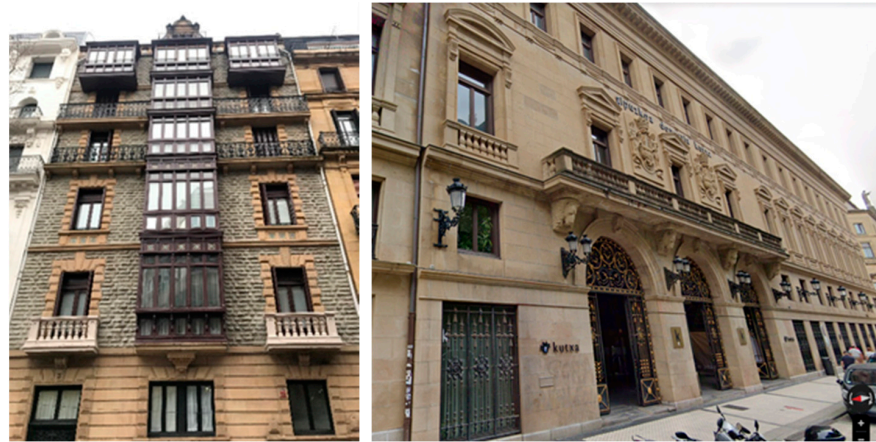
**Figure 7.** Unprotected eclectic buildings.

The second sub-scenario is 'eclectic'; its main feature is more decoration attached to the facade wall, which is thicker and also filled with different textures and materials. Although its compositional base is rigorously geometric, as the neoclassical was, there is a clear intention for each construction to be distinguished from the others and to be unique. The eclectic style most used in San Sebastián, whose main reference during that period was Parisian architecture, is the 'Beaux-Arts' eclecticism characterized by the use of forms and decoration from different French classical styles. Details from the Italian and French repertoires would also be added. The facades would be filled with balustrades, corbels, veneers of different kinds of stone, bossed bases, mansards, and opening surrounds, etc. Toward the end of the 20th century, decorative elements such as isolated columns, large cantilevered corbels, bay windows, or balustrades increased in number and variety and would be detached from the face. The appearance of moulded cement mortar decorative elements, much cheaper than carved stone and marketed in catalogues since the late 19th century, contributed greatly to making the eclectic styles increasingly ornate. They would

continue to be significant in the 20th century until the war of 1936. In Figure 7, unprotected eclectic buildings are presented.

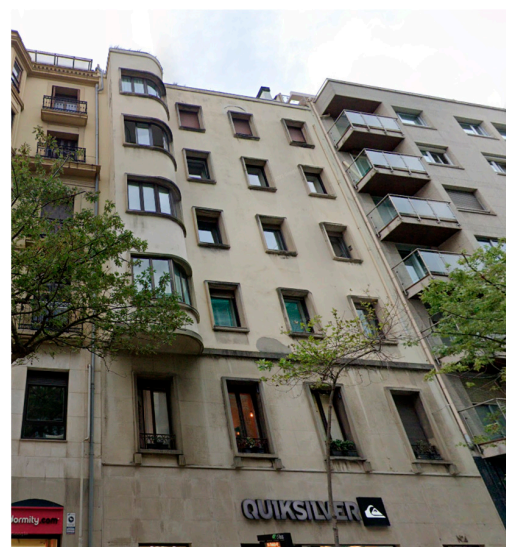
**Figure 8.** Unprotected modern building.

The third sub-scenario has been called ‘modern’ because it arises from some of the premises of the European modernist movement in the 1930s. After this new architectural trend arrived in San Sebastián, the initial pureness of approaches in its most vanguard and radical version was diluted in other ways more appropriate for the taste of the general public. On the one hand, the deco option, the most successful in the 1930s, appeared. On the other, especially in the 1940s, a formula which arrived at modernity from the classicist synthesis matured. With Spanish precedents such as Teodoro Anasagasti and the influence of fascist architecture in Italy, its continuity was maintained without problems, as the regime’s new director-general for architecture, Pedro Muguruza, was one of its most relevant followers. This formula is based on very rigorous geometric order, which differs from Ugartemendía, in that the openings are more square (there are no balconies and if there are they tend to have a blind parapet instead of a balustrade). A base level is usually differentiated, which includes the commercial ground floors and a first floor that can be for either offices or dwellings. This is read as a different unit from the body of floors immediately above, as the chosen material is changed: stone veneer for the base and render or brick for the body of floors. In Figure 8, unprotected modern buildings are presented.

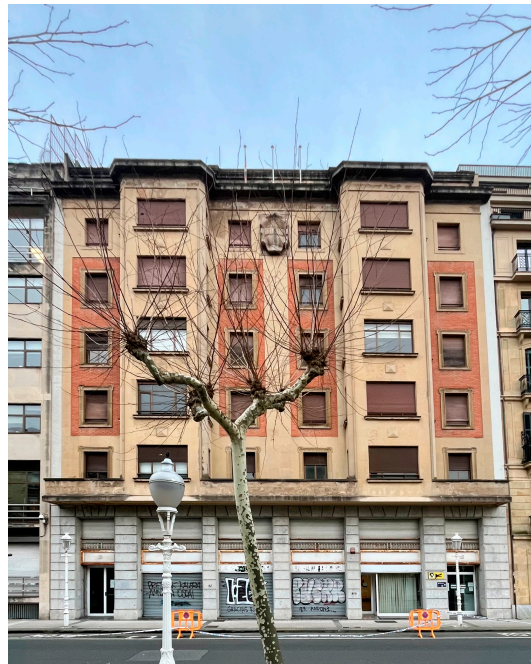
Figure 9. Unprotected post-war building.

The fourth sub-scenario is labelled 'post-war', gathering the new compositional models that appeared after the war of 1936 and constituting the urban language of the Franco regime. Over a rigorously geometric base, proceeding from Escorial and early Castilian baroque, are superimposed various classical lines, from those marked by Luis Gutiérrez Soto at the Air Ministry to the forms and dispositions of late-baroque Madrid palaces. As for materials, brick is included (usually brick veneer), alternating with artificial stone veneer, which runs from white to light ochre, from limestone to sandstone. It can include large vertically arranged bay windows and balconies set back from the facade surface. Vertical rhythms are often found in the composition, with brick surface strips, bay windows, and balconies, etc., and always assuring geometric regularity and symmetry. Another sign of identity of this compositional pattern is the two-colour tendency. The type ranges between two models: one more ornate, with bay windows and cement mortar decorative elements attached to the façade, without ever reaching the excesses of the *ensanche's* eclecticism, and another more synthetic and modern where there are only balconies, windows, and facing of brick, reducing decoration until it almost disappears. In Figure 9, unprotected post-war buildings are presented.
