Article

Methodological Proposal to Resolve the Dichotomy between Improving Energy Efficiency and Preserving Heritage—Case Study: Brutalist Built Heritage

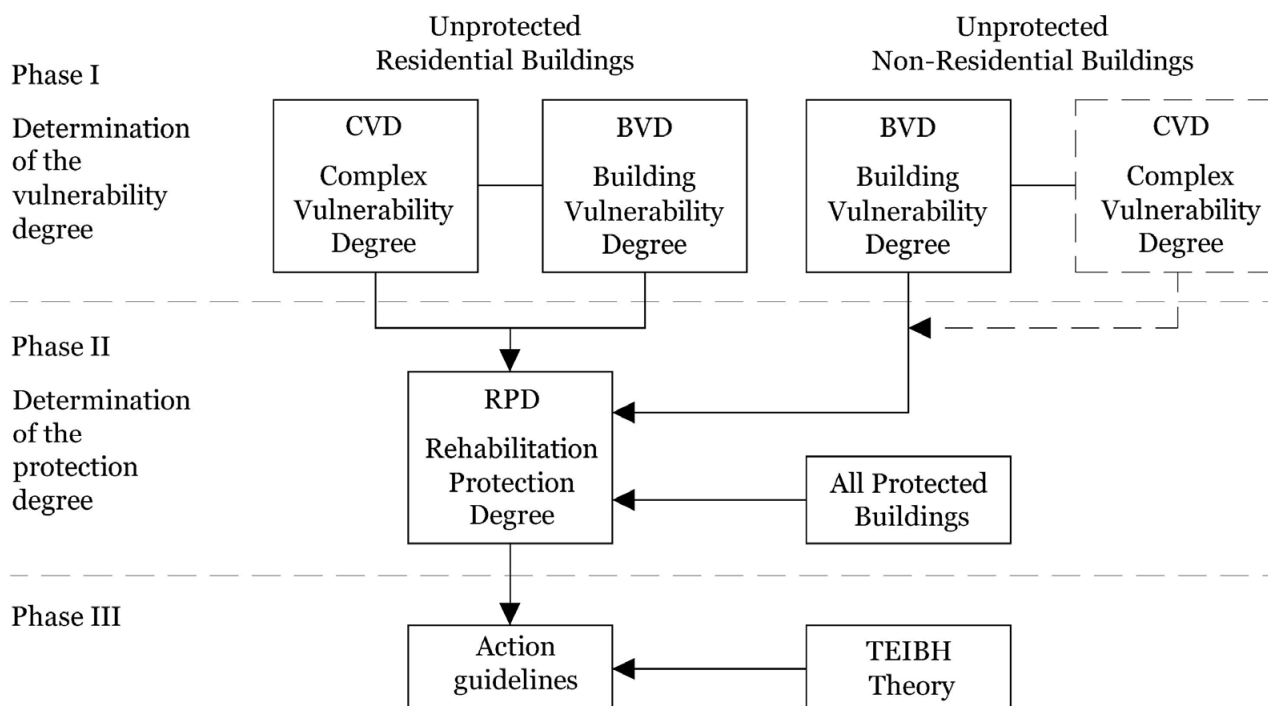
Figure 3. Organization of the CRIRB+ research method.

Ultimately, what is proposed is to take a further step in the CRIRB methodology, which initially addressed how to intervene in the façades of residential buildings, highlighting, among others, the inclusion of the following two aspects: on the one hand, broadening the scope of application to all buildings in the municipality, irrespective of their protection degree and use, and, on the other, the extension of the intervention criteria for energy efficiency improvement to the building as a whole, as stipulated in the TEIBH. Figure 3 summarizes the different phases of the proposed methodology:

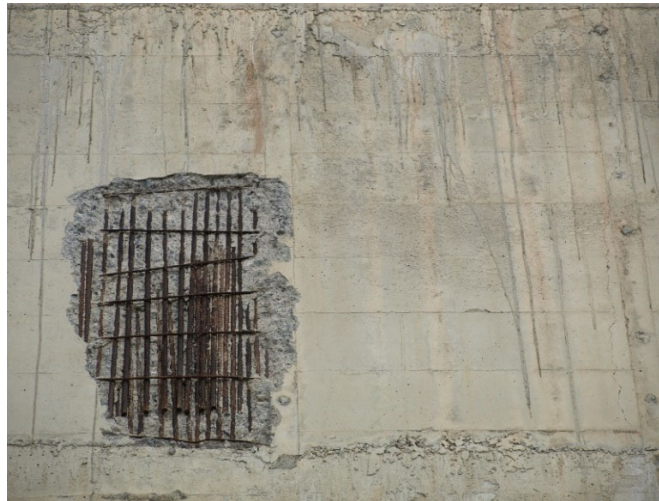
Figure 5. Vertical wall of the brutalist Carmelo Balda Fronton building in San Sebastián with some carbonatation damage. Photo: authors, 2019.

At present, a substantial number of interventions carried out in buildings with surfaces of exposed reinforced concrete, whether structural or not, are limited to repairing elements. The most common superficial damage in any reinforced concrete construction element is carbonatation, a phenomenon whereby atmospheric carbon dioxide reacts with the concrete's alkaline components, neutralizing the material and leaving the interior reinforcement totally unprotected. The increase in rebar volume due to corrosion generates enormous pressure on the surrounding concrete, causing cracks and, if not repaired in time, subsequent bursting and eventual detachment (Figure 5).

The repair process for this superficial pathology is described in European standard EN 1504-3 [35]. Although such occasional repairs try to preserve the original elements, prolonging their useful life, they do not approach restoration from an integrative perspective. Nevertheless, to follow a rigorous methodology does not have to condition the choice of construction techniques or limit to one single criterion the action possibilities.

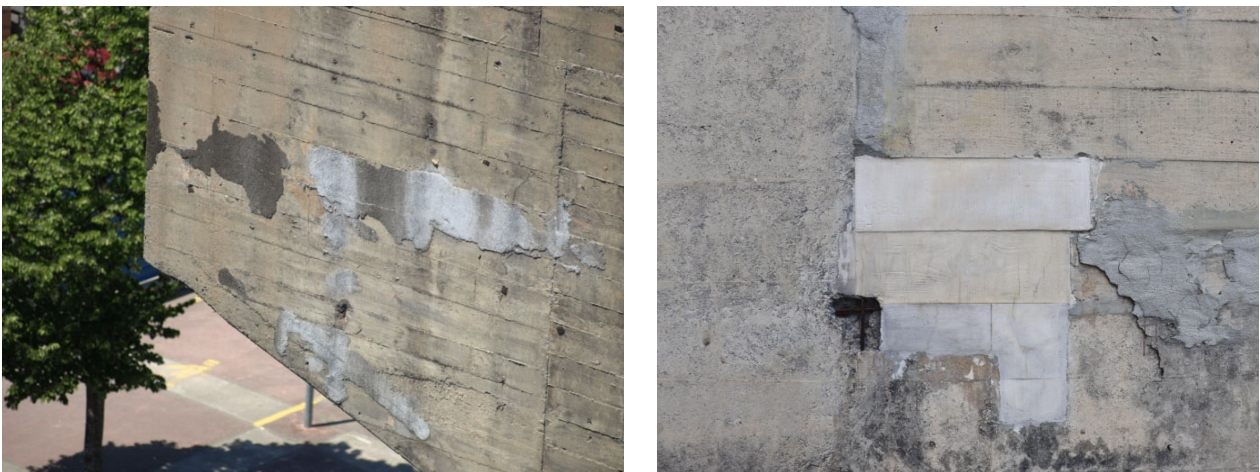
Figure 6. Current state of an isolated repair and a test with repair mortars of different tones on the brutalist Carmelo Balda Fronton building in San Sebastián. Photos: authors, 2019.

In any case, it has been seen that even when there is no need to intervene from an energy standpoint, these buildings still present major difficulties when intervening in them, especially on their façades. The perimeter concrete bearing walls comprise the façade, and the latter's texture is provided by the material's form and finish. For that reason, when interventions must be done in such buildings, any change of façade typology or thermal insulation can degrade the original architectural concept (Figure 6).

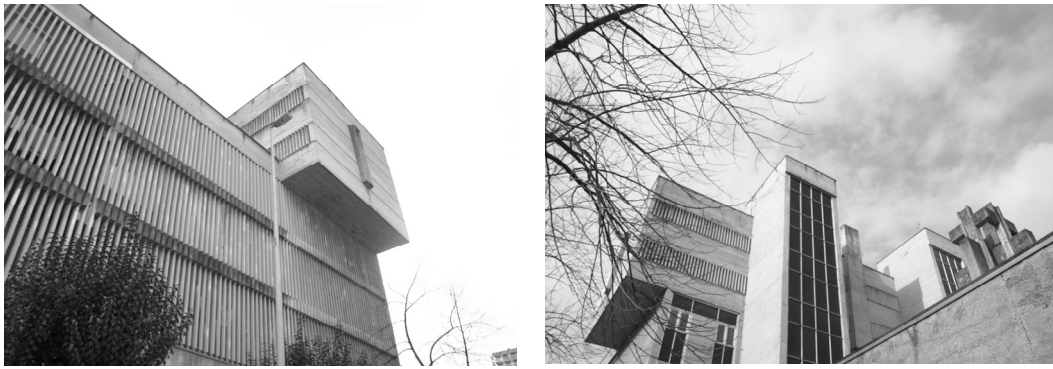
Figure 9. Infant Jesus of Prague School, M. Oriol and G. Lafuente, San Sebastián, 1965–1967. Photos: authors, 2019.

The first building in the brutalist style built in San Sebastián was the Infant Jesus of Prague School [43]. The project designed in 1965 by Miguel de Oriol and Gregorio Lafuente and built in the following years used *béton brut* and was the first totally brutalist building to appear in the city (Figure 9). At present, it is not protected, even though it signifies a radical change in the conception and style of architecture used until that time in Spain. This is a clear example of the incursion of the new architectural movements introduced from Europe. Its value therefore stems from its originality as well as the expressive solution of its architecture. The building maintains the original function for which it was designed: a Catholic school with a religious residence.
