Article

Advanced Intervention Protocol in the Energy Rehabilitation of Heritage Buildings: A Miñones Barracks Case Study

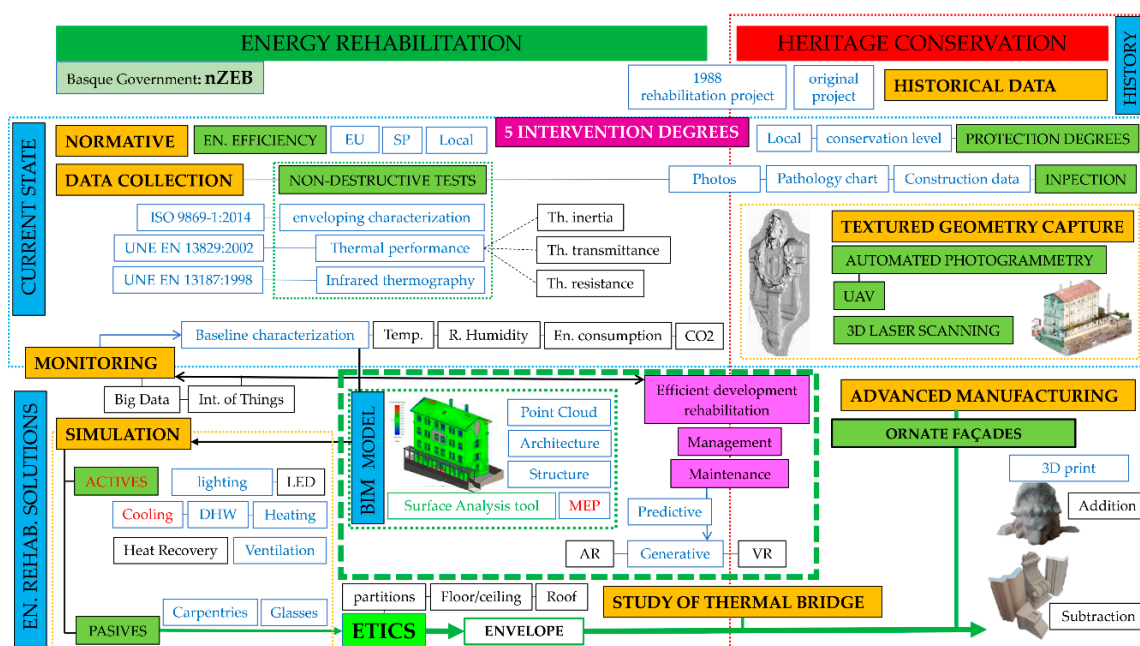
Figure 1. Diagram of proposed intervention protocol. (Source: Authors).

Hence, it is considered that the most adequate energy intervention in built heritage is the solution that combines energy improvement of each building and respect for its original configuration [11]. This leads us to propose that each intervention must be specific for each specific case. In this applied study, a protocol consisting of different stages is proposed (Figure 1):

- (1) Collect historical documentation
- (2) Data collection of the current state
 - Analysis of existing regulations on energy efficiency
 - Analysis of building protection regulations (study case). Establish the degree of intervention (0-IV)
 - Building inspection
 - Non-destructive testing, extraction of data from the baseline

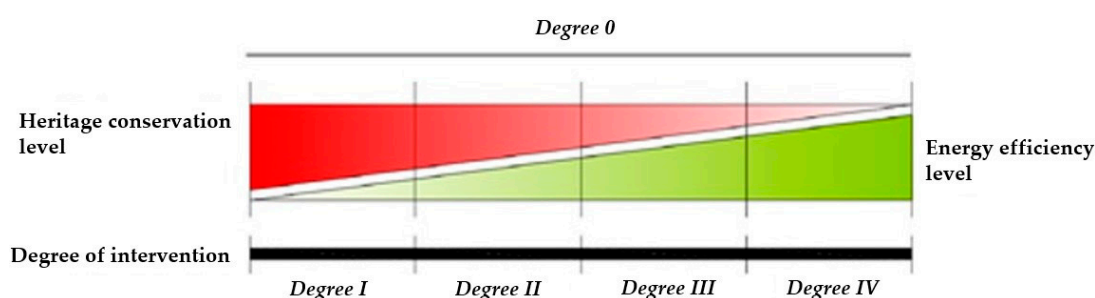
Figure 2. Diagram of configuration of the 5 intervention degrees. (Source: Authors).

After analyzing many residential buildings, a 5-degree theory was determined for energy intervention in heritage. This theory must cover the entire spectrum of buildings considered to form part of the built heritage, and even those that are not protected, but that may have some value that must be protected. This classification in degrees must contain two basic values to be considered: On the one hand, the degree of building protection value, and on the other, the level of energy improvement that can be reached, bearing in mind the first value. Both values must form part of one single concept. The different degrees are going to be presented, starting with Degree 0, which is the study of the property as it is today, continuing until Degree IV, which would be the case of the most intervened building. Within these degrees, there is a progressive energy efficiency improvement level, and a regressive heritage protection level (Figure 2) [14].

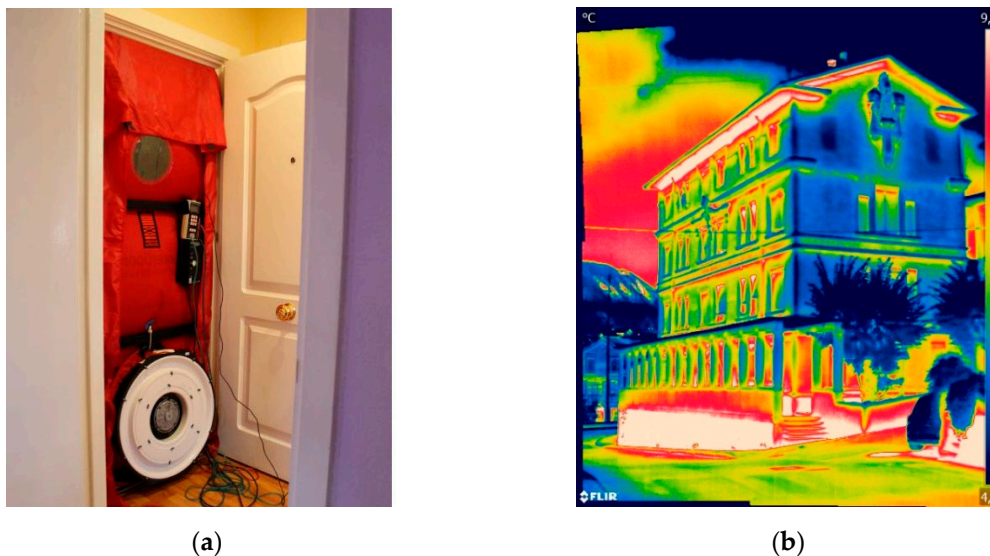
Figure 4. (a) Installation of the fan to test the permeability of the windows; (b) Thermography of the main facade. (Source: LCCE).

Following this, the recesses and carpentry were analyzed. The windows are made with wood carpentry, with 4 mm double glazing and 6 mm air chamber. The air permeability of the windows was determined by means of tests conducted on site, following UNE EN standard 13829:2002 “Thermal performance of buildings. Determination of air permeability of buildings—Fan pressurization method” [29] (Figure 4a). The test findings point to very low infiltrations for a building of this type: 2.3 renewals an hour at 50 Pa. It was concluded that the wooden windows are in good conditions, and that there are no filtrations through false ceilings or installations.

Finally, a study of the irregularities of the thermal envelope of the house was conducted, by means of thermographic test EN 13187:1998, “Thermal performance of buildings. Qualitative detection of thermal irregularities in building envelopes. Infrared method”. We also used a simplified method for building envelopes (ISO 6781:1983 modified). The outer images were captured on 15 November 2017, between 8 and 9 am, to analyze the steady-state effect after a cold night, and minimize solar effects (Figure 4b). The thermal images have been processed by means of FLIR Tools+ software, adjusting the images based on on-site verifications. A FLIR E60bx, 320×240 resolution camera was used. Both camera and software were manufactured by 2020 FLIR®Systems, Inc., and were sourced by the Basque Government’s Quality Control in Building Laboratory (Spanish acronym, LCCE).

The surface temperature performance of the opaque sections of the facade is similar in all dwellings. No significant differences were noticed between the floors of the original construction and the upper floor, which was built at a later date. However, the ground floor facades do have higher temperatures and there were hotter localized areas, such as the contours of recesses, the fronts of forging slabs, and on the eaves. The thermal bridges can be identified from the analysis of the thermographic photographs, as well as those points of the envelope where a greater heat loss occurs. These points are the window panes—especially those with one single sheet of glass—, the blind boxes, given that they have no built-in insulation on the inside, and the eaves, which are a prolongation of the attic deck, which has no insulation. On the other hand, it was deduced that the larger-sized ornamental elements, such as the Vizcaya shield and the lion that protects it, do not represent considerable thermal bridges, in contrast with the rest of blind walls of the envelope. However, they do represent an interruption insofar as the constructive characteristics of the envelope are concerned, which are the source of a series of difficulties, in the event that an improvement of the envelope, entailing the incorporation of insulation on the outside, was proposed.

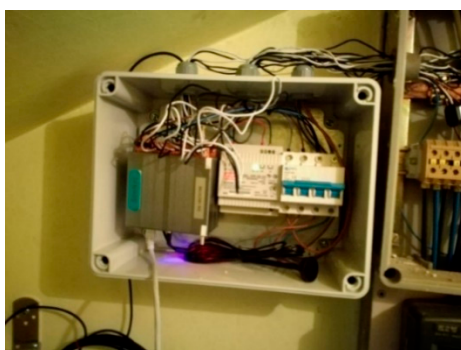
Figure 5. Installation of the datalogger (Source: Ekitermik Efizientzia Energetikoa).

The measurement system, whose composition is described below, was installed to carry out the monitoring (Figure 5). A data controller permitted the capture and local filing of data, as well as their transmission to a data management server for later display on a web platform. Regarding data capture, the following communication interfaces will be available: RS485, Ethernet, Wireless Network, GSM/GPRS; compatible with a variety of protocols, MODBUS RTU/TCP, MBUS, IEC870-5-102, KNX, IEC62056. In view of the age of the building, and in order to minimize the wiring work, data capture by means of the MBUS Radiofrequency protocol was selected. The captured data were sent from the datalogger to the external server by GPRS.

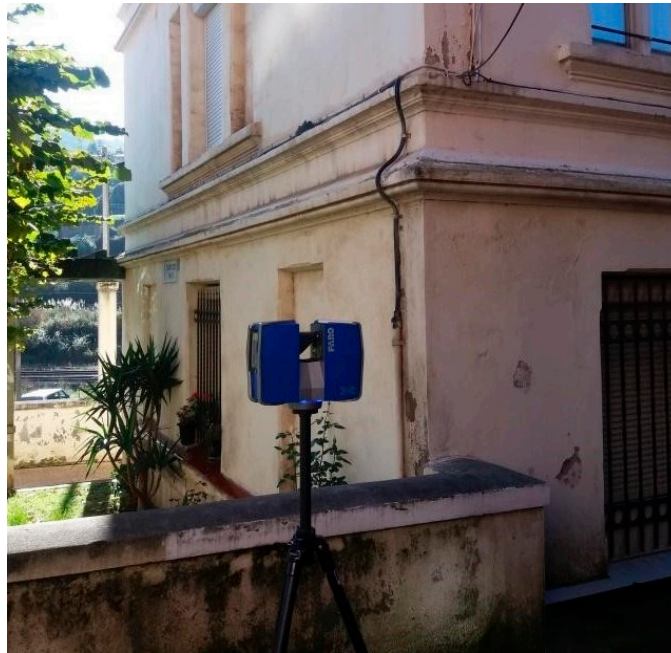
Figure 6. FARO Focus 3D×330 scanner on a tripod (Source: Urquizo Ingenieros&NorthBIM).

Capture with 3D laser scanner requires defining the positions of the device location at each scanning point, as an initial step. These positions were located both on the inside and outside of the building, to be able to model with an accuracy of less than a square centimetre of surface area. The scanner used for the work was FARO Focus 3DX330, manufactured by FARO[®] Technologies, Inc., due to its light weight, precision, speed, resolution, and above all its scope range (Figure 6). Scanning

was alternated on the outside of the house every 15–20 m, so the final point cloud overlapping exceeded the indicated resolution. A 1/4 resolution was used (44.4 million points per scan, 6 mm distance between points, at 10 m), and a 2× capture quality (low noise level and medium to high reflectance surfaces). Likewise, the capture of photograms on the outside was used to apply color to the resulting point cloud. The camera configuration was standard, without HDR, since the work demands precision in geometry, above all. On the inside of the building [36], as the distances were shorter than on the outside, a resolution of 1/5 was used (28.4 million points per scan, 9 mm distance between points, at 10 m), with the same 2× capture quality. No photograms were captured on the interior, due to the small added value provided.

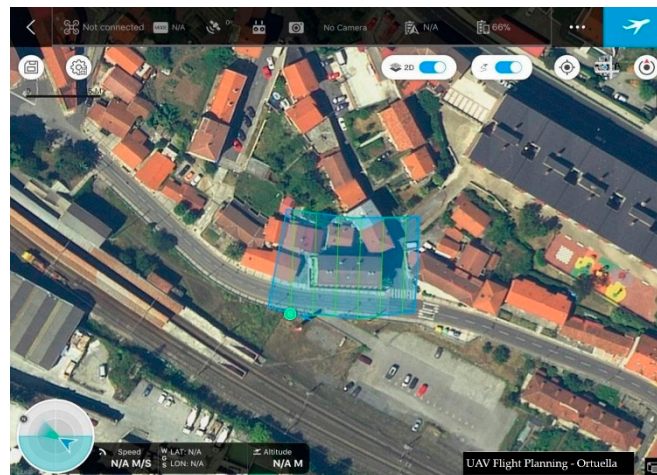
Figure 7. Planning of the unmanned aerial vehicles (UAV) flight. (Source: Urquizo&NorthBIM).

The UAV-assisted capture complemented the work of the laser scanner, to accurately represent the roof and the side ornaments of the building. The capture of the ornaments required a better definition than 5 mm between points on all sides and orientations, sufficient to generate an exportable grid to formats that can be integrated into additive manufacturing systems (3D printing). The flights were planned automatically with the DJI Ground Station Pro application (Figure 7). The equipment used was Phantom 4 Pro, manufactured by DJI®, with 20 megapixel and one-inch camera. To obtain the Digital Elevation Model (DEM), a photogrammetric flight was planned to cover an area of 2.28 Ha, at a flight height of 70 m, and a resolution on the terrain of 2.69 cm/pixel, taking 89 images. A network of 10 bases distributed over the coverage area was estimated [37]. These points are necessary in the topographic referencing at UTM coordinates both for processing data obtained with the UAV, and for the data captured with 3D laser scanner. A GNSS system in RTK was used to observe the points materialized on the terrain around the building studied in this project. Thus, both mappings could be superimposed and unified in one single dense point cloud.

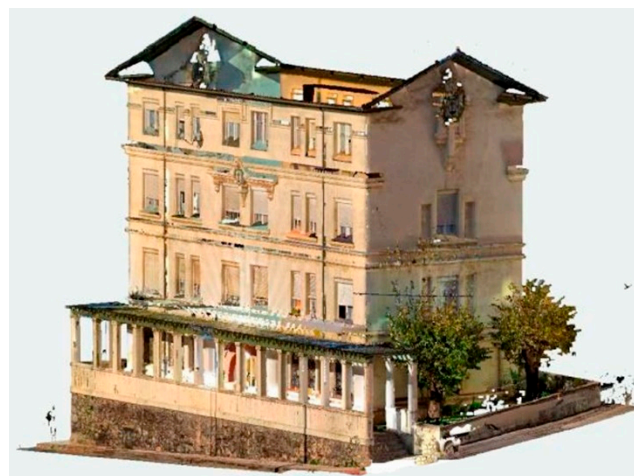
Figure 8. 3D Model produced by the laser scan (Source: Urquizo&NorthBIM).

The second phase of the 3D digital elevation method was the data processing [38]. Work on the data from the scanner and from the UAV was also carried out independently in this phase, to finish by combining the work into one single georeferenced and coherent model [39]. Regarding the 3D laser scanner data processing, a series of steps must be followed to obtain a consolidated, coherent, and precise dense point cloud [40], that can be used to generate the definite 3D model. The first step entails filtering all the scans to optimize the point cloud. Then, the different scans were accurately combined and consolidated in one single block, in relative coordinates. The third step was the application and offset of the cloud color, unifying the differences between scans. Finally, taking the points materialized in the terrain with topographic technology as reference, the coordinate system was transformed to fit the 3D scanning model in the UTM global topographic system (Figure 8).

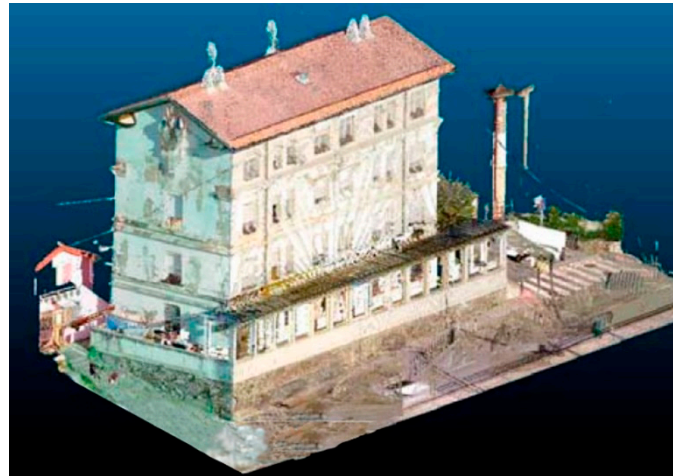
Figure 9. Final 3D Model, combining both clouds (Source: Urquizo&NorthBIM).

The 3D products, both from the laser scanner and the UAV, obtained separately, have used the same georeferenced points as reference to give coherence to the final model. Although, the precision and quality of the results were verified in each of the two partial models, it is in this last step when they were combined in one single 3D model, verifying the correct relative location of some data with respect to others (Figure 9).

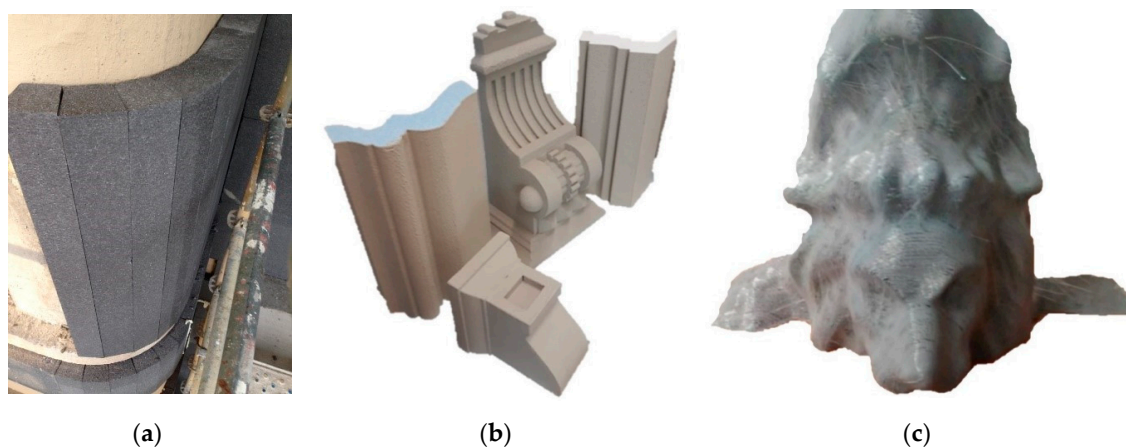
Figure 10. (a) Artisanal adaptation of polystyrene sheets by means of faceted cut (Source: FRL Arquitectos); (b) Advanced manufacturing of ornamental motifs after 3D scanning (Source: FRL Arquitectos); (c) Printed part of the shield in 3D after scanning (Source: 3R3D Technology Materials).

Certain ornamental elements are difficult to reproduce with prefabricated products, in the form of moldings or other types of parts (Figure 10a). If these elements are artistic with sculptural, plant, or animal motifs, and the solution requires their reproduction, the method must be 3D scanning, for subsequent printing (Figure 10b,c). The 3D printer reproduction technique, after scanning the element, has been applied to one of the ornamental elements of the Miñones Barracks of Ortuella. This consists of a lion on the shield of Vizcaya, situated on the side facade, on the top floor, under the side pinion. To this end, the facade, as well as the ornamental elements, were scanned, by means of UAV flights and fixed scanning stations. After scanning the ornamental elements and modeling them in 3D, they were printed on a 50 cm Creality printer in three dimensions. To this effect, the choice made was to reproduce the shield in 6 parts that were later joined together (Figure 10c). The printing material of the prototype was recycled PLA (Polylactic Acid) with plant origin and biodegradable material. A technical polymer such as ASA (Acrylonitrile Styrene Acrylate) is proposed for the definite solution on the exterior.

The first option studied is Rehabilitation with ETICS from the exterior. This consists of removing all the ornamental elements, such as moldings and shields, and replacing them with reproductions in plastic materials. The insulation thickness would be 6 cm, in polystyrene (XPS) (Figure 16). The improvement of the thermal transmittance of the opaque envelope of the building would be 63%. It affords an obvious improvement from the thermal viewpoint, as all the thermal bridges are avoided. However, it is not compatible with the protection of the facade. The solution can be improved by advanced manufacturing of the ornamental elements at a larger scale in insulating material, covering the original motifs and not eliminating them. This would make the solution compatible with the protection. Nowadays, it is a feasible, but very complex, option (see Figure 10b).

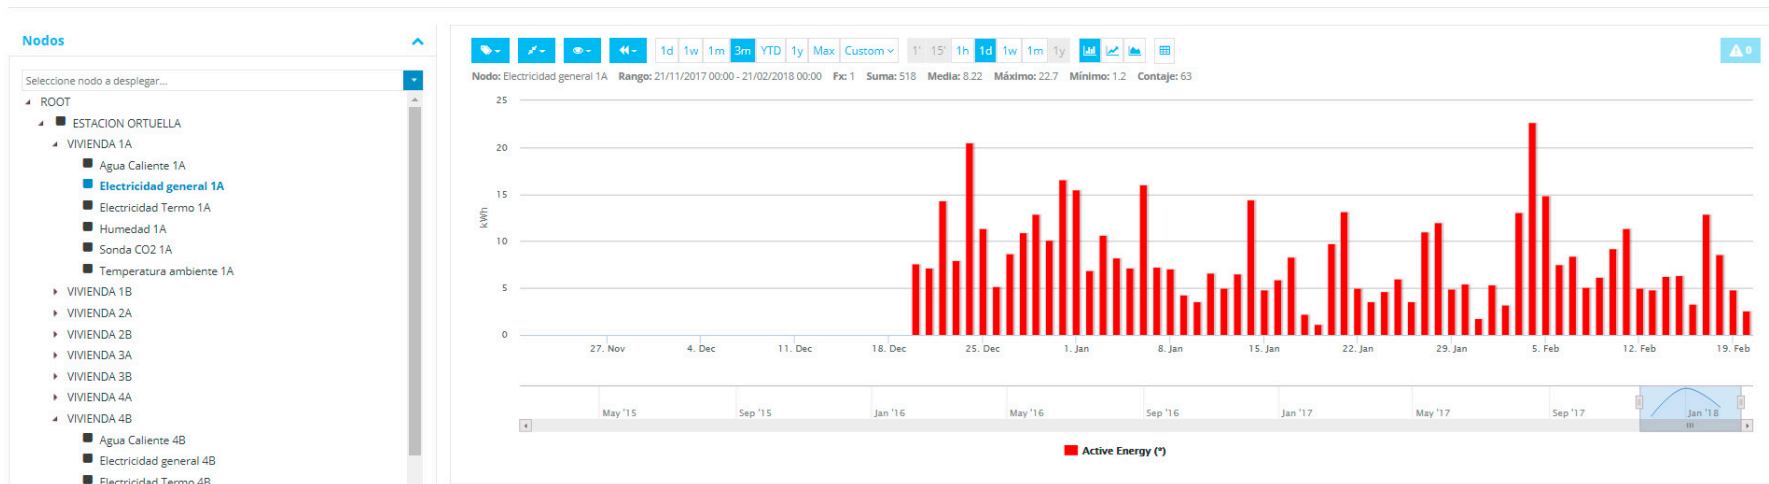
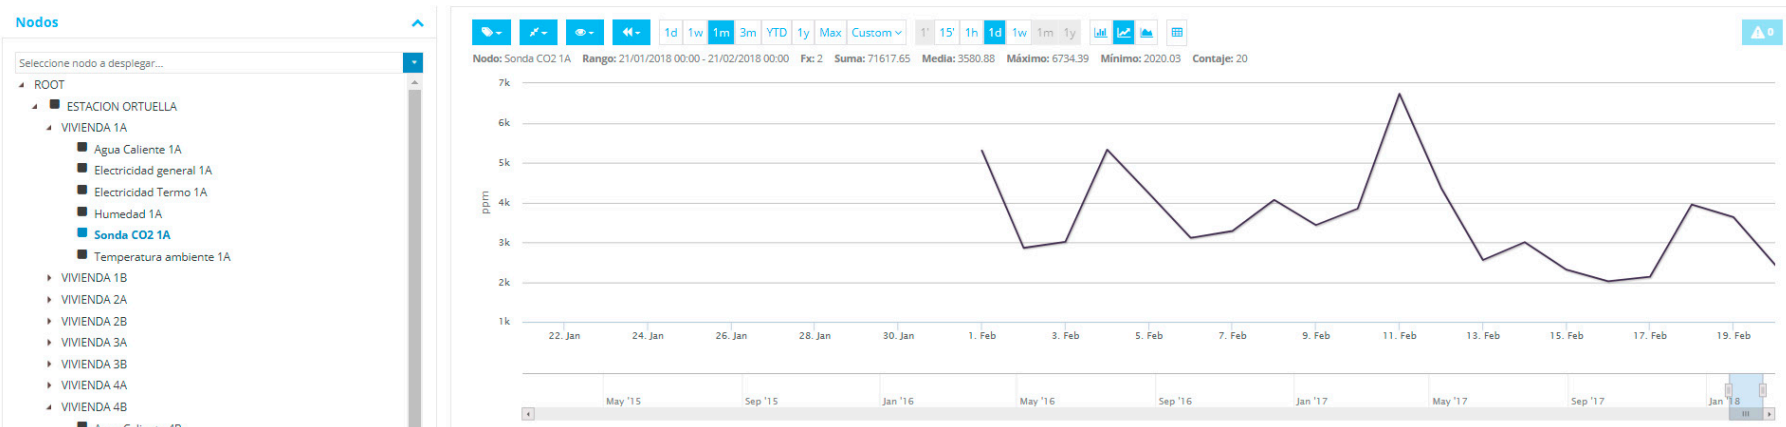
Figure 12. (a) Monitoring and obtaining of data relative to electricity consumption; (b) Monitoring and obtaining of data relative to atmospheric CO₂. (The data of the 2 images are not relevant, they serve to see the graphical options for displaying the monitored data). (Source: Ekitermik).

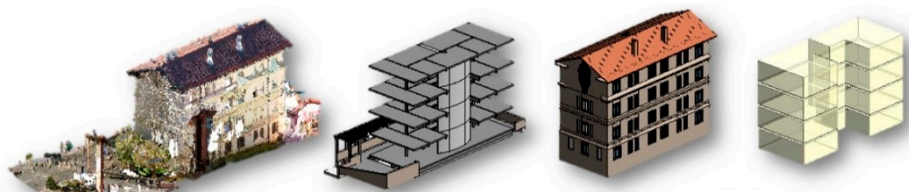
Figure 13. The four Autodesk Revit models. (Source: Urquiza&NorthBIM).

In the basic project modeling (initial state of the building), the families were identified based on the information collected on site, and the information was obtained through the study of the reform project underwent by the building in 1988. These families have been collected for the Structure model, on the one hand, and the Architecture model, on the other hand. The following families were identified in the latter model: partitions (several types: inner partitions, separation between dwellings, etc.), doors, enclosures (facade, facade to inner courtyard), outside carpentry, roof, and stairs. A flow was developed to optimize the modeling work by way of federated models, as follows: one general or central model, which includes the masses by dwelling, and a URL link to external data, such as, for instance, the monitoring data. The following models were federated to this general model: A model with associated Point Cloud in .rcp format, Structure discipline model, and Architecture discipline model (Figure 13).

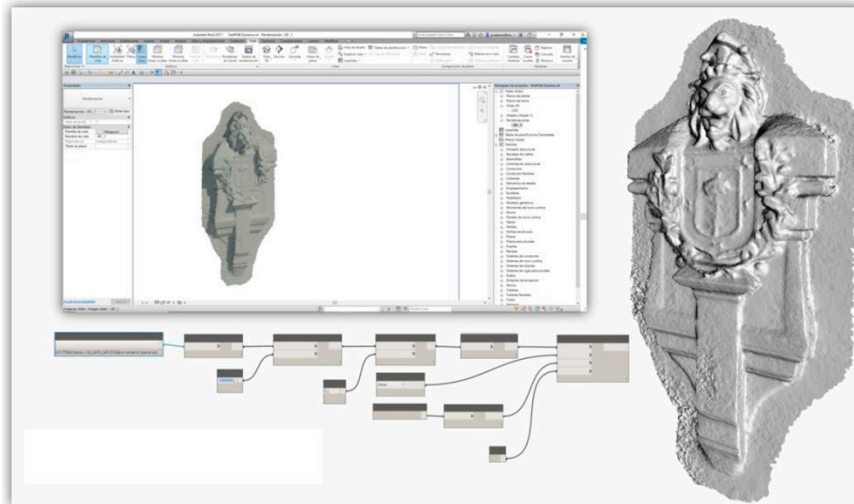
Figure 14. Volumes of the side shield for 3D printing (Source: Urquizo&NorthBIM).

There are ornamental elements on the facade that have a complex geometry and make manual modeling difficult. For these cases, a routine for Autodesk Dynamo, a visual programming tool compatible with BIM methodology that has been used through Autodesk Revit, was applied (Figure 14). This enables generating the volumes in the model.

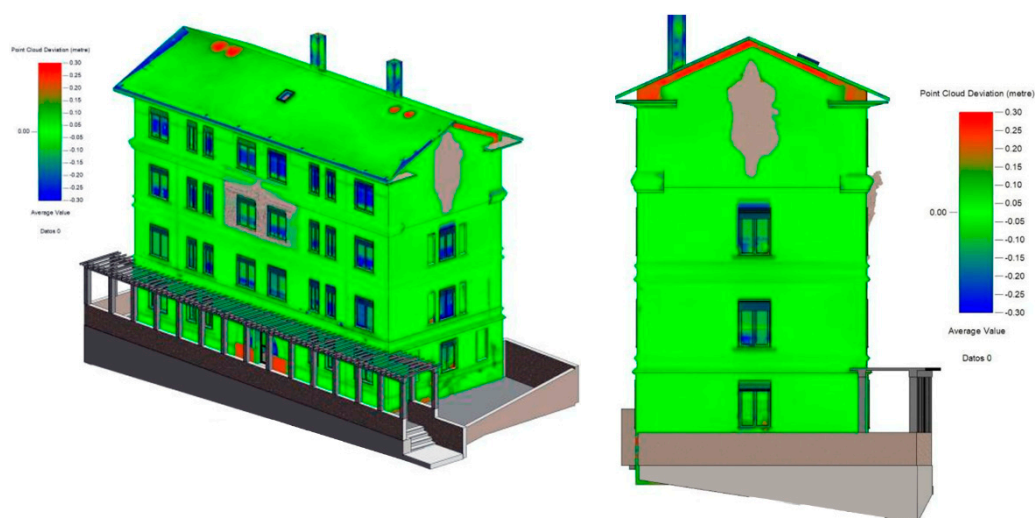
Figure 15. Inspection of the differences between the Cloud and the Model (Source: Urquizo&NorthBIM).

After modeling the building, the point cloud was used to measure the accuracy of the model compared with the reality include in these clouds. Pointsense Surface Analysis Tool for Revit, created for FARO scanner solutions, permits generating a 3D inspection map, and analyzing these differences (Figure 15). The analysis was performed in 2 stages: a first analysis at the half-way point of the first modeling phase, when the ornaments or moldings still have to be generated, and a second analysis when the model is finished. Based on the superimposition of the point cloud on the definite model, it has been possible to analyze the modeled surfaces by means of objects with generic surfaces (portions of drawings, cylinder, torus, cones or spheres, etc.). Further, it has permitted correcting deviations in a first iteration of the model, specifically on the roof: after correcting its slopes, the analysis shows optimal results (roof in green). Also, thanks to this tool, some differences were detected in the contours of the roof (in blue) between the point cloud and the model. However, the conclusion was that, in this case, it is due to the capturing uncertainty of the farthest contours, so the model was not adapted.

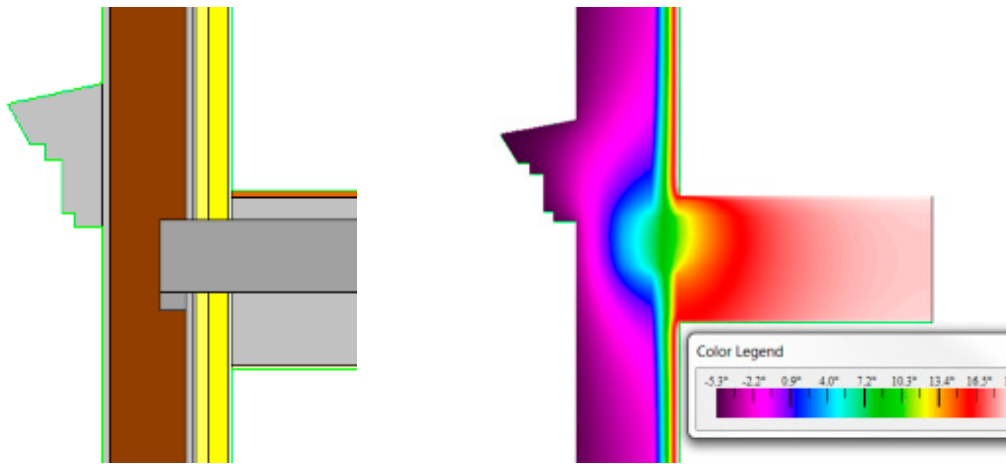
Figure 17. Diagram of the analyzed insulation and temperature profile for the case of vertical cladding insulation (Source: Tecnia Research & Innovation).

The second option presented is the interior rehabilitation solution. This would consist of applying 6 cm polystyrene (XPS) insulation on the existing cladding (Figure 17). Different interior insulation options with different combinations of walls, ceiling, and floor, have been studied. However, only the two options that represent the extreme cases analyzed are included below. The improvement of the thermal transmittance of the opaque envelope of the building would be around 43% for the vertical cladding, which may increase to 55% if the insulation were to be placed on the floor and ceiling, in addition to the walls (Figure 18). This solution would preserve the ornamental elements, but however, the impact of the work inside the building would be high.

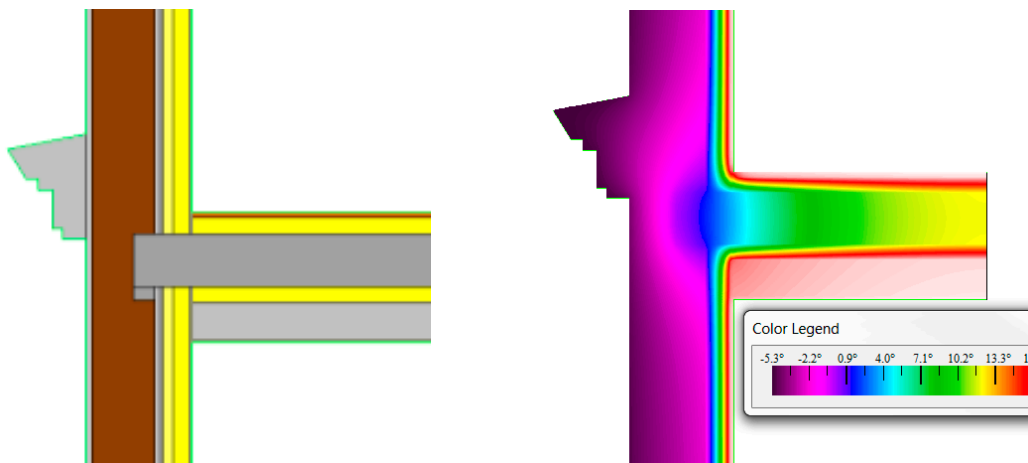
Figure 18. Diagram of the analyzed insulation and temperature profile for the case of vertical cladding insulation and insulation on floor or ceiling (Source: Tecnia Research & Innovation).

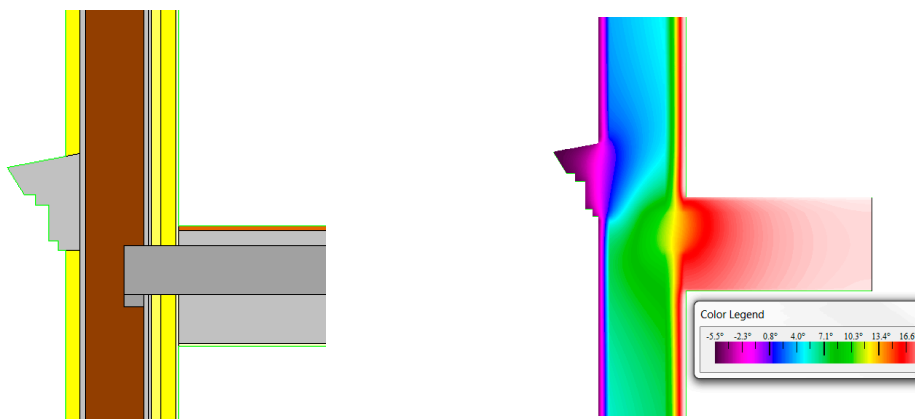
Figure 19. Diagram of the analyzed insulation and temperature profile for the case of vertical cladding insulation on the outside and inside (Source: Tecnia Research & Innovation).

The next option presented is the mixed rehabilitation solution. This would consist of applying 6 cm thick polystyrene (XPS) ETICS on the outside, without removing ornamental elements, in addition to occasionally placing another, 6 cm thick XPS, insulation on the inside, in order to eliminate the thermal bridges in affected areas (Figure 19).

As we can observe in the graphs, the improvement of thermal transmittance of the opaque envelope of the building is between 63% for the vertical cladding, both on the outside and on the inside, increasing to 69% if the insulation is also placed on the floor and ceiling, in addition to the vertical insulation (Figure 20). The results obtained are not comparable with those obtained from the two previous hypotheses, from the viewpoint of the economy and performance, as the insulation thickness is doubled on being placed both on the outside and the inside. The ornamental elements of the facade would be saved, although there would be a possibility of condensation building up at critical points. This is an intrusive action, however, which affects the inside of the dwellings, and which would cause inconvenience to the tenants.

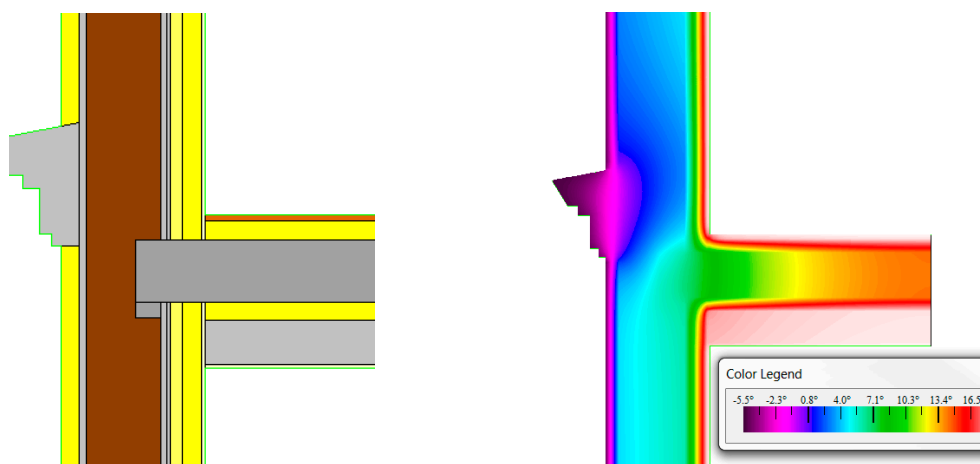
Figure 20. Diagram of the analyzed insulation and temperature profile for the case of vertical cladding insulation on the outside and inside, and insulation on floor or ceiling (Source: Tecnalia Research & Innovation).

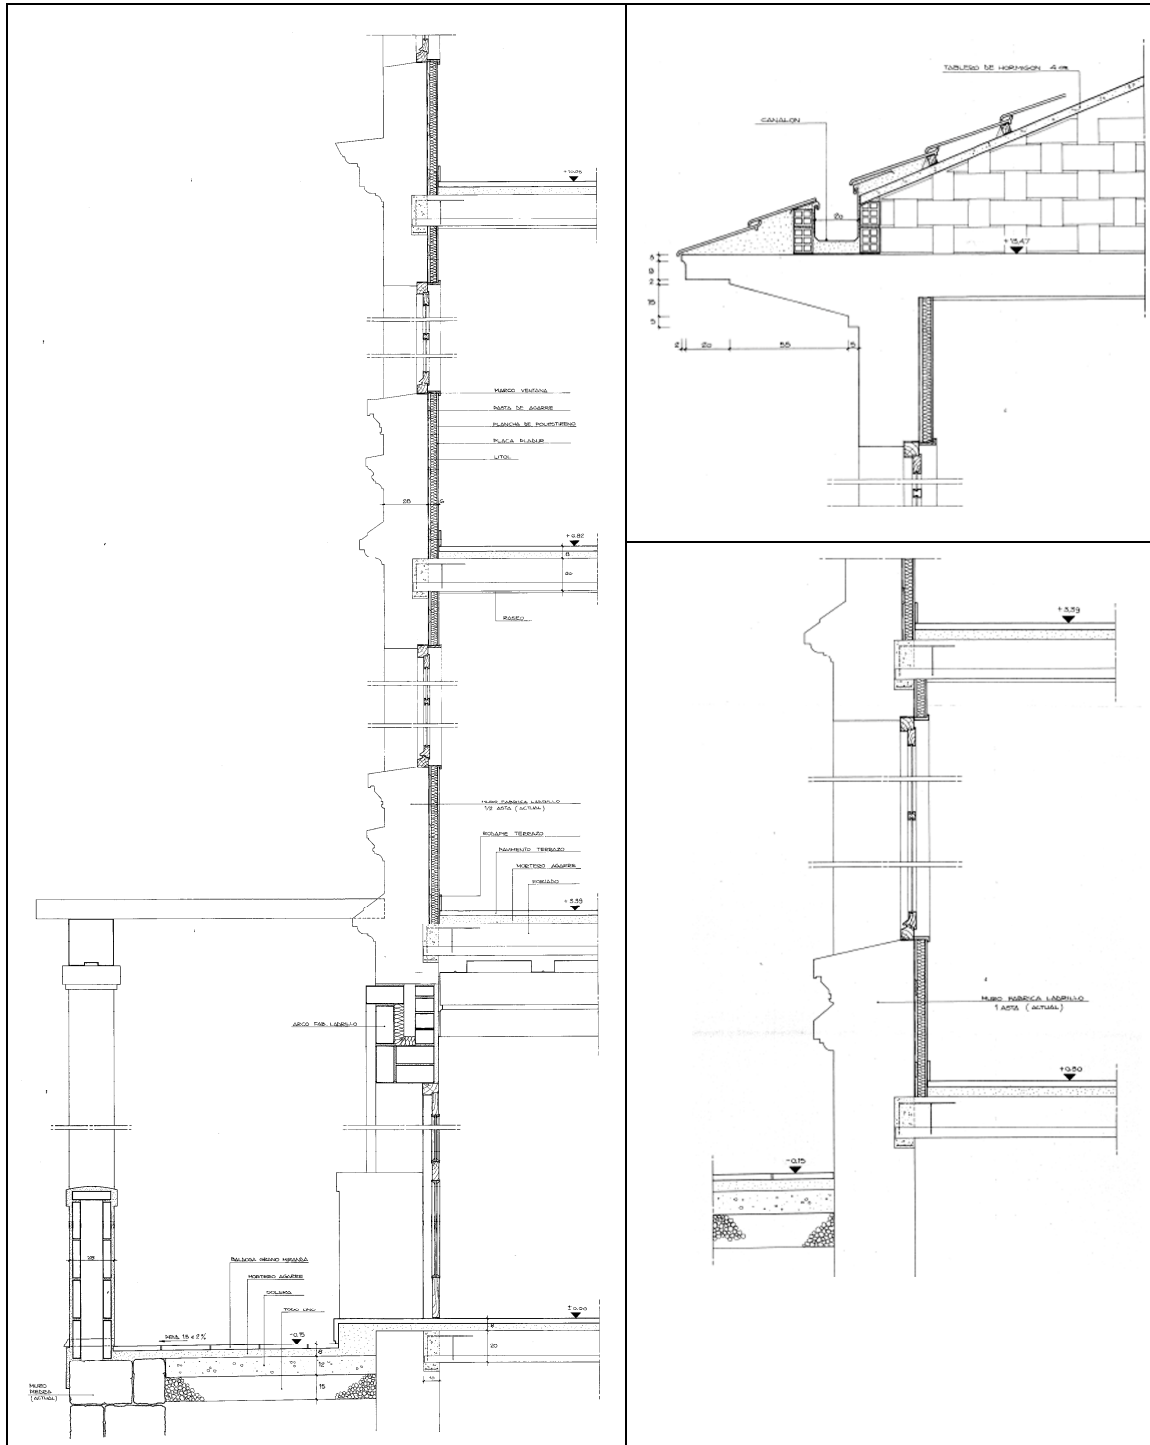
Figure A1. Constructive sections of the Rehabilitation Project (Source: Rehabilitation Project of the Miñones Barracks (1988); Architects: Cenicacelaya, J.; Saloña, I.).
