Abstract	
TITLE:	Geometric documentation and reconstruction of the church of the Monastery of San Prudencio (La Rioja, Spain)
ABSTRACT:	<p>This diploma thesis is the result of a collaboration of two universities, the University of the Basque Country (UPV/EHU) and the National Technical University of Athens (NTUA). It is part of the bigger project of the documentation of the Monastery of San Prudencio at the province of La Rioja at Spain, which is undertaken by professors and students of the University of the Basque Country and with the contribution of six universities of Europe (National Technical University of Athens, HafenCity University of Hamburg, Polytechnic University of Madrid, University of Studies of Siena, Vilnius Gediminas Technical University) as part of an ERASMUS educational Intensive Programme. This ERASMUS project aims to document the whole Monastery by all the adequate, in any case, methods with the long-term target to make the large history of the monument known to the habitants of the region and the rest of people and to be the background of the measurements that the government will take to protect it. As part of this project, this diploma thesis deals with the d

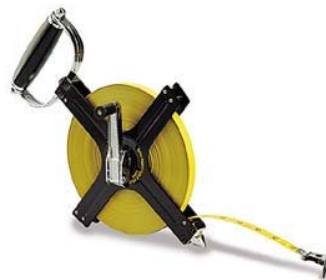
Image_1: Measuring tape

A way to document a monument is by using simple “instruments” such as a measuring tape for measuring the basic dimensions of the object and a plumb for checking the verticality of two directions, triangles. This method does not need any difficult to move and expensive topographic instruments and under suitable conditions (small distance, not very complex shape) can obtain a good accuracy. The raw data are registered in sketches and later manually are introduced at a CAD⁶ environment. As result the method gives distance measurements that can be represent as line drawings of the object. It is not very common to be used for document with details a monument as it is rather consuming the registration of many distances. In any case, it is quite common to take some measurement with a measuring tape at the field just for checking the final result, which of course it is not the only way to check it.

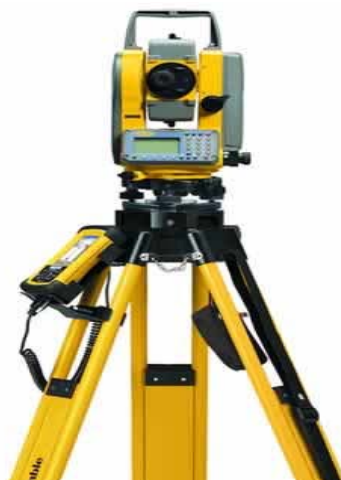
Image_2: Total station

The representation of that kind of collecting data is usually 3 Dimension vector drawings in a *CAD*⁴ environment. These drawings have point and not continuous information.

For sure the topographic methods of measurements are irreplaceable in projects of documentation that requires georeference even though it is not very typical due to the complexity of the object to be used as the main method in the documentation of many monuments. Without known coordinates of a few points of the object, the following – methods might be unable to goreference the monument

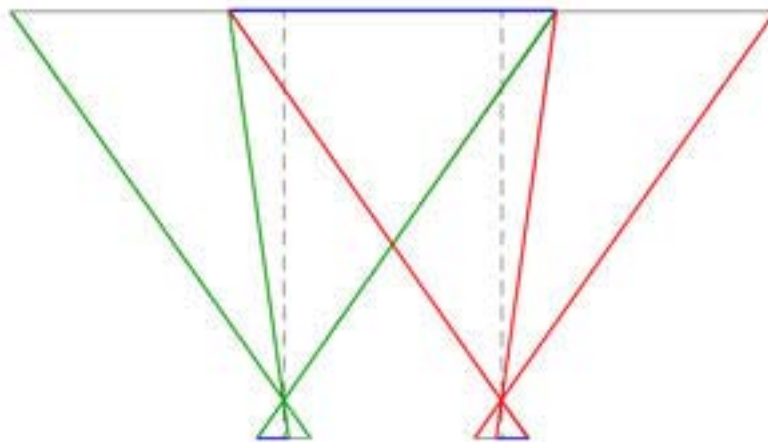
By simulate the human vision, the classical photogrammetry needs the axes of two photos to be parallel and a ratio between the base - B (distance between the two camera positions) and the height – H (distance between the camera and the object) to be into the limits $1/10 < B/H < 1/3$. This permits the user to see stereoscopically the 3 Dimension Model as the human can see stereoscopically his environment.

Conventional Stereo Photogrammetry

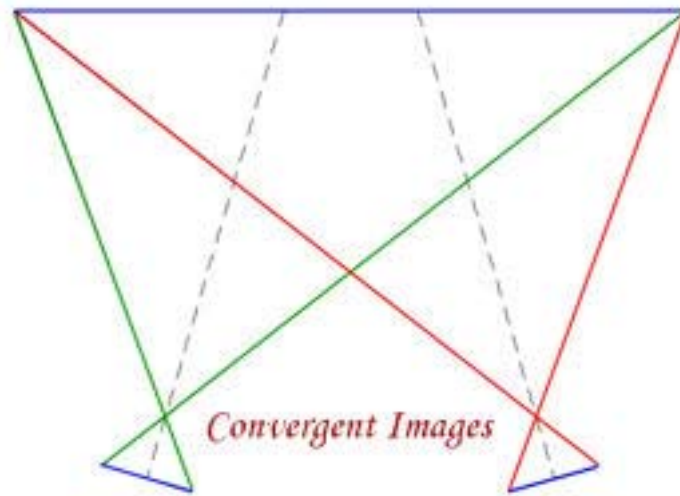
that the required geometry of the photos leads to more flexible position of the camera. On the other hand, it does not give the ability of stereoscopic view.

Image_4: Geometry of Convergent Photogrammetry

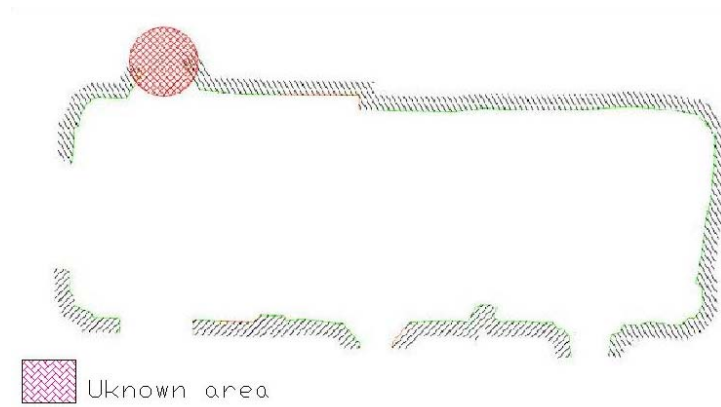
Image_7: Floorplan of the church¹³

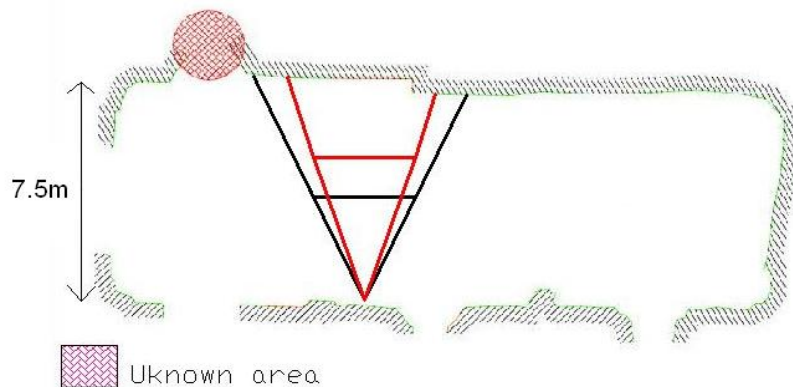
The first plan of the work included photos of the four walls of the church. The available focal lengths were one of 21mm and one of 35 mm. The smaller the focal length the bigger the surface covered by the photographs. In the case of the church there was not a big flexibility to the points from which take the photos as it is a closed area. So, it was chosen the 21 mm length. The 35 mm would need more pares in order to cover the whole church as it captures in a bigger scale less area of the object (Image_8).

Image_8: Different focal lengths (red: 35mm and black: 21mm)

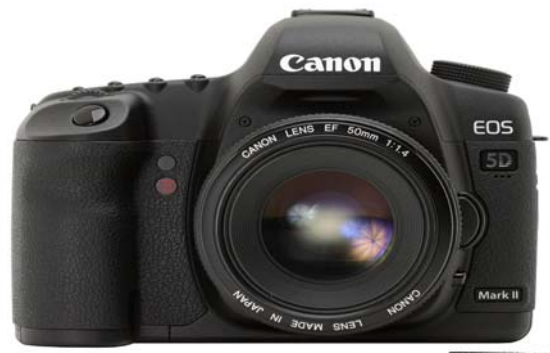
Image_9: Canon EOS 5D Mark II

Image sizes (RAW)	5616 x 3744 (21.0 MP) 3861 x 2574 (10.0 MP) 2784 x 1856 (5.2 MP)
Shooting modes	Auto Creative Auto Program AE(P) Shutter priority AE (Tv) Aperture priority AE (Av) Manual (M) Custom 1 Custom 2 Custom 3
Storage	Compact Flash Type I or II (inc. FAT32) Supports UDMA cards Copyright metatag support Canon Original Data Security Kit supported ("Original Image Data")
Dimensional	152 x 114 x 75 mm (6.0 x 4.5 x 2.9 in)
Weight	No battery: 810 g (1.8 lb)

The camera was used with focal length 21 mm and images of 21 MP

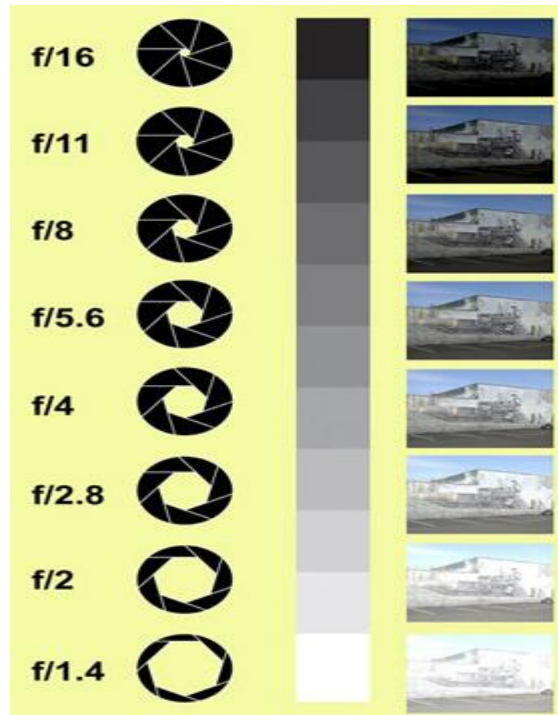
The velocity is also related with the quantity of light. The bigger the velocity the less is the introduced light. For the best combination of these parameters, they were checked the automatical values of them that the camera gives focusing at the middle part of the object and these values were fixed for the pairs of the same model in order to obtain homogeneity at the taken photos.

Image_11: Demonstration of the influence of the light at images (f: the opened diaphragm)¹⁷

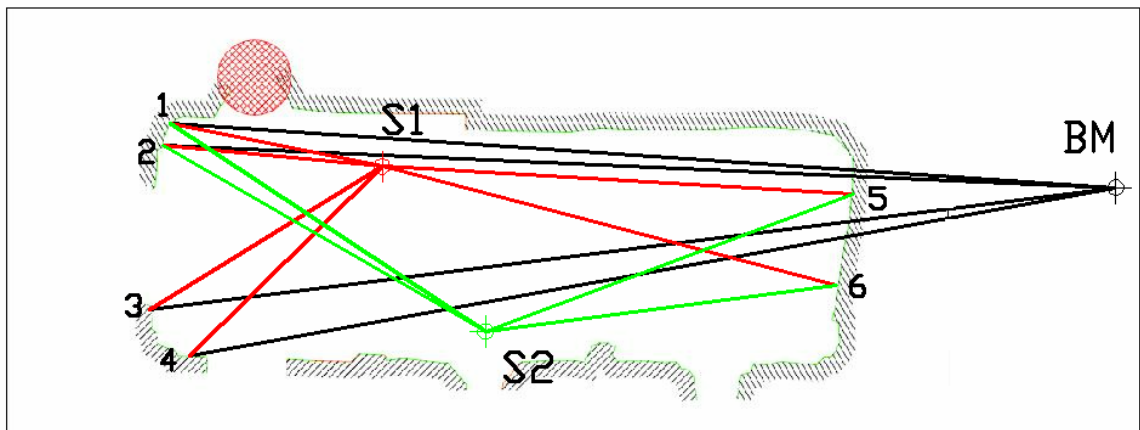
At the image_12 it is presented with black colour the bench mark (BM) with known coordinates. From this point were measured minimum 4 points at the western wall of the church (1,2,3,4). Then these points were used for the resection of the point S1. After the resection, the S1 had known coordinates and could be used as a station point for measuring the visible by it control points. The existence of one more station point (S2) was needed in order to be measured part of the northern wall that could not be measured by the S1 station point. For the resection to the S2 they were used minimum 4 known points of the walls of the church (1,2, 5,6). It should be mentioned that the image_12 is only a sketch and not a faithful representation of the correct positions of the points. It only demonstrates the relative positions of them.

Image_12: Sketch of the resections

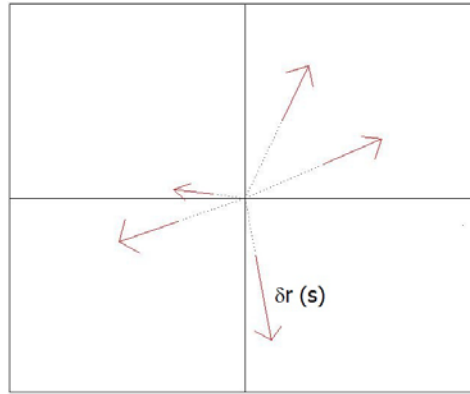
Image_13: Radial distortion Seidel ($\Delta r (s)$)

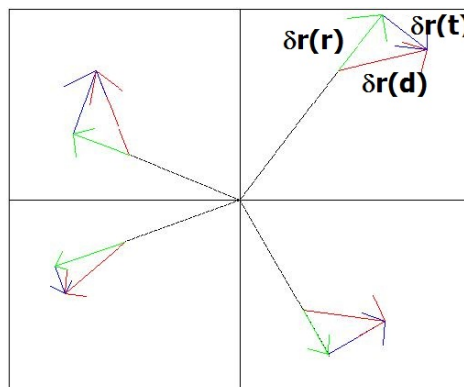
In addition to this, there is another non symmetric distortion due to the decentering of the lens, which can be divided at one radial component and one perpendicular (image_14).

Image_13: Distortion due to decentering of the lens ($\Delta r (d)$)

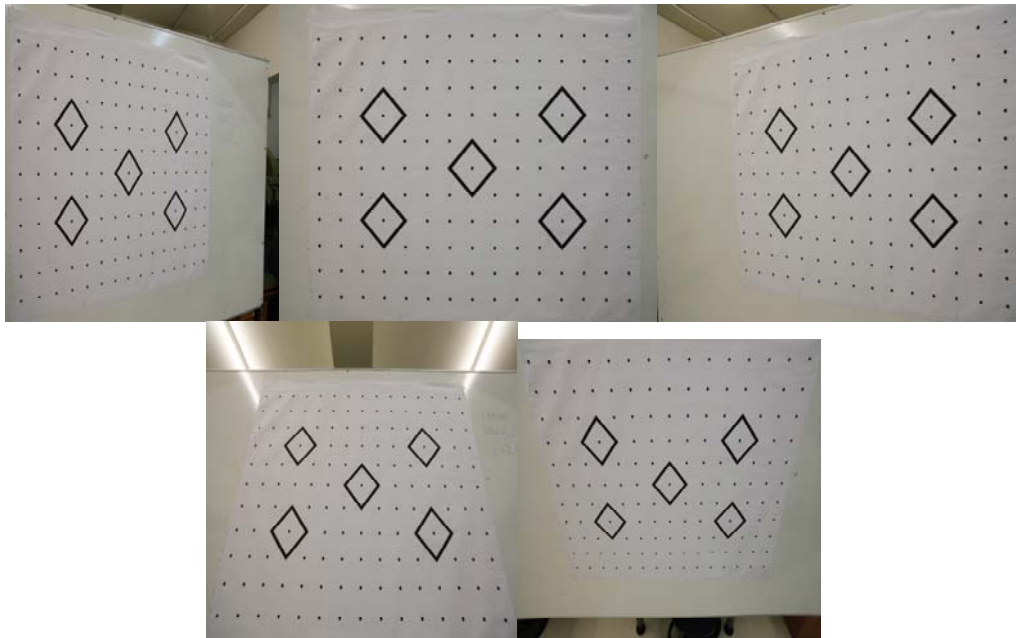
After placing the calibration sheet on a plan surface for not distorting the shape of it, five photos by different point of view of the sheet were taken. The photos had to include the entire sheet under the geometry that appears below.

Image_14: Photos required for the calibration of *Image Master*

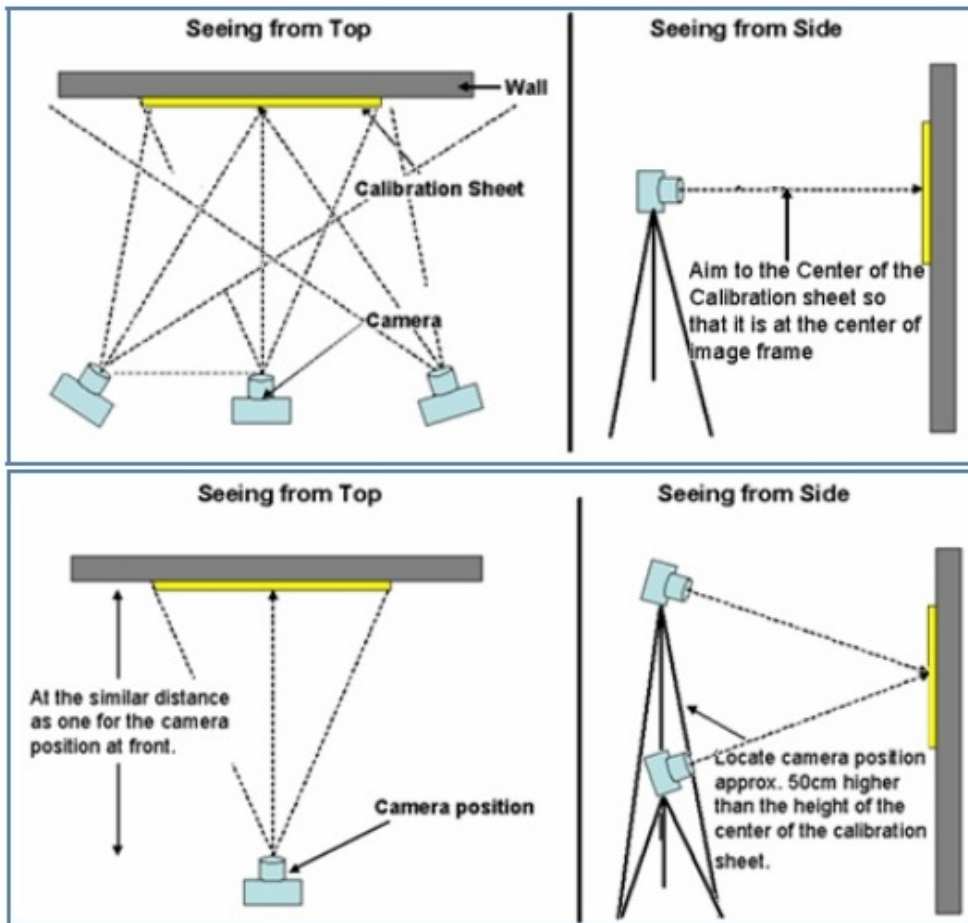
Image_15: Geometry of the taking photos for calibration¹⁹

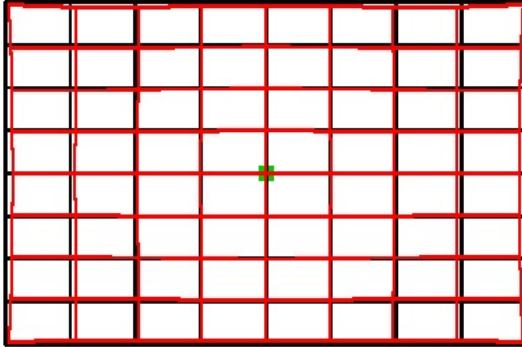
Max of Before Correction: 53.465 [Pixel]

Black Line: Ideal Value
Red Line: Before Correction

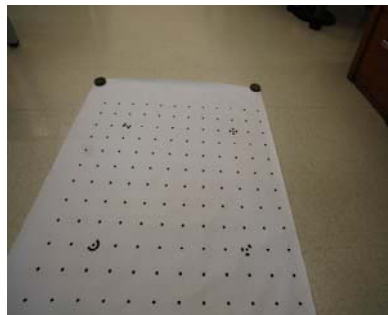
For *Photomodeler Scanner 6* 12 photos are necessary with the suitable geometry similar with the one that *Image Master* needs. At this moment, it is needed to mention that the initial photos for the calibration were not very good as it is shown on them a lot of area outside the calibration sheet that *Photomodeler Scanner 6* uses (different from the one of *Image Master*). Moreover as these photos were taken on 08/06/2010, the calibration does not take into account the changes of the interior orientation that the system has since this date.

Image_17: "Bad" photo for calibration

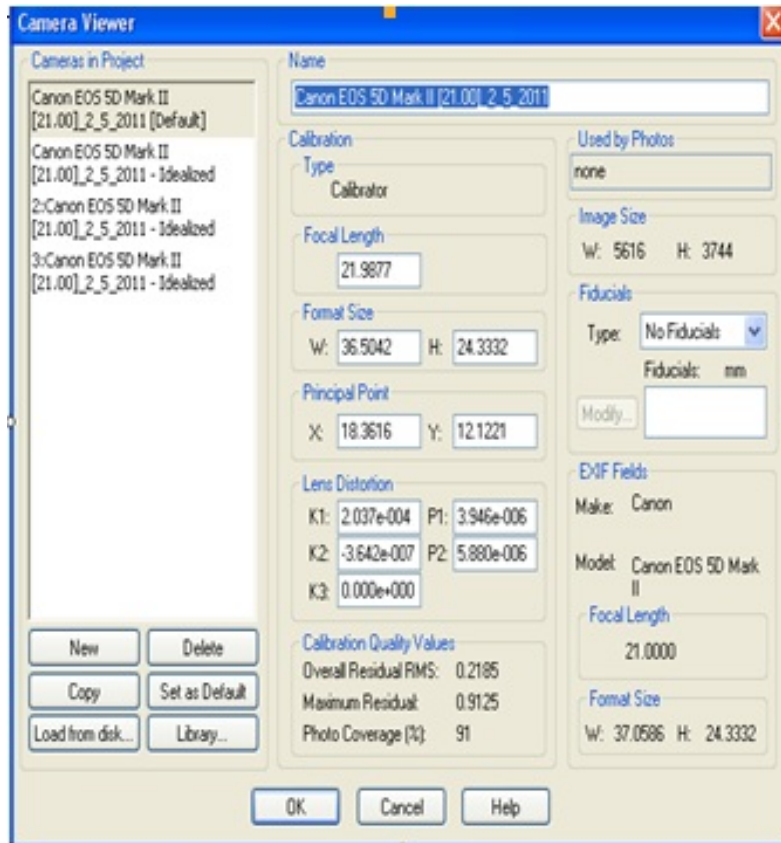
Below (image_18) it appears the calibration results made by *Photomodeler Scanner 6*

Image_18: Calibration results of *Photomodeler Scanner 6*

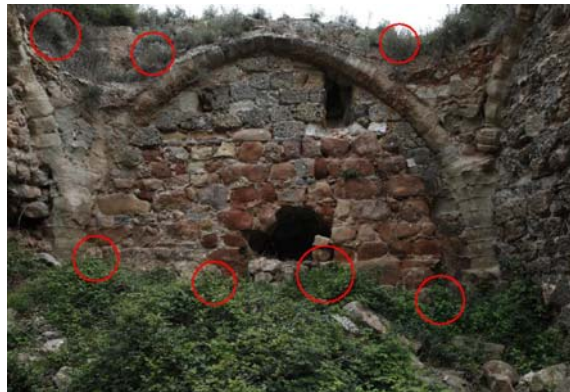
Its length (7.5m) and shape permitted one single project. So they were chosen 3 photos – 2 pairs that covered the entire wall. Below (image_19) appear with red colour the problematic areas. They are areas covered by plants that cannot be represented well on a model. In addition to their shape, their movement as they are not part of the wall (maybe they are not in the same position at the two photos), create problems in the mesh. It is estimated that the plants at the bottom of the wall should have been cleaned before the taking of the photos. However the plants at the upper part of the wall, cannot be removed and moreover it was evaluated that the cut of them would create static problems to the wall.

Image_19: Problematic areas

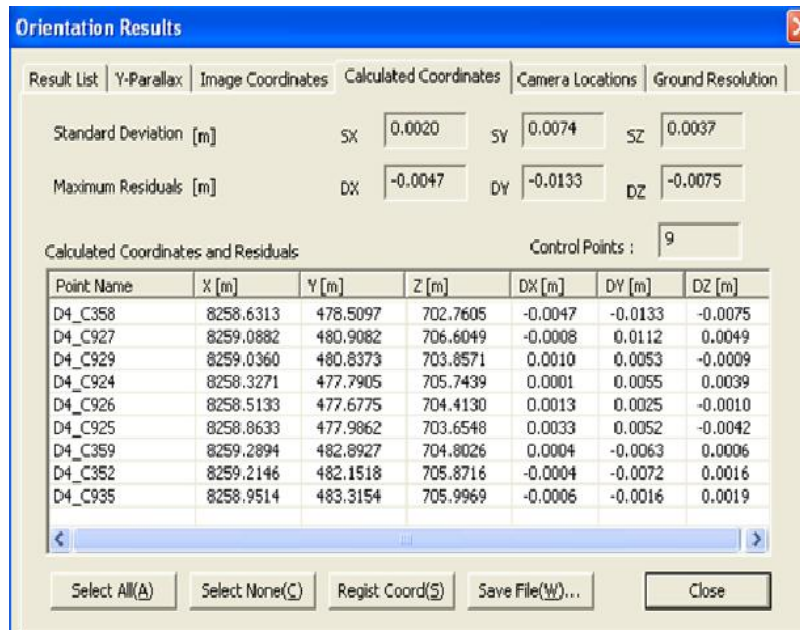
Four points were not used for the orientation in order to be used to check their position at the final products (3 Dimension models and orthophotos). The analysis of this checking will be presented in chapter 4.

Image_20: Error at absolute orientation

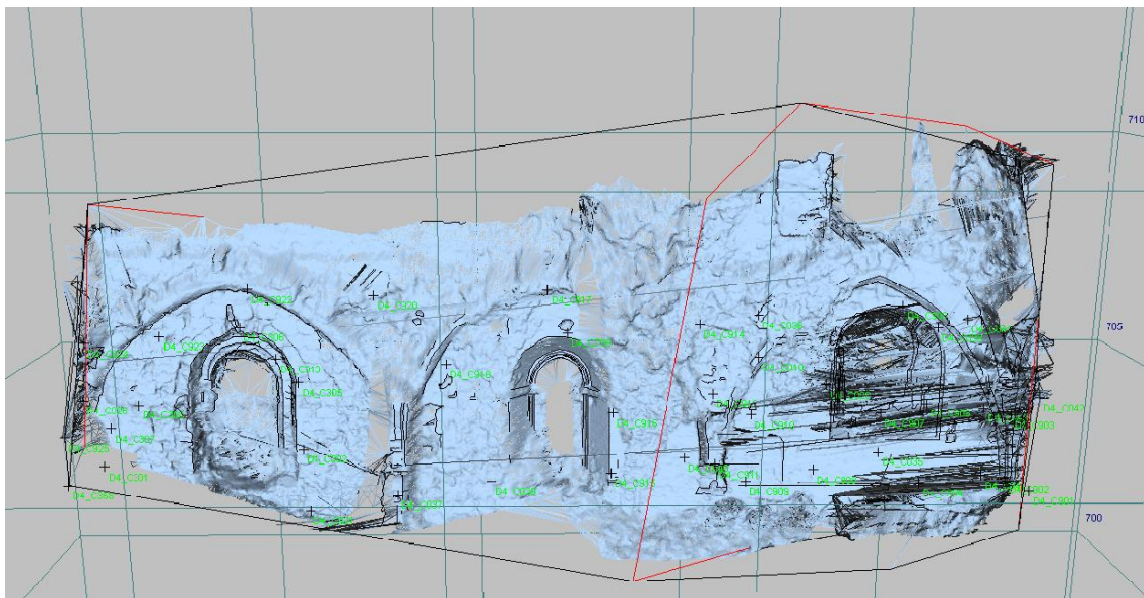
Our first effort to create one mesh of the entire wall gave us a disappointing result, (image_21). There were triangles linking points that should not be joint to each other and the noise of the mesh was impossible to be cleaned, something that was avoided spotting the are in three big meshes and some smaller ones.

Image_21: South wall in a go

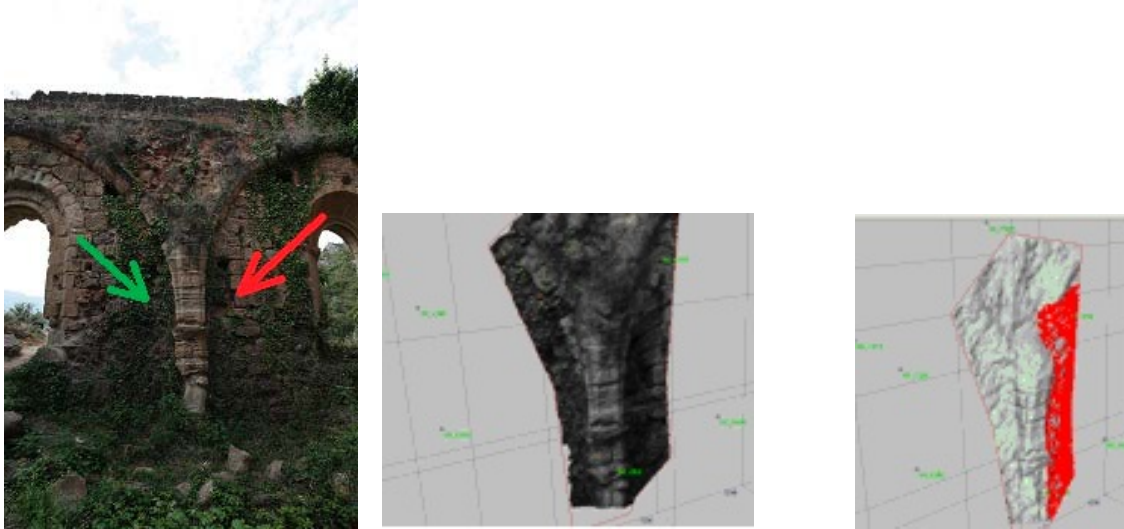
Moreover, the wall had some parts that were not visible in the first pairs that were selected to create the model, so new models with new pictures and new orientation were made. A characteristic part was the column between the two big openings. For taking the complete model of this column it was needed to make 2 small meshes only for this area. In order to create these meshes were selected photos that had all the information for the column. With a pair of two photos was taken the information for the left part and with another pair was taken the information of the right part (image_22). It was not possible to combine the four photos at one orientation and one mesh due to the fact that their axis were not parallel. The software should permit orientation like this, but in this case did not work, maybe due to the geometry of the photos that need to have specific characteristics for that kind of orientation.

Image_22,23 & 24: Column at Southern wall

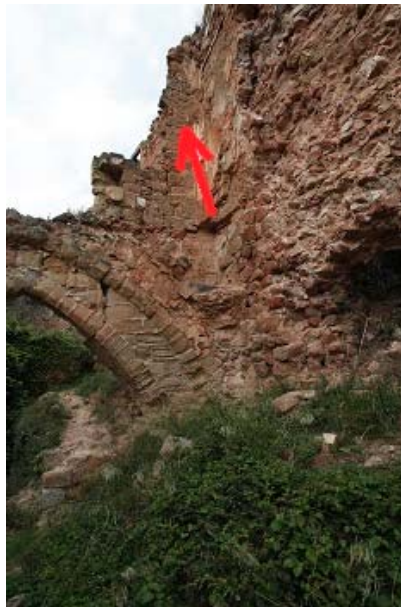
One more pair should have been worked for the highest southern part of the wall, but there were no photos that this part was completely visible. Moreover this part had a lot of creepers something that did not help the documentation of it.

Image_27: Highest part of western wall that was worked on a different model

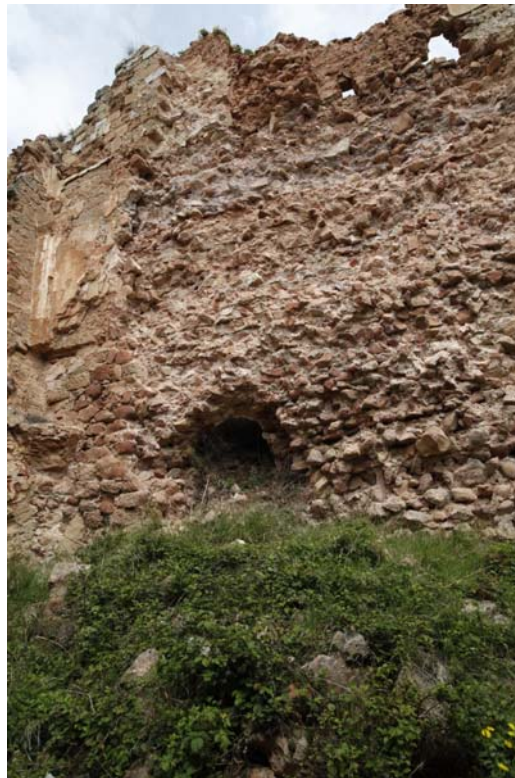
We also tried to orientate only the lower part of this area, but the result was also bad even though there were enough control points. Due to the irregular surface and the texture, it was not possible to be recognised many homologous points at the two photos something that led to a bad – not dense mesh. So it is concluded that the surface and the texture of the object was the main problem and not the lack of control points (lack of control points at the highest part of the western wall lead to a sufficient result). For these kinds of surfaces are needed photos from different points of view.

Image_28: Part of the northern wall will irregular surface

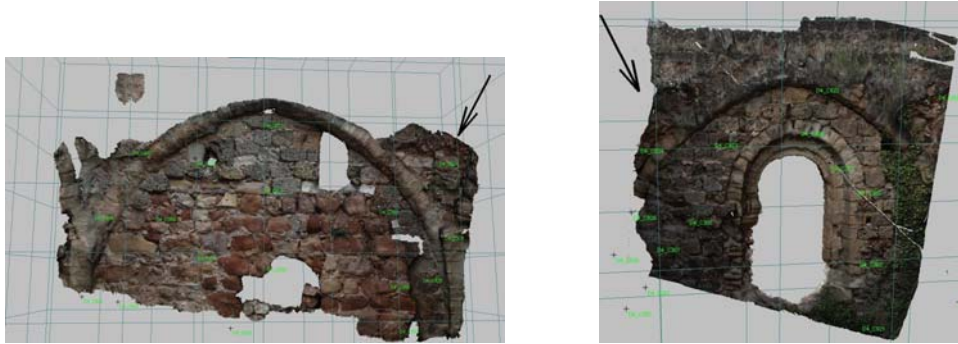
The corner between the eastern and the southern wall was presented only in the mesh of the eastern wall. This was due to the fact that when the model of the southern wall was done, this corner did not appear in two pictures.

Image_29 & 30: The eastern-southern corner

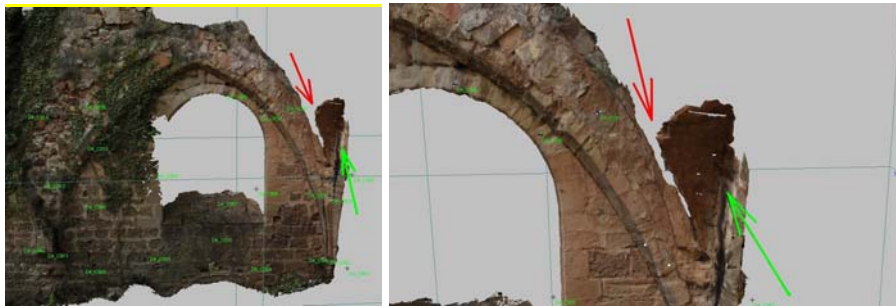
The corner between the southern and the western wall was presented in both models of each wall but in each model appears a different part of it. This was normal as the two models were created using photos from different points of view, so that different parts of the corner were visible. Consequently, the one model completes the other. After merging the two different models with *Rapidform* we saw that the adjustment at the part of the corner was good.

Image_31 & 32: The corner as it appears at the model of the southern wall, where: red the not presented part, green the appeared part

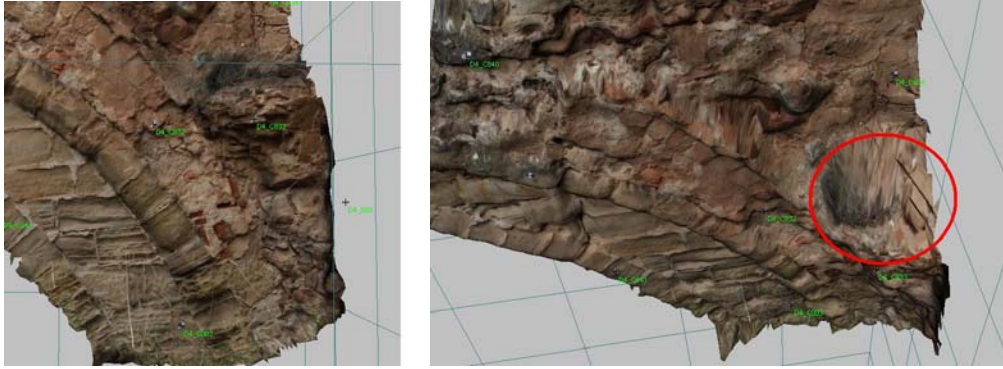
At the image_36 it is demonstrated the bad representation of the corner regarding the part of it that is visible from the top. In order to improve this representation, photos from this point of view (from the top) should have been taken.

Image_35: Northern – western corner
Image_36: Northern – western corner, problematic area

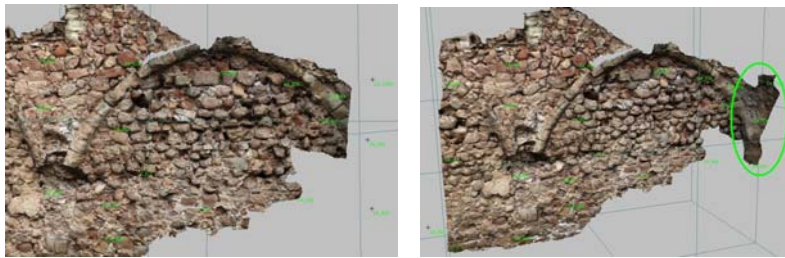
The northern – eastern corner is represented in both the projects of the two walls. In a first effort to create the model of the northern wall the corner was not appeared (image_37) something that was corrected (image_38) by choosing the suitable photos in a stereopair.

Image_37 & 38: The corner as it appears at the model of the northern wall

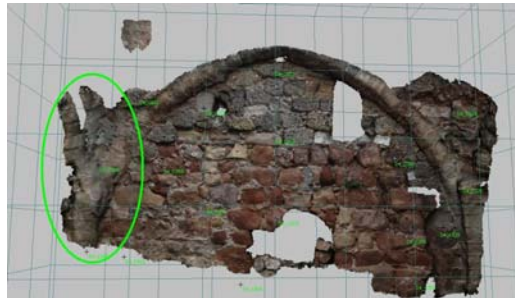
Image_39: The corner as it appears at the model of the eastern wall

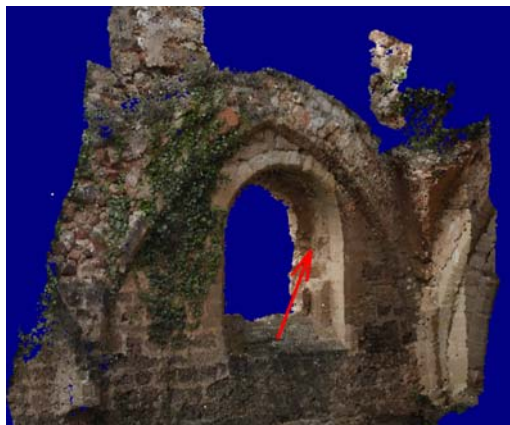
By using this software it was possible to take all the information of the western part (project_1) of the southern wall in one model which was not possible using *Image Master*. For example, the window of this area (image_41) was covered by a pair of photos that were orientated at the same bundle adjustment of the whole project. This leads to an homogeneity concerning the result of the orientation.

Image_41: Point cloud of the western part of the southern wall created all in one project (one orientation)

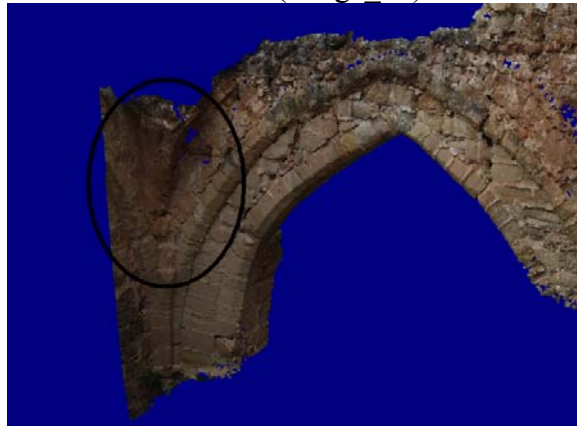
It was worked in one project that was consisted of 12 photos. We paid a lot of attention at the corner with the southern wall (image 42).

Image_42: Western – Southern corner

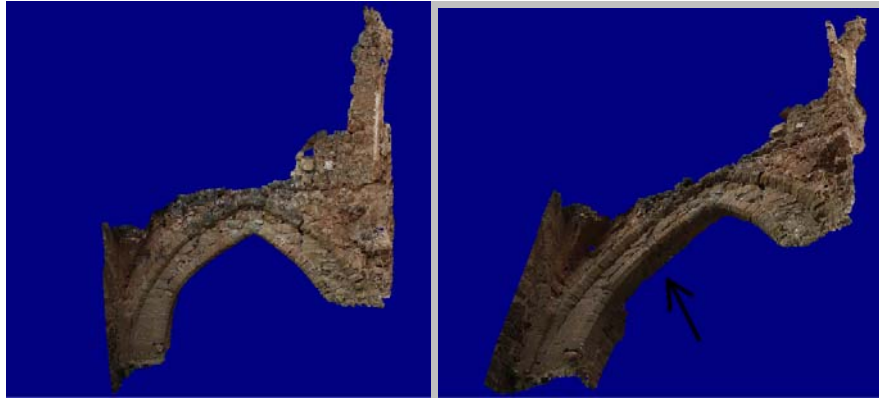
The geometry of the photos that *Photomodeler Scanner 6* uses permits to obtain more information in one model. At the images_44, 45 & 46 is pointed out the fact that the *Photomodeler Scanner 6* in one only model could represent better than *Image Master* the bottom of the arc. These two projects use the same set of six photos for representing this wall. These six photos included almost all the information that *Photomodeler Scanner 6* used in order to create point cloud for this area. With the same six photos *Image Master* could not create mesh for this area. A possible explanation for this, is that the bottom of the arc is in the same direction with the axis of taking the picture. The areas that *Image Master* can represent well are the ones that are perpendicular to the axis of taking the picture.

Images_44: The western wall

Image_45: The bottom of the arc part represented at *Photodeler Scanner 6*

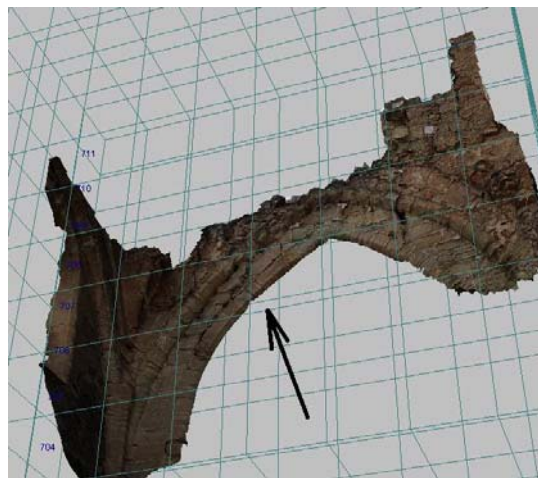
Image_46: The bottom of the arc part represented at *Image Master*

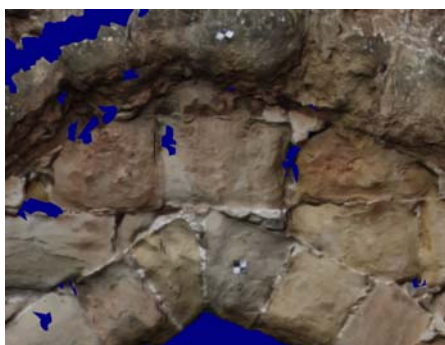
In addition to this the procedures of creating the mesh using this software are slower than the ones of *Image Master*.

Image_47: Mesh of *Photodeler Scanner 6*

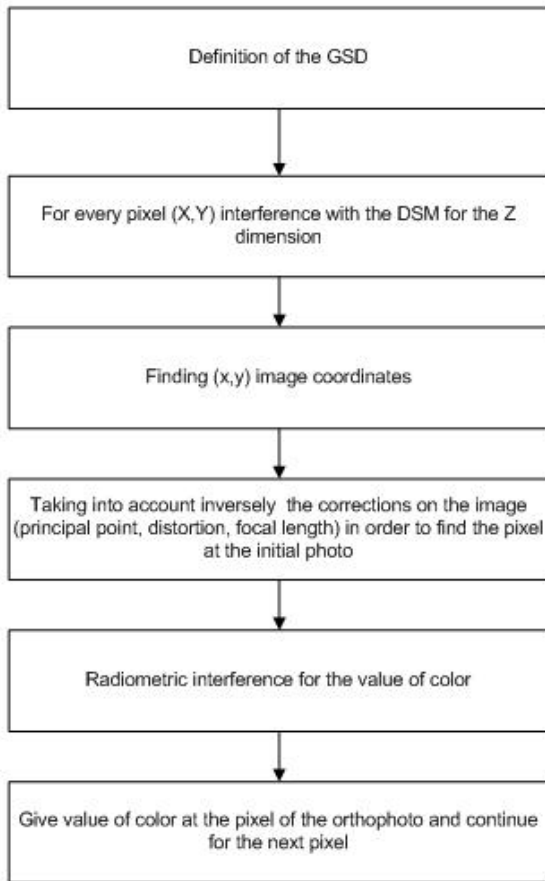
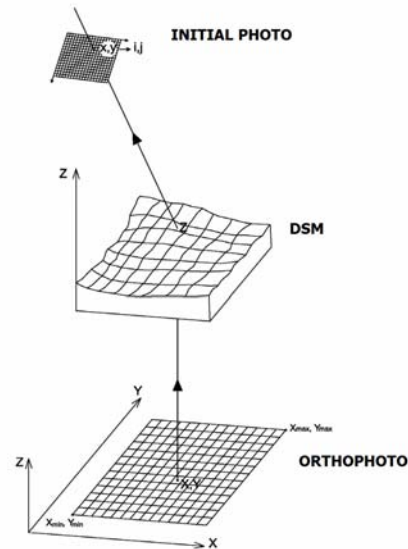
Diagram_2 & Image_49: Generation of orthophoto ²³

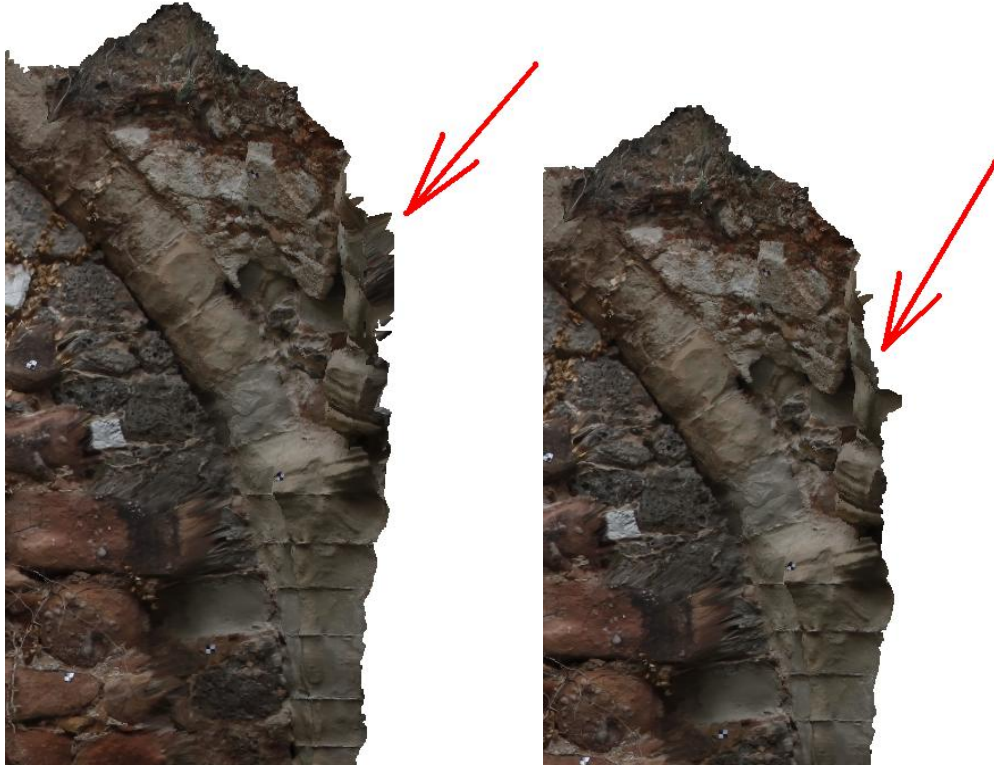
Images_50 & 51: Orthophoto with bad and no information at the corner

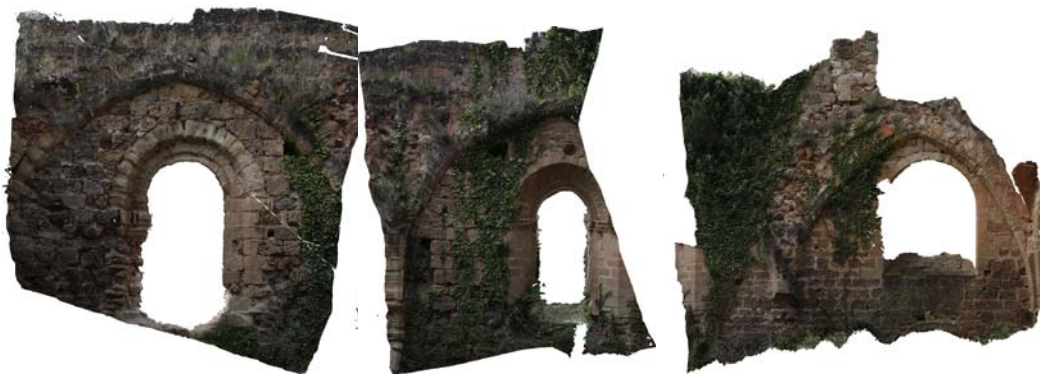
For this wall they were created three basic orthophotos (image_52,53 & 54) for the three different meshes.

Images_52,53 & 54: Orthophotos of the southern wall

As it is visible at the images_52 and 53 it is missing the column between these parts. Using the suitable photos by the appropriate point of view there were created the meshes and the orthophotos for this part (images_55 & 56)

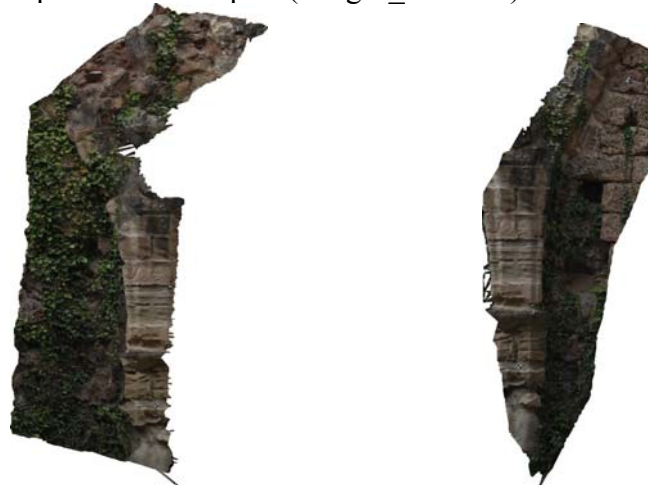
Images_55 & 56 : Orthophotos of the column (southern wall)

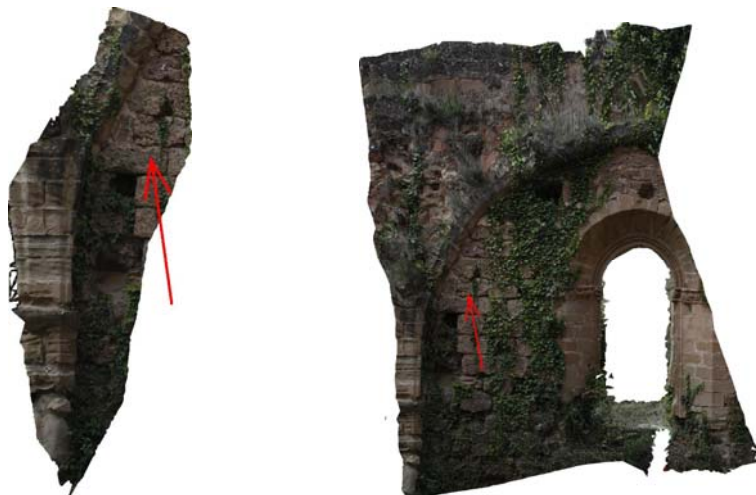
For the common parts that different orthophotos have (images_57 & 58), it was used the orthophoto with the better geometric accuracy, checked by the control points.

Images_57_58: Common parts at different orthophotos

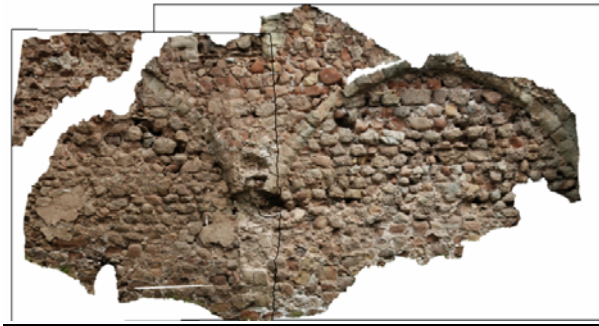
Image_60: Orthophoto of the northern wall consisted of two united orthophotos

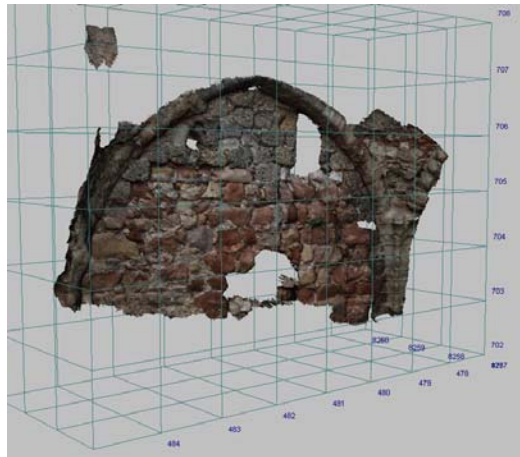
Image_61: Mesh of eastern wall

It is represented the bigger part of the wall. The areas where there is no information are mainly dark holes. A proposal for taking information for these areas if it is needed (i.g. archaeologist and architect needs), is to use special lighting condition for taking the photos.

- In cases that it is needed the interior of the holes at the eastern wall (measuring its depth, observating its rocks etc), they should be used special light conditions.

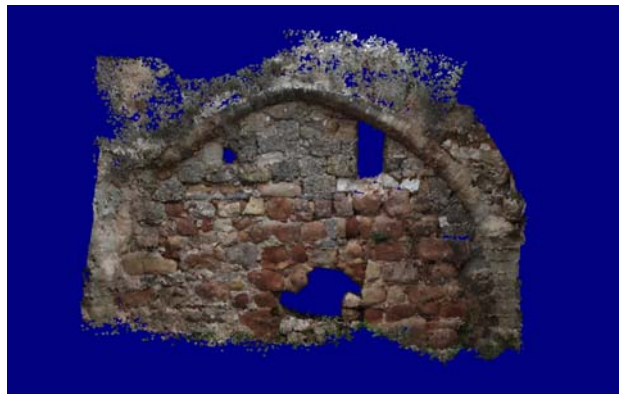
Image_62: Point Cloud of eastern wall

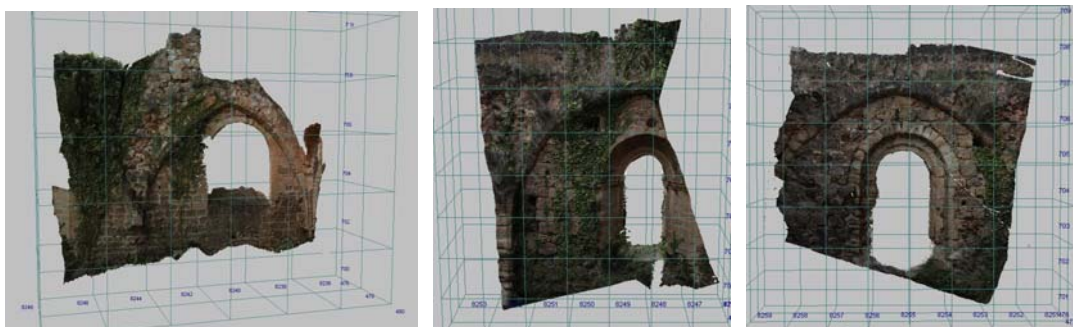
Images_63, 64, 65, 66, 67 & 68: Meshes of southern wall

There are parts of the wall that are missing but most of them are not included at the needed for documentation area, because they are part of the walls with plants. Something that was needed to be represented but failed due to a lack of suitable photos was the eastern part of the window (image_66).

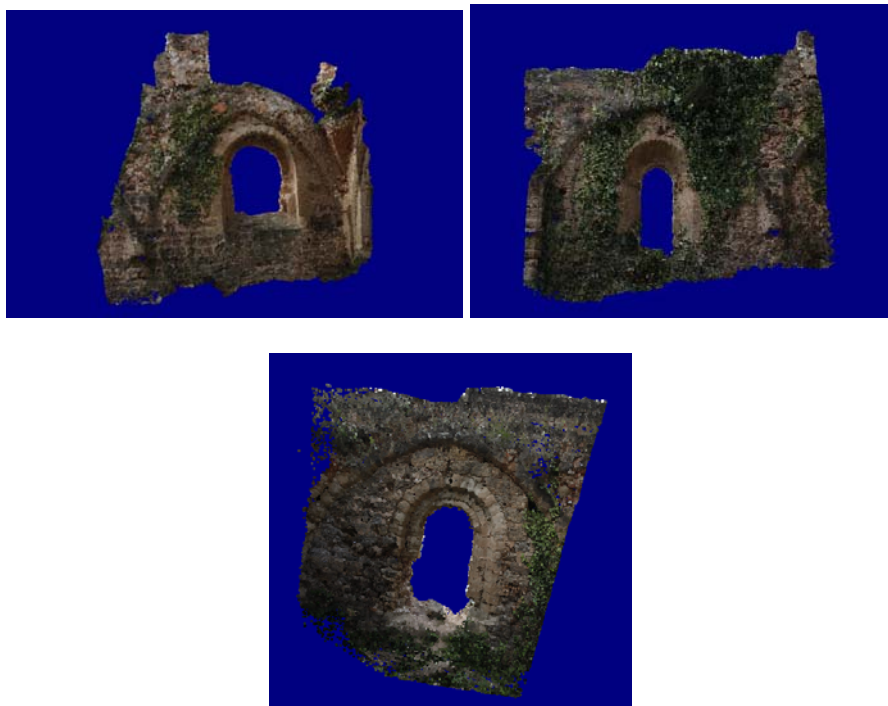
Image_69, 70 &71: Point Cloud_1, 2 & 3 of southern wall

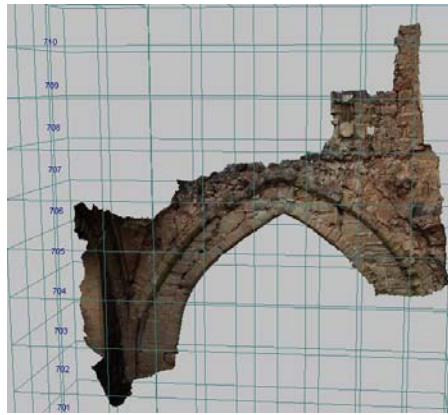
Image_72: Mesh of western wall

The mesh completes enough the representation of the wall. It is missing the southern upper part due to the fact that there were not photos for this part. The bottom of the arc is also missing. Some photos taken by a point of view that this part is visible is the solution for completing this area.

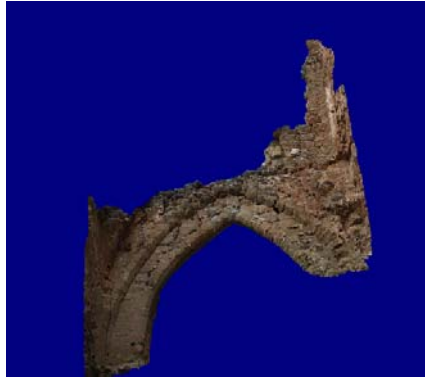
Image_73: Point Cloud of western wall

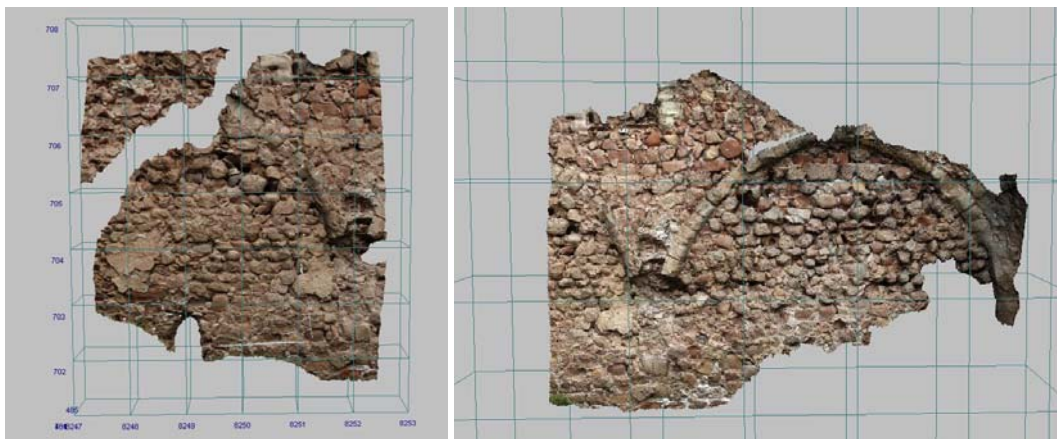
Image_74 & 75 : Meshes of northern wall

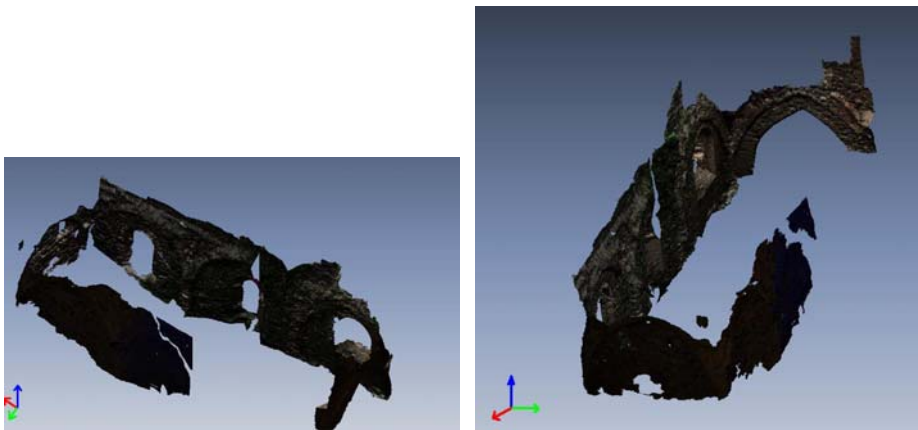
Images_76 & 77: The merged mesh from different points of view

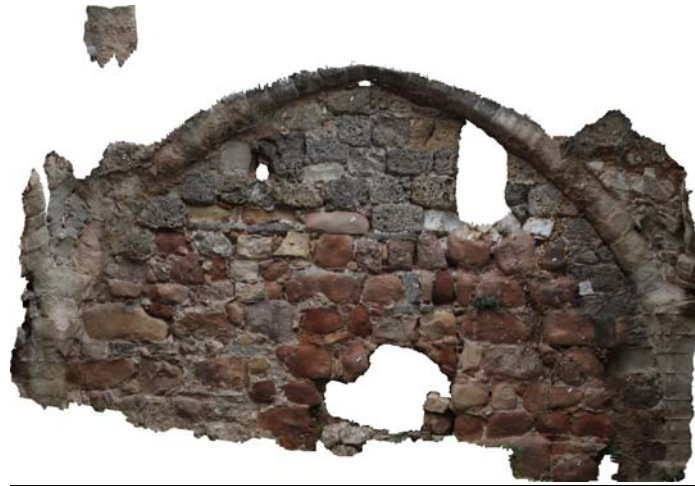
Image_78: Orthophoto of the eastern wall

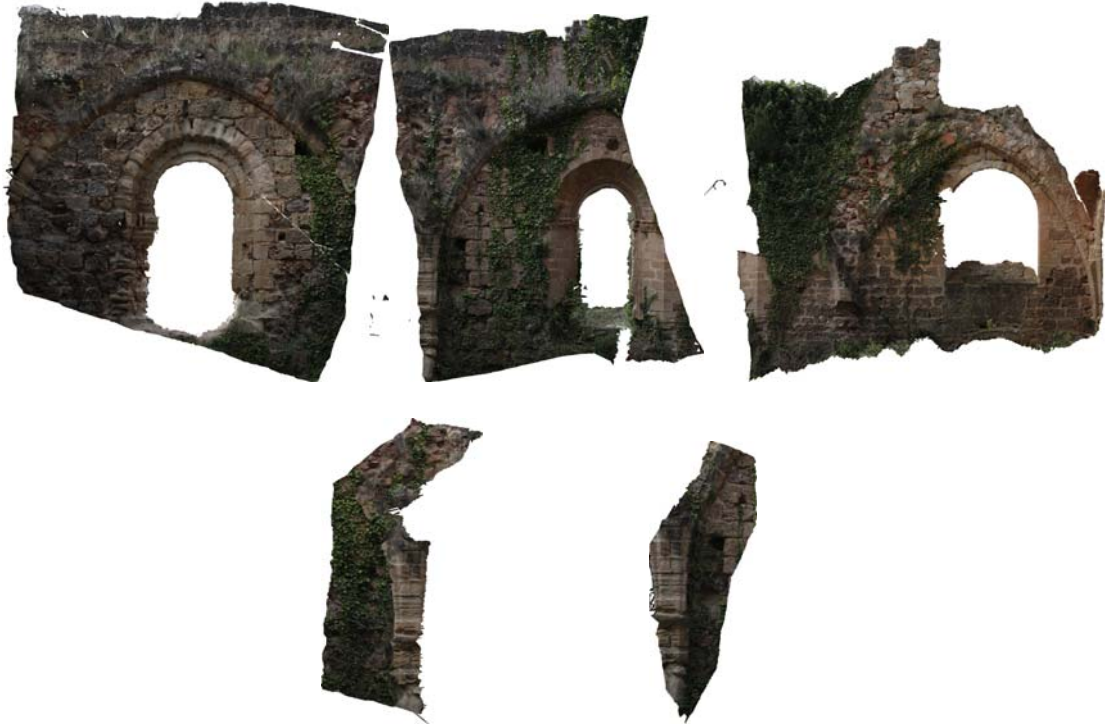
Image_79, 80, 81 & 82: Orthophotos of the southern wall

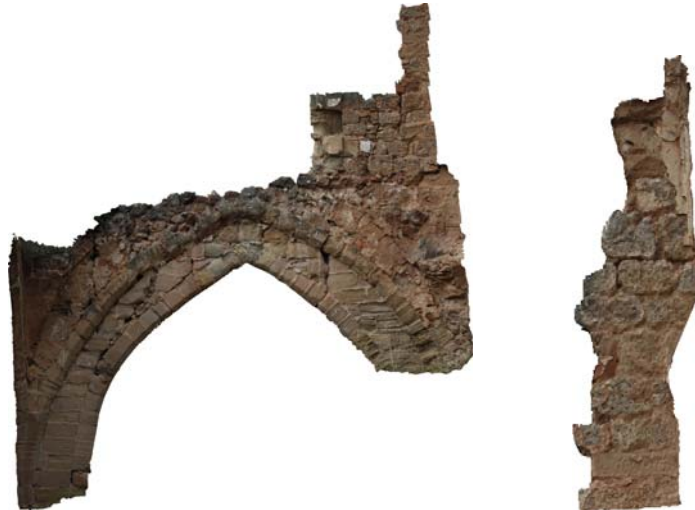
Images_83 & 84 : Orthophotos of the western wall.

These two orthophotos cover almost all the part of the western wall. It is missing the upper southern part, that it is almost all covered by plants.

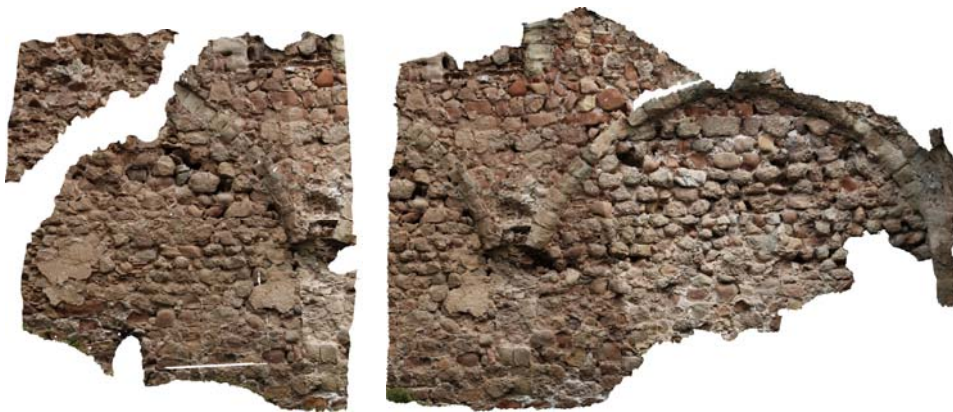
Images_85 & 86: Orthophotos of northern wall
