Case Report

# Combination of Diagnostic Tools for the Proper Identification of Moisture Pathologies in Modern Residential Buildings

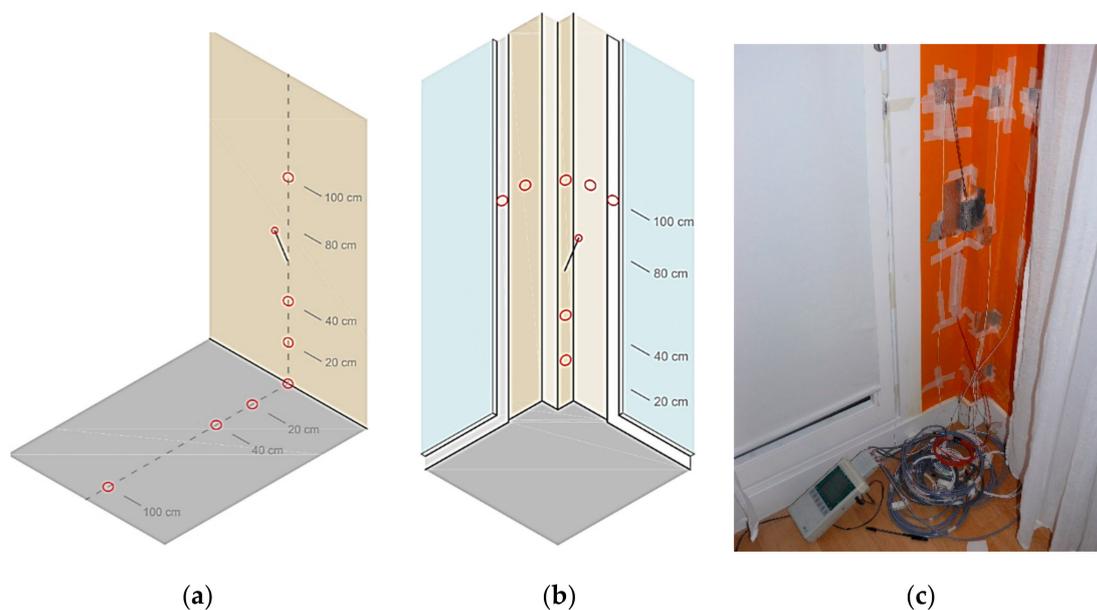
To measure the thermal performance of the opaque elements and the thermal bridging effect, a number of surface temperature meters were placed on the envelope, as shown in Figure 3. By using those sensors, detailed temperature profiles were obtained, and temperatures in the coldest point in contrast to the adjacent elements were evaluated. Data acquisition was done using two small data loggers.

**Figure 3.** (a) Schematic of sensor installation in a façade and slab thermal bridge; (b) schematic of sensor installation in a façade corner pillar; (c) sensors and data logger installed in a façade pillar.

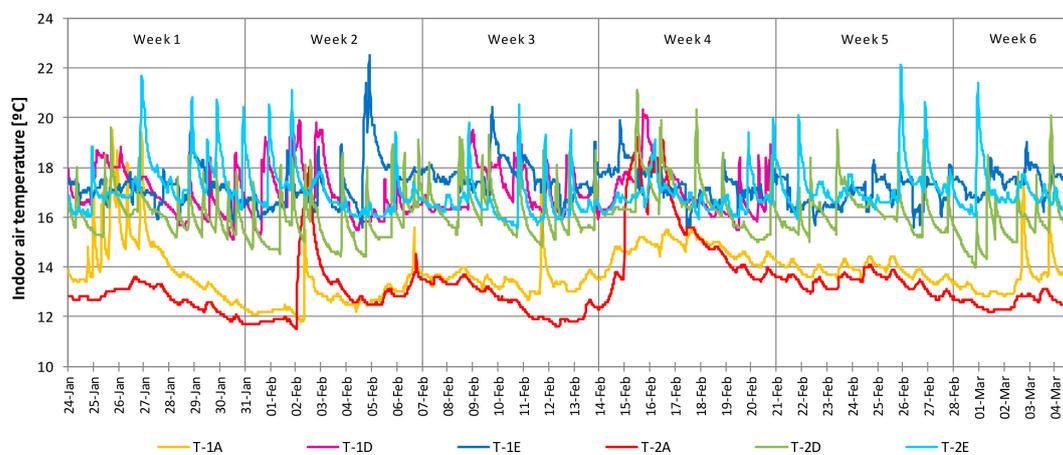
The measurements lasted 40 days and registered a high variability of users with different habits, as shown in Figures 4 and 5. Very little use of heating was observed in all the dwellings, especially in dwellings 1A and 2A. Additionally, the RH levels were high, especially in dwelling 1E, which lacked ventilation during the study period.

Apart from those few exceptions, the average indoor air temperatures of the dwellings were low, around 16–17 °C, and the peaks of warm temperatures were around 19–20 °C. The average indoor air RH was measured around 55%–65%. According to these results, the indoor air conditions are below the minimum limit of 21 °C set by the Spanish regulation of thermal comfort [9] that is based on the well-known Fanger limits of indoor air temperatures for heating in residential spaces [10].

Figure 4. Measured indoor air temperature of six dwellings.

- Improve the indoor conditions of use. The regular use of heating and ventilation would surely warm up the envelope, control the indoor RH, and dry the air cavities. These cheap and non-invasive decisions would contribute significantly to solve the problem. This would mean an approximate increase of 400€ of individual heating use per home and year to maintain a minimum indoor air temperature of 19 °C.

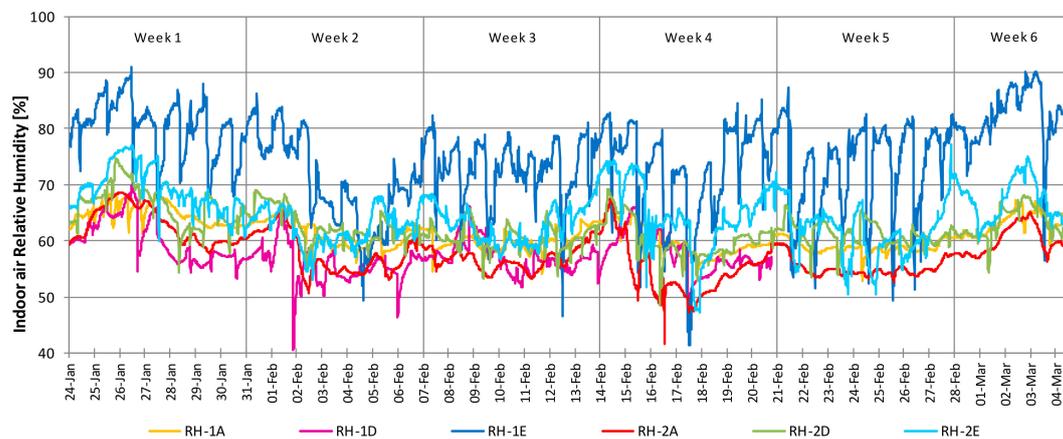
Figure 5. Measured indoor air RH of six dwellings.

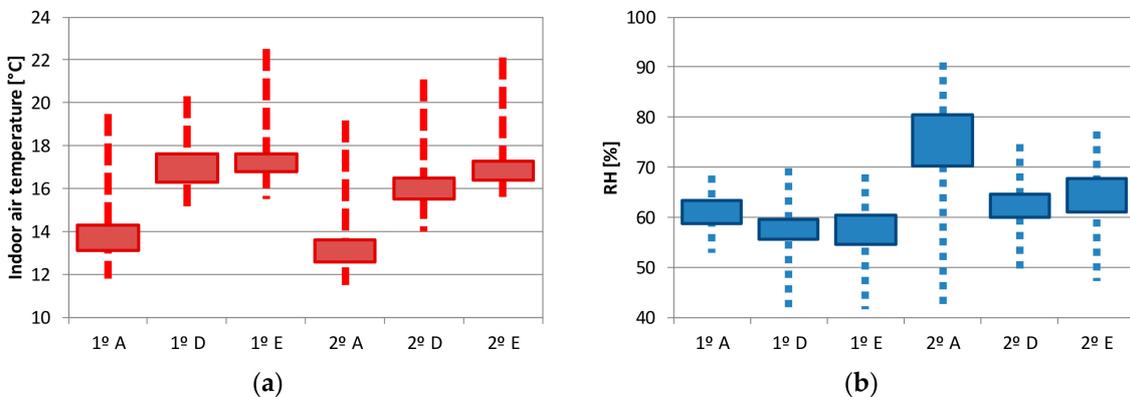
First, the assessment of the condensation risk in the studied façade, based on the D1 climate zone typical winter conditions and the measured indoor air conditions, is summarized in the box-plots in Figure 14, with the most frequent indoor air conditions of each dwelling. This assessment provides some evidence that there are three dwellings where the RH was over 70% for many hours. This high level of humidity is related to low heating use and insufficient ventilation. Additionally, it is worse in this case because of the small stack ventilation effect and inadequate window-opening habits for natural ventilation. The condensation risk for the building façade indicated that when the indoor air RH is over 70%, there is a clear interstitial condensation risk in all six dwellings, according to the annual method of the UNE-EN ISO 13788:2016. Table 2 gathers the main results of this verification, and in Figure 15 a comparison of condensing and non-condensing façade examples is presented. The situation in each dwelling is singular on a daily basis; on a monthly calculated basis, only one dwelling presented a measurable risk of interstitial condensation. The other dwellings presented only occasional surface condensation risks. For this reason, taking into account only this tool, it wasn't possible to determine the origin of the humidity problems of the other five dwellings.

**Figure 14.** (a) Box-plot of monitored indoor temperatures; (b) box-plot of monitored indoor RH.

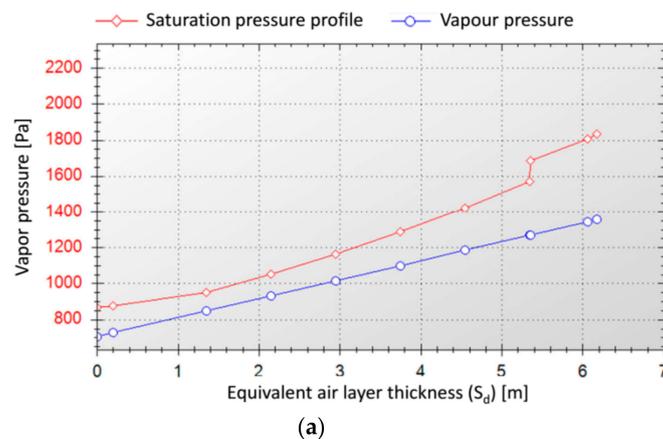
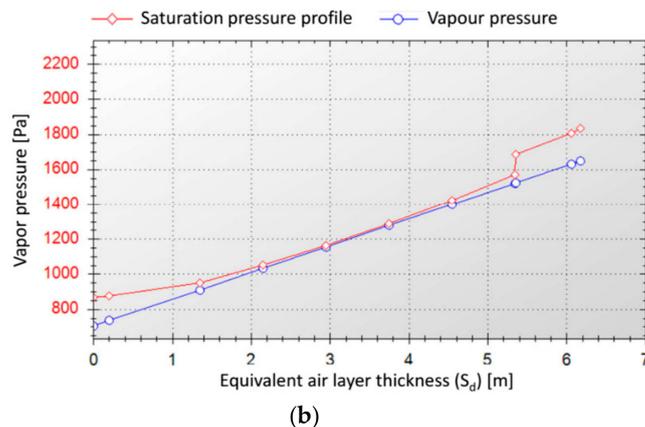
**Figure 15.** (a) Vapor pressure resistance profile of a façade when the indoor temperature is 17 °C with 65% RH; (b) vapor pressure resistance profile of a façade when the indoor temperature is 17 °C with 80% RH.

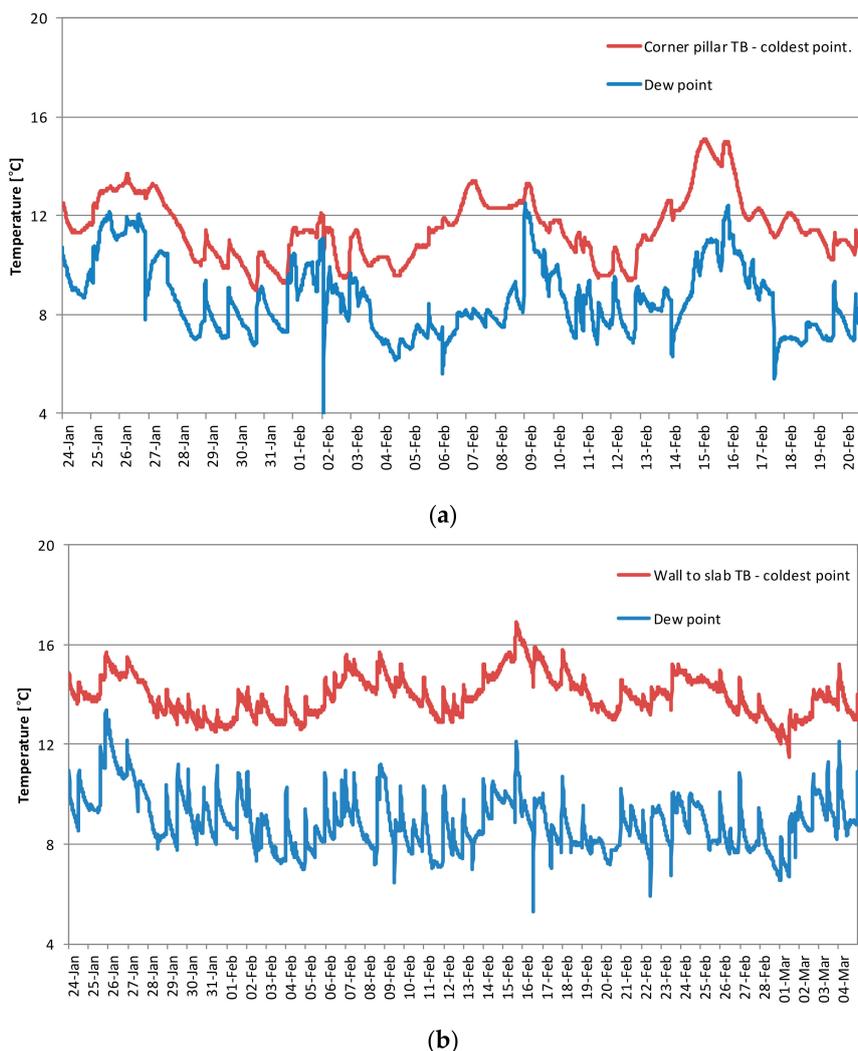
Second, the study of the surface temperature profiles in thermal bridges and the air dew point showed that the corner pillars have a measurable condensation risk. The joint of the façade-floor slab did not show any condensation risk under the monitored indoor air conditions. The pathologies around the corner pillars could be explained by this phenomenon, but other pathologies around ceilings, window frames, and walls could not, as can be seen in Figure 16.

**Figure 16.** (a) Dew point and thermal bridge coldest point for the corner pillar; (b) dew point and thermal bridge coldest point for the façade-floor slab joint.
