In-situ analytical study of bricks exposed to marine environment using Hand-Held X-ray fluorescence spectrometry and related laboratory techniques

Punta Begoña Galleries (Getxo, Basque Country, Spain)

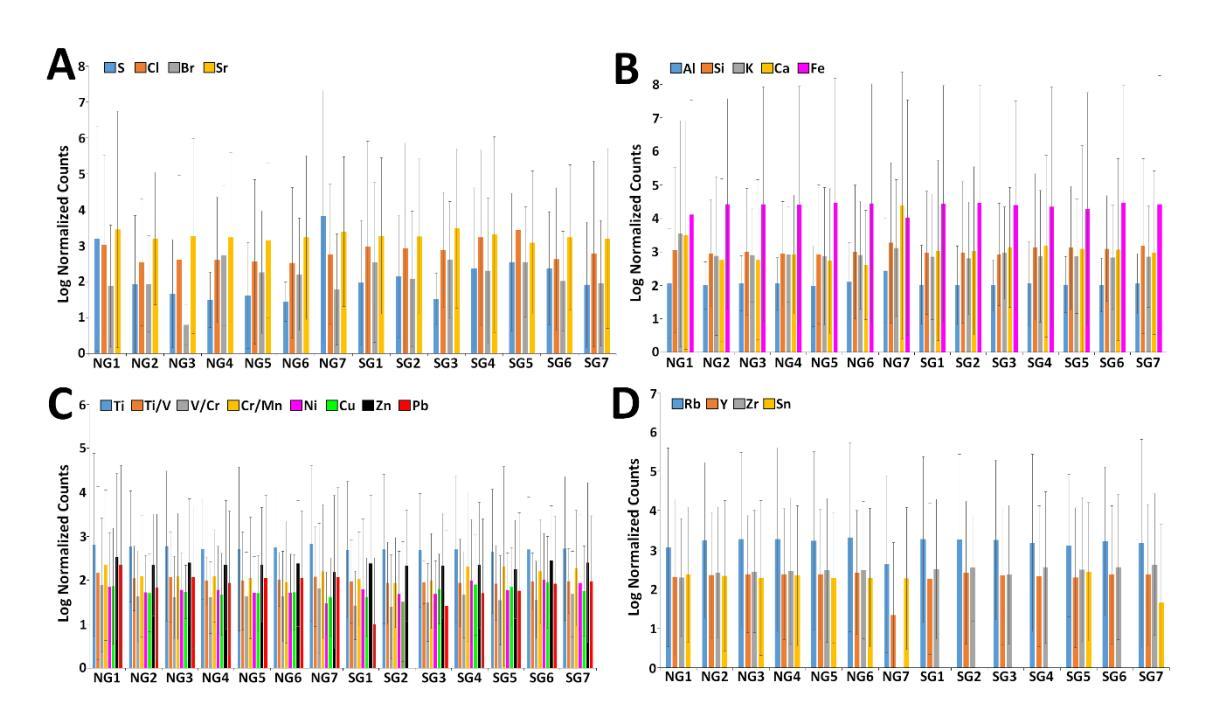
In all the analyzed areas, S was also detected. The presence of this element in the bricks could suggest the possible presence of sulfates. These compounds can be present in the bricks due to the influence of infiltration waters rich in sulfates or as a consequence of the impact of atmospheric SO_x . Calcium carbonate that can be present on them can react with the sulfates in the first case and with the H₂SO₄ coming from the atmospheric SO_x . S normalized counts values are higher in the SG than in the NG, except for the case of NG1 and NG7 areas.

The normalized counts of Ti, V, Cr, Mn, Ni, Cu, Zn and Pb are presented in Fig. 2C. Ti, V, Cr and Mn show interference once with each other's. Thus, these interferences could alter the conclusions that can be extracted analyzing the normalized counts. Leaving aside this observation, the normalized counts of each element is similar in all the analyzed areas, suggesting that the main contribution of these metals come from the natural raw material itself. This tendency was not observed for Pb. In this case, higher normalized counts were obtained in the areas from NG than in areas from SG; particularly, this element was not identified in the SG2 area. This observation could suggest a possible deposition of Pb coming from the surrounding atmosphere, especially in the bricks from the NG area. It is necessary to remark that there are metallurgical industries from the metropolitan Bilbao, not far away from the Galleries, and they contribute to emissions of metallic particles, being possible their subsequent dry deposition [22, 23, 45].

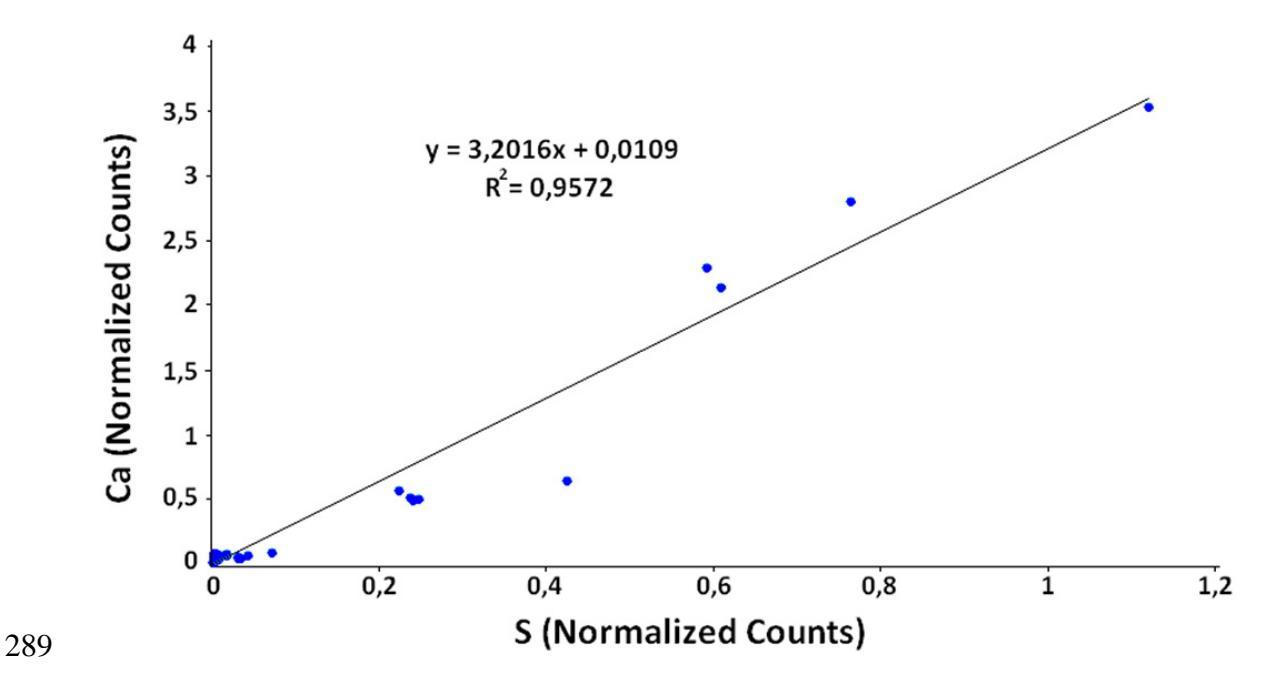
265 (PCA). In this case, major elements related with the original composition of the bricks 266 such as Al, Si and Fe were removed from the data matrix before performing the PCA 267 analysis. Fig. S1 shows the scores and loadings Bi-plot. The most remarkable trend is the 268 high correlation between Ca and S (see the representation of Ca normalized counts vs. S 269 normalized counts in Fig. 3 showing a high correlation) and the high distribution of both 270 elements in NG7 area. These results confirm that this area could be the most affected one 271 by calcium sulfate salts. The formation of calcium sulfates in brick is one of the most 272 critical factors in their conservation state. According to the literature, some authors point 273 out that in some cases the formation of gypsum on the surface of the bricks material can 274 lead the inclusion and the formation of anhydrite inside the bricks as cryptoefflorescence 275 [19, 51], decreasing the stability, which is a critical factor for the bricks [52].

290 Fig. 3. Representation of Ca against S normalized counts extracted from the ten replicate

291 measurements obtained from each measured area.
