The presence of secondary creep in historic masonry constructions: A hidden problem

S. Sánchez-Beitia (corresponding author, santiago.sanchez@ehu.eus), D. Luengas-Carreño and M. Crespo de Antonio

Abstract

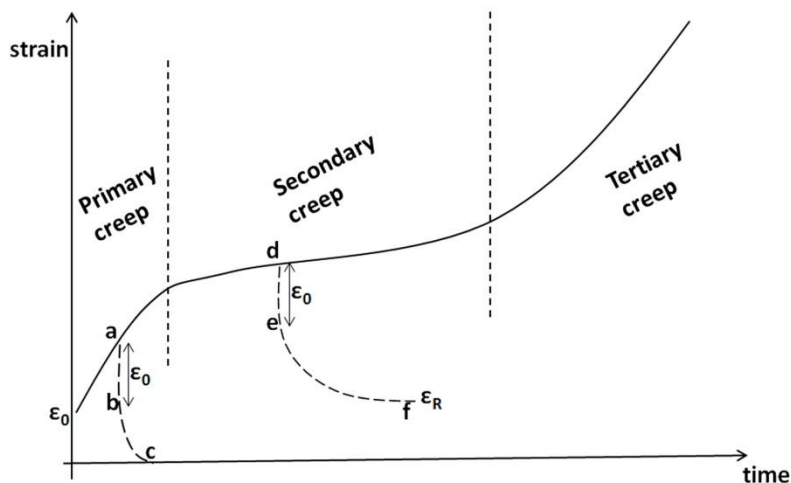
According to previous laboratory works on masonry blocks, the phenomenon of creep has three phases [14]. The same way, creep phenomenon is described on a unitary stone block [29]. The primary creep has reversible visco-elastic behavior, the secondary creep has viscoplastic behavior and the tertiary creep causes the early failure (Fig. 2). Assume an initial load that on a stone block produces an instantaneous deformation which value is ϵ_0 . If during primary creep the block is discharged, the deformation follows the path “a b c”. The section “ab” coincides with the initial strain ϵ_0 . Strain in the stone block will continue decreasing asymptotically till its complete disappearance (visco-elastic behavior). In the secondary creep, the deformation follows the path “d e f”. In this case, the discharge reaches a remaining value of plastic deformation ϵ_R . The tertiary creep quickly leads to collapse. The integrity of a historical construction will depend on the detection of the presence of secondary creep. After that, adopted models would be applied for estimating the residual life of the masonry.

Figure 2. The vertical creep strain under uniaxial compression in a stone block.

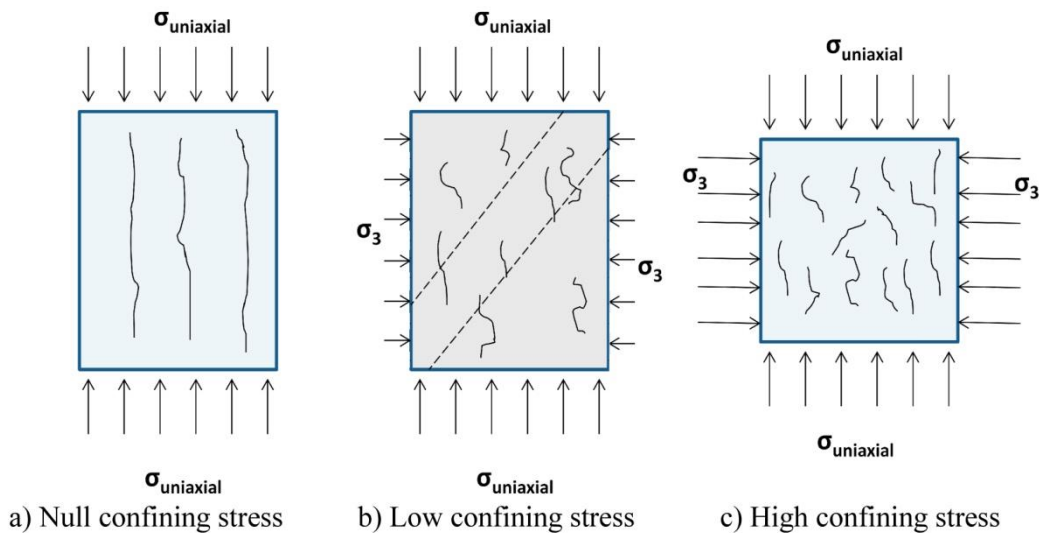
propagation starts under compression loads (σ_{uniaxial}) which levels are below the half of the breaking load of the rock [29]. Under a low confining pressure (σ_3) the crack growth is unstable: inclined cracks, related with shear strain (Fig. 3b). When the confining pressure (σ_3) is high, microcracks growth turns more difficult, the block behaves as a pseudo ductile high deformation due to the contribution of a large number of microcracks (Fig. 3). Therefore, depending on the confining pressure, a stone block varies from a fragile behavior to a pseudo ductile one.

Figure 3 Crack types according to the confining stress value (σ_3).

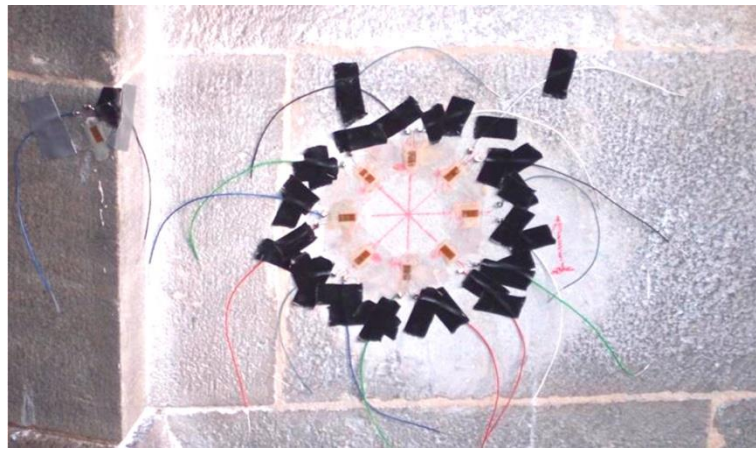
structural states, the first author used the technique of Hole Drilling. The first step in this technique is to lightly polish the surface of the masonry element to be measured to provide adequate adhesion of the strain gages that will subsequently measure the relaxed strains (Fig. 4). The presence of fissures or cracks studied in this paper in the material is revealed in this step (the patina is eliminated). Previous similar studies are not known and never before this phenomenon detected by chance was studied. These fissures were not considered relevant by the authors until more recently, when research projects conducted by various European research groups were analyzed. The first author began documenting this problem in the middle of the previous decade, as shown in the following figures (Figs. 5 to 7) where the cracks are previously marked. Figure 6 shows the top and bottom respectively of the same pier in the Colegiata church at Toro city in Spain (Fig. 8). Although fissures were observed in the great majority of cases, graphical results are not available for all of them due to the low resolution of the pictures and because it was not the damage studied in these cases. However, visual inspection under the patina on big historic stonework masonry constructions can be performed anyway.

Figure 4. Strain gage rosettes in the Barcelona cathedral (Spain).

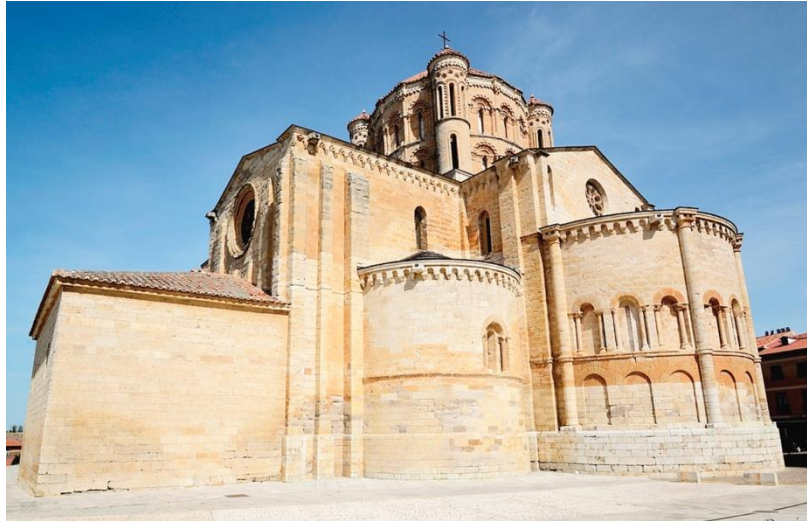
Figure 8. A general view of the Colegiata Church in Toro (Spain).

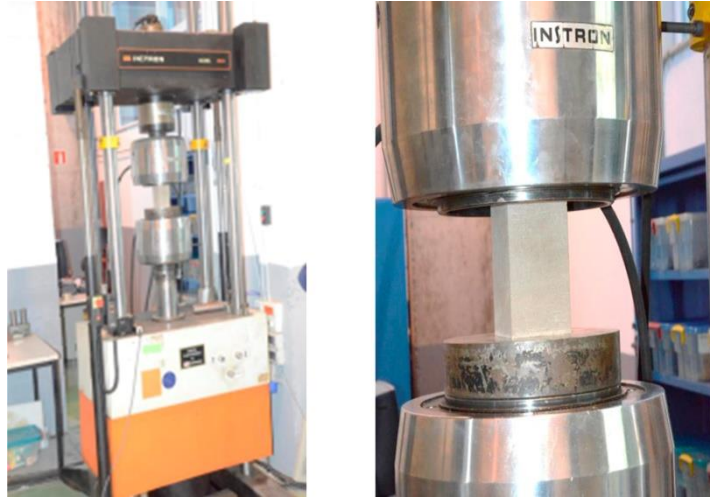
In the laboratory work sandstone masonry blocks were tested, which were subjected to 25 ± 2.5 MPa cyclic load at five Hz, at five minute intervals. After each interval, the surfaces of the blocks were examined under different magnifications, with the aim of detecting the number and the size of generated cracks. In this sense, the micrographs did not require a contrast and no computer application was used to count and size these cracks. Both the level of charges and the frequency chosen are arbitrary although the adopted stress level is close to the elastic limit of this kind of sandstone common in Spain (between 30 and 35 MPa). It should be pointed out that the objective of this test was not to check the behavior of the material under creep-fatigue or to reproduce in the laboratory the loads originated in a real stonework masonry construction. The aim of this test was to verify if a cyclic load generates vertical cracks in sandstone masonry blocks and to establish a procedure for its identification. The technique applied in the laboratory was the quantitative metallography, commonly used in laboratories for testing fracture in metallic materials. Figure 9 shows what type of block was tested and the machine used for the tests. In all cases the prisms are 122 mm in length and have 72 mm side square section. Before starting the test, first block's four vertical faces were photographed at different zooms (between 25X and 36X) in order to distinguish the grains and the pores of this first sample, where compression microcracks will start. Figure 10 shows one of those vertical faces of the block.

Figure 9. Test process and sandstone block type.

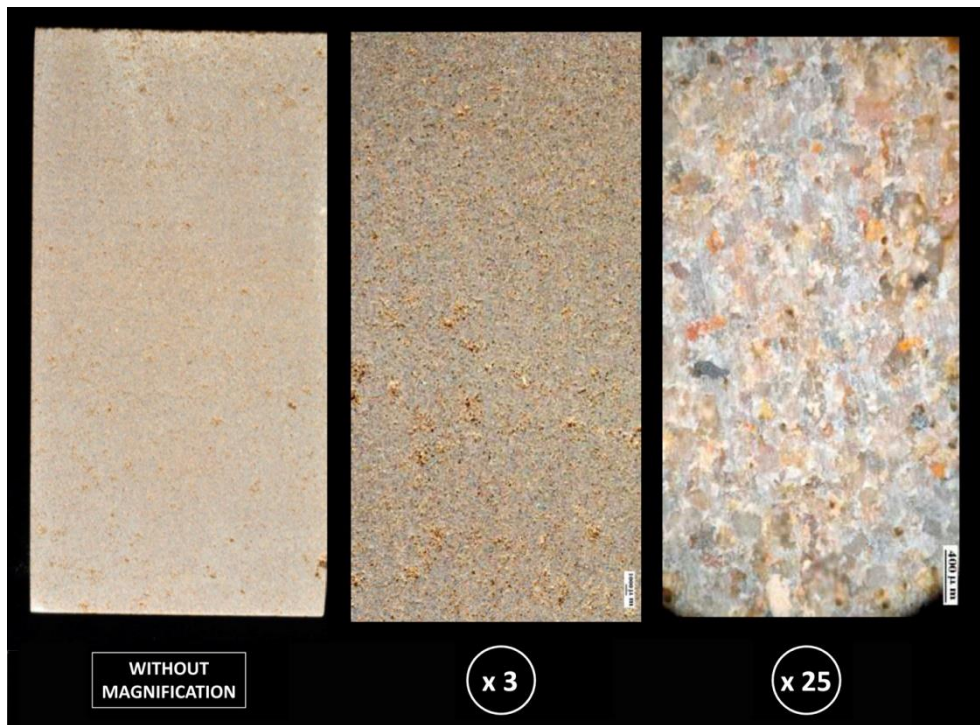
Figure 10. Photographs of the B side of the first block at different magnifications before fatigue test.

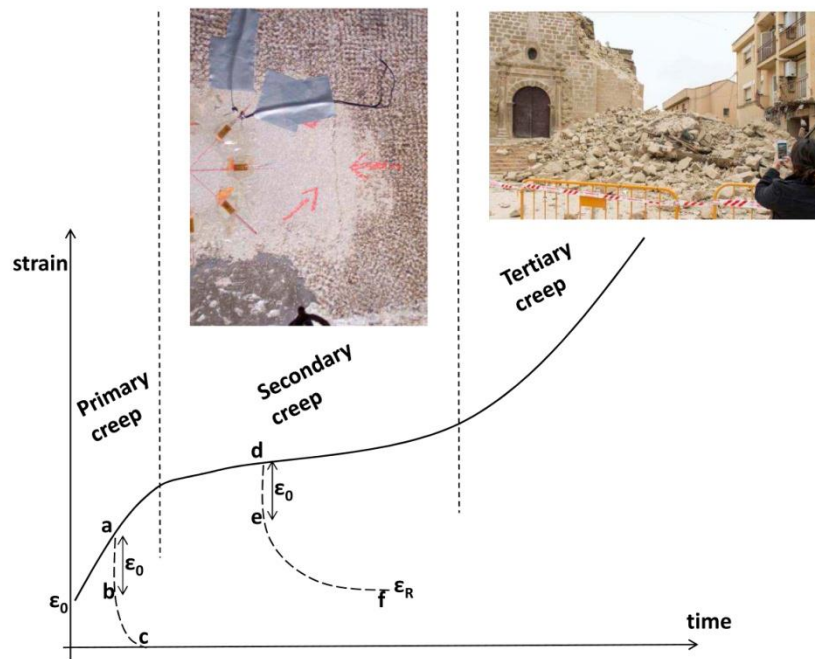
Finally, figure 18 is an assumption in which the graph of strain- time of the Figure 2 with the observed crack in a sandstone block from the Cathedral of Santa María del Mar in Barcelona (Spain) and the collapse occurred in Roselló's church in Lleida (Spain). If this were so, it would have opened here the possibility of detecting onsite the location of a historical building in the process of the creep-fatigue interaction.

Figure 18. Creep process assumption in a historic construction.
