Historical-Constructive Analysis of the Lighthouse of Santa Clara Island (San Sebastian, Spain)

Santiago Sánchez-Beitia¹, Daniel Luengas-Carreño^{1*}, Maite Crespo de Antonio²

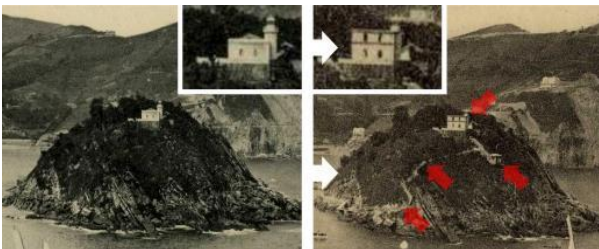
Figure 5. First refurbishing: Second floor and new accesses road. Donostia-San Sebastián Postcard Collection of GureGipuzkoa repository

According to the historical photographs (Figure 5), the lighthouse underwent an important refurbishing in the late 19th or early 20th century, when a new upper floor was built in the adjacent building. Although the project of these works could not be found, the images show a substantial alteration of the structure. The new floor, built on top of the walls of the existing plant, was covered with a flat roof, which is the one that remains today. During this work a new door was opened in the tower, to connect it with the new floor.

The modification to include two storeys and a practicable flat roof simplified the work related to the exterior upkeep and maintenance of the tower. The new floor had three bedrooms and a full bathroom. A water tank was located in the flat roof, which was filled from the cistern using manual operating pumps. Outside, a new access road was also built, to improve the accessibility (Figure 5).

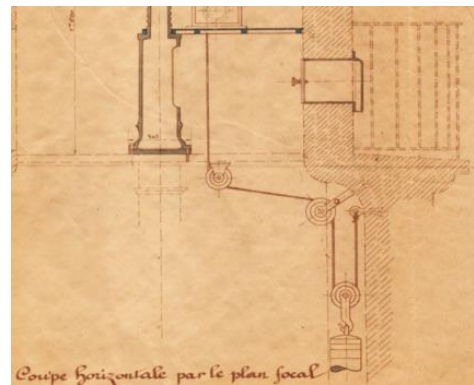
(a) Weight system of the rotation system

Figure 6. (a) Weight system of the rotation system according to the 1911 project; and (b) Acrylic optics of 2008 on white-coloured and the optics implemented in 1943, with inclined struts

According to the 1911 project (Figure 6), the screens were placed floating in a tank of mercury, connected to a cable and a 30-kg weight that descended by force of gravity down the

lighthouse tower (8 m run). The great advance represented by the design of mercury floats in O-ring vats to facilitate the rotation process must be pointed out. This system was ordered in 1911 from the French firm Barbier, Benard and Turenne, increasing the reach of the light to 12 nautical miles (22.224 km). The lamp was incandescent powered by gasoline. The complete replacement process ended on 25 August 1916. The long construction and installation period reflect the difficulty of taking any material to the lighthouse. Probably the onset of the First World War in 1914 contributed to the delay of the work.

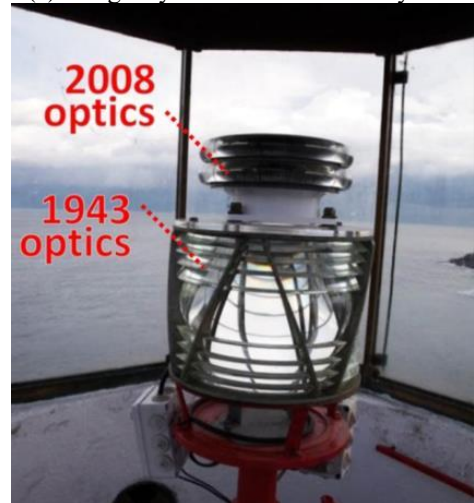
(b) Acrylic optics

Several decades later, in 1942, the electrification of the lighthouse was carried out. In 1943, the optics was also replaced (Figure 6). This second optics worked with a lamp of compressed acetylene dissolved in acetone. Nowadays, this optics is still kept in the lighthouse as reserve of a new one, which was implemented in 2008. The new optics works with LED lamps, generating flashes with no rotation mechanism.

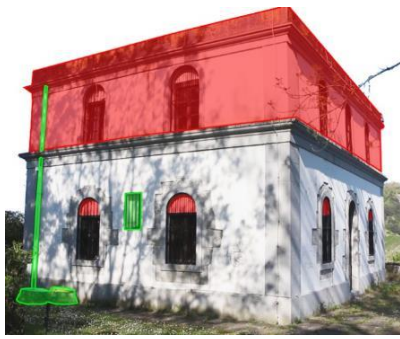
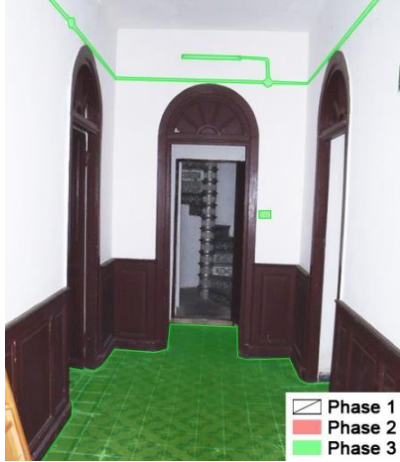
(a) Outside view of the lighthouse

(b) Inside view of the lighthouse

Figure 7. Phases of the lighthouse of Santa Clara Island: (a) Building façades; and (b) Access to the tower from the main entrance hall

During this period, the building also underwent some minor alterations. In 1945, the floor planks of the adjacent building were replaced with ceramic tiles (Figure 7) and some repairs were made to the path going from the wharf to the lighthouse. The facades of the building also underwent some modifications in the last decades of the 20th century, opening some windows and installing some sanitation facilities (Figure 7).

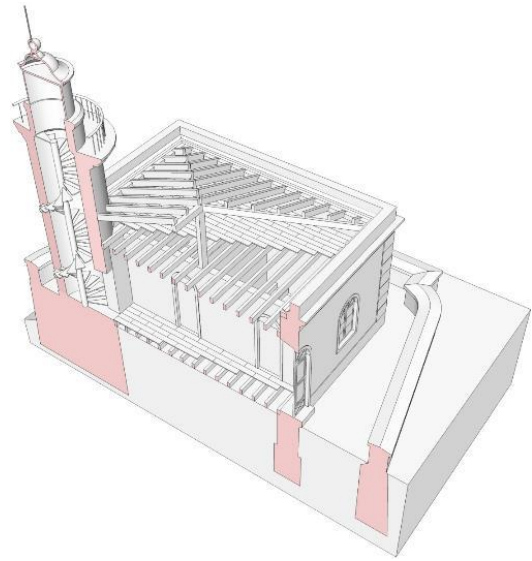
Figure 8. Virtual reconstruction of the original system and structure

The historical-constructive study has served to identify and to analyse the original architectural, structural and technological elements of the lighthouse of Santa Clara Island. Following the results of this study and the graphic documentation of 1867, a virtual reconstruction of the original building has been elaborated (Figure 8). The 3D model was made using AutoCAD. The model was exported to SketchUp in order to manipulate and render it.

The original building had very thick and deep foundation walls, possibly due to the steep slope of the site. The perimeter walls of the building were erected on top of these structures, using mainly limestone masonry. The use of ashlar was reserved for the openings and corners. As mentioned above, the walls of the tower were built with compact blue stone blocks from the quarries of Astigarribia (Mutriku).

The original building had a very simple structural system. The floors of the adjacent building were made with wooden beams. These beams were supported by the inner setbacks of the walls. The building had two interior stone walls, perpendicular to the main façade, on which the attic beams rested. These two walls also had the function of supporting the two posts of the roof, elements on which the ridge beam and the four hip rafters rested. The rafters, planks and tiles of the hipped roof were supported on this structure. The spiral staircase of the tower was sustained by a long circular metal column.

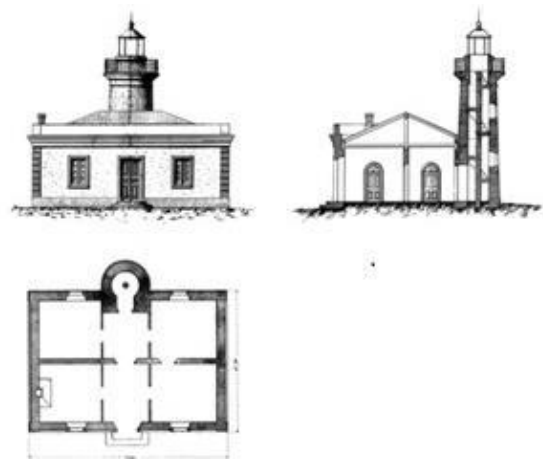
Figure 9. Drawings of the lighthouse of Suances

From a constructive-architectural viewpoint, the lighthouse of Santa Clara Island is quite similar to other Spanish lighthouses of Typology B-2 (Figure 1). In particular, both in terms of its shape and its interior distribution, it is very similar to the lighthouses of Suances (Figure 9) and San Vicente de la Barquera (Figure 10), which are located in the nearby province of Cantabria. The lighthouse of Suances was planned on one single floor, with a hipped roof and a rectangular ground plan of 12.00 x 8.50 m². It had a similar structure to that of the lighthouse of Santa Clara Island, although in this case the interior stone wall was built parallel to the main façade.

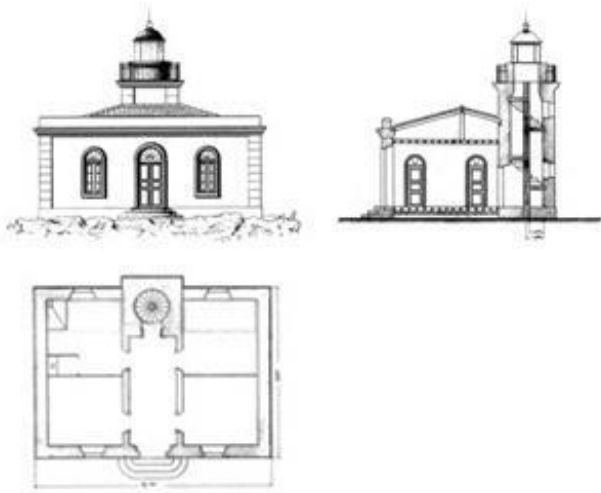
Figure 10. Drawings of the lighthouse of San Vicente de la Barquera

The lighthouse of San Vicente de la Barquera was also erected with a hipped roof and a rectangular ground of 11.70 x 8.65 m². According to the original drawings, this building originally had doors and windows very similar to those of the lighthouse of Santa Clara Island. Unlike the two previous lighthouses, a square tower was erected in this building. This tower was raised almost completely embedded in the adjacent building.
