Title: Deciphering past and present atmospheric metal pollution of urban environments: the role of black crusts formed on historical constructions

Deciphering past and present atmospheric metal pollution of urban environments: the role of black crusts formed on historical constructions

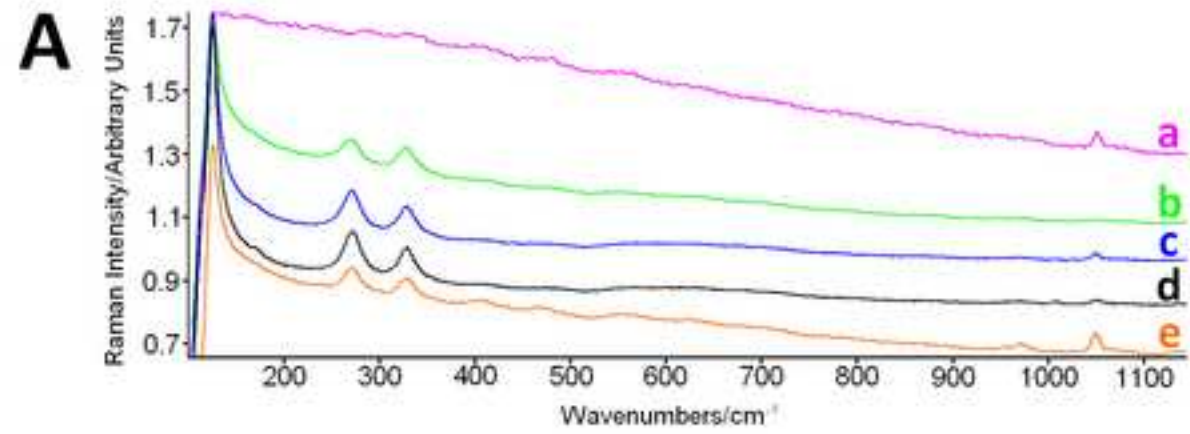
Figure 6
[Click here to download high resolution image](#)

Two main lead compounds were detected in the Pb accumulation area, laurionite (PbClOH), with bands at 124, 269 and 327 cm^{-1} , and hydrocerussite ($\text{Pb}_3(\text{CO}_3)_2(\text{OH})_2$), showing its main band at 1051 cm^{-1} (see Fig. 6 A) (Frost et al., 2003; Frost and Williams, 2004). The molecular results confirm that previously detected Cl-Pb elemental joint distribution can be related with the presence of laurionite. Apart from the mentioned Pb compounds, a band at 971 cm^{-1} which can be attributed to the ν_1 of PO_4^{3-} was also detected (Ranjesh et al., 2016). A possible compound related with it can be tsumebite, $\text{Pb}_2\text{Cu}(\text{PO}_4)(\text{SO}_4)(\text{OH})$, which presents its principal band at 971 cm^{-1} (Downs and Hall-Wallace, 2002). Considering that this Raman band was detected in few isolated spectra acquired by single point analysis and it was not possible to detect its presence by Raman imaging, this kind of phosphate can be present at very low concentrations.

In Fig.6B-D, the distribution maps of laurionite (spectral range 123-156 cm^{-1}), hydrocerussite (spectral range 1042-1059 cm^{-1}) and calcite (spectral range 1080-1090 cm^{-1}) are shown. Laurionite is mainly distributed in the Pb accumulation area, while hydrocerussite is sporadically present (as hot spots) and close to the calcite presence. Probably, this lead carbonate was formed owing to the reaction of laurionite with solubilised calcium bicarbonate coming from the calcite layer close to laurionite.

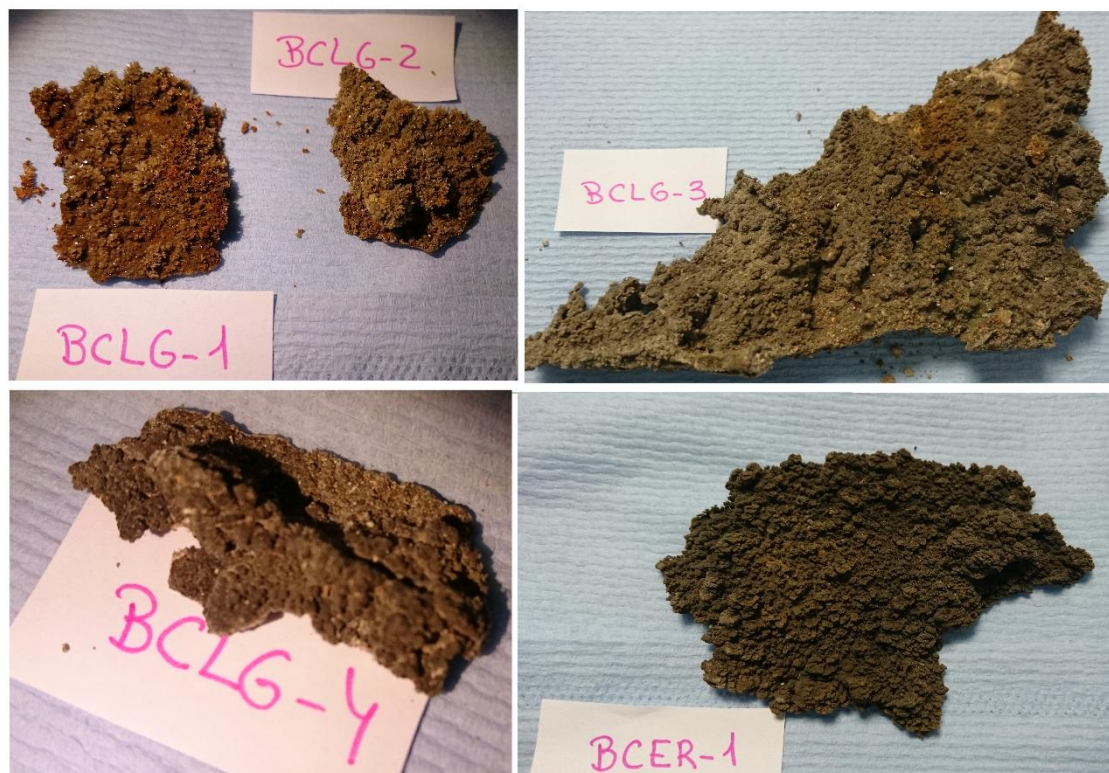
Figure S-1. Aesthetical appearance of some of the black crust samples.

In Table 1, the mineralogical composition of the BCs under study is displayed together with a description of the sampling area and the colour/morphology of the samples (see Fig. S-1 from Supplementary Material section).

The BCLG-1 and BCLG-2 samples, collected on the wall of the Lower Gallery, showed a characteristic orange colour (see Fig. S-1 from Supplementary Material), which can be related with jarosite ($\text{KFe}_3(\text{OH})_6(\text{SO}_4)_2$) presence, identified by XRD as one of the majors compounds of these samples. In the walls where these samples were taken (see Fig. 1), a red coloration coming from the iron leaching of the reinforcement of the concrete of the ceiling is observable. The solubilised sulphate ions coming from the BCs matrix can react with the leached iron to form jarosite in these specific BCs.
